Menemsha Commercial Fishing Dock Chilmark, MA Waterfront Inspection & Assessment Report

March 2022

Childs Project: 2982-22.00

Inspection Dates: March 10, 2022

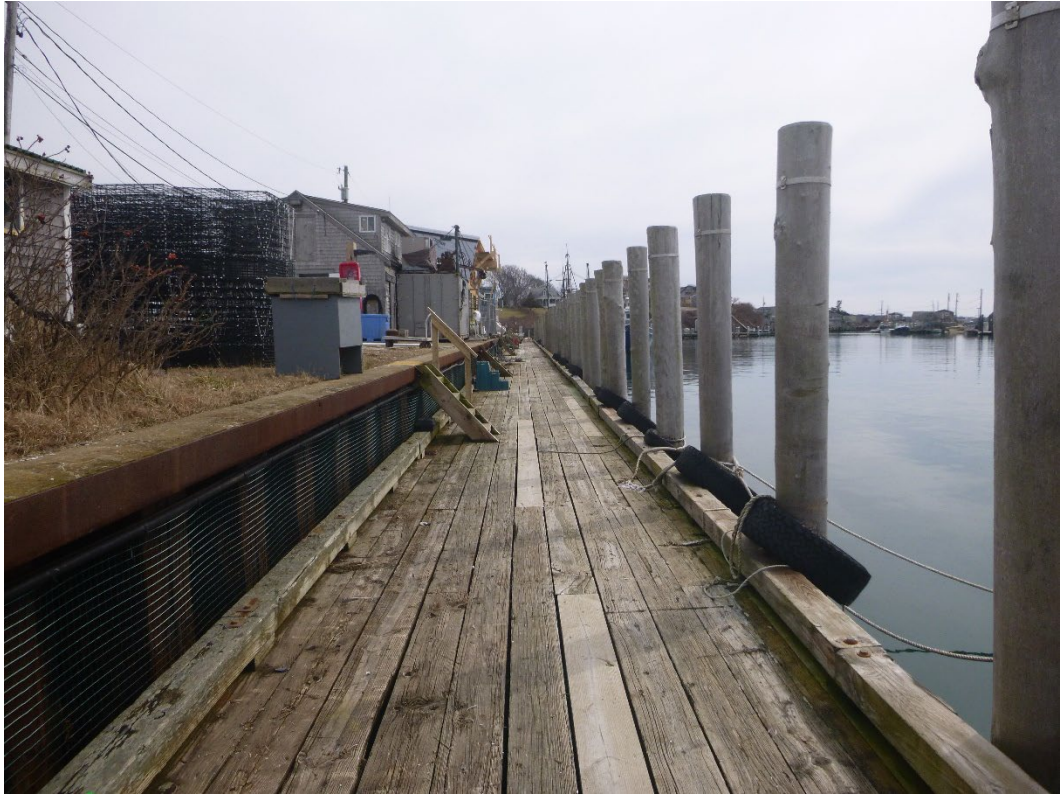
The inspection found that the Menemsha Commercial Fishing Dock as a whole is in **fair** condition with minor to moderate defects located throughout the facility and more advanced deficiencies found in isolated areas (see Photo 1 through 3). While many different structural elements are combined to comprise the Commercial Fishing Dock facility, a few isolated areas and structural elements govern the overall structural stability. The steel sheet pile and cap, which provide a border for the harbor and support the land behind to provide a foundation for adjacent buildings, are in **fair** condition with widespread minor to moderate deterioration and localized areas of advanced deterioration that do not currently compromise the overall structure or operational capabilities. The timber bulkhead is in **poor** condition due to the holes in the exterior timber face and unknown extent of recent repairs. Overall, the timber wharf is in **poor** condition with widespread structural deficiencies. The area of concern regarding the timber wharf is the connection at the inshore end of the timber pile caps to the steel sheet pile. These connections appear to have moderate to advanced corrosion. The fuel pier overall is in **satisfactory** condition with no defects noted. A cursory structural inspection was performed on the utilities which appear to be in **satisfactory** condition. Overall, we estimate that the existing structures have a remaining lifespan of 10 to 15 years if repair and preventative maintenance projects are completed. Additional lifespan lengthening project could be undertaken to increase the useful life of the facility, but the costs would likely be high compared to the overall return on value.

Photo 1 – Typical portion of the wharf in fair condition.

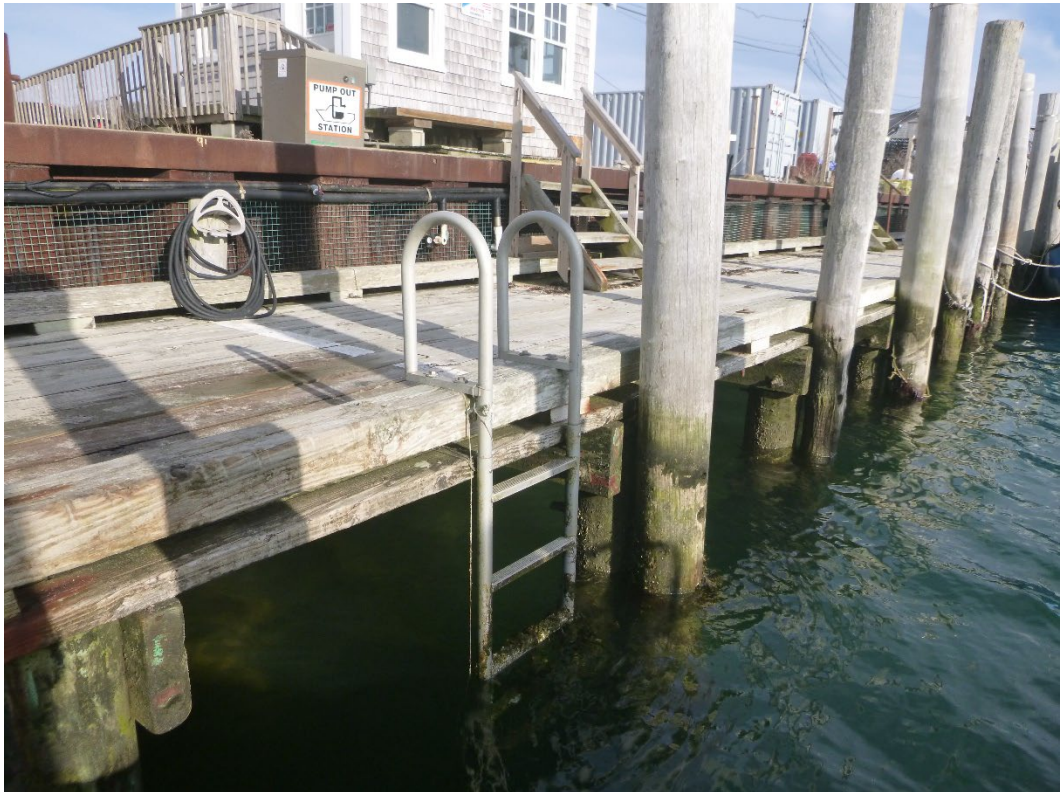
Photo 2 – General view of the wharf construction.

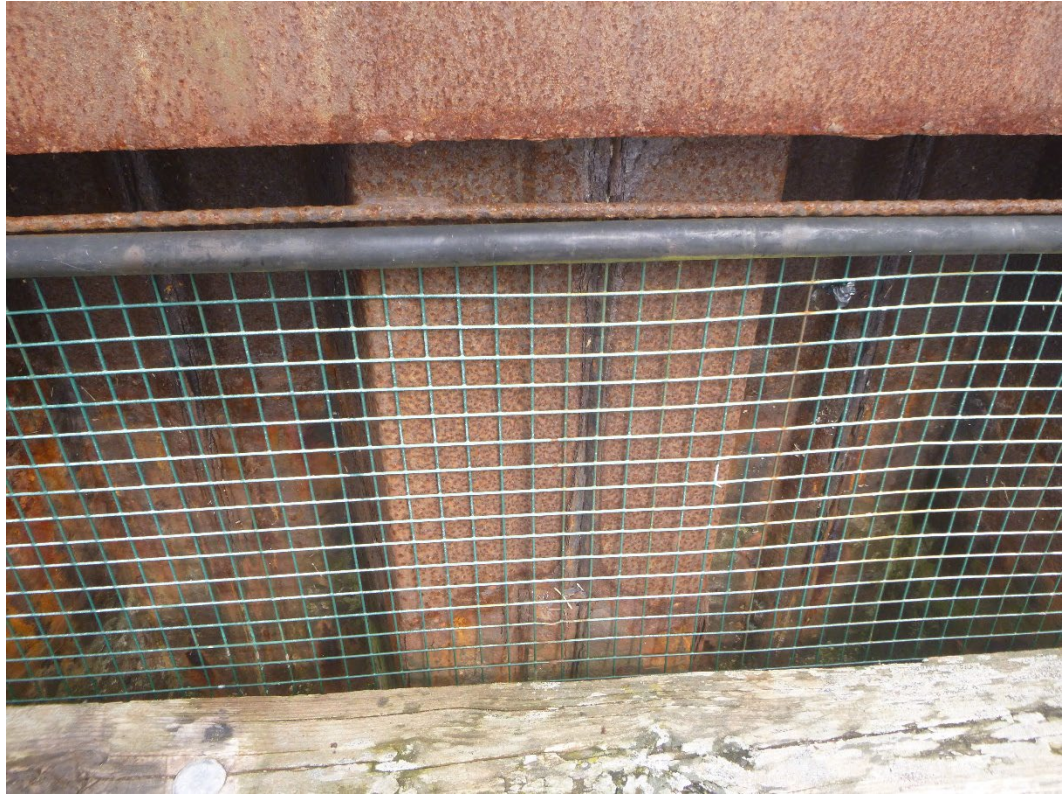
Photo 3 – Typical view of the steel sheet pile bulkhead.

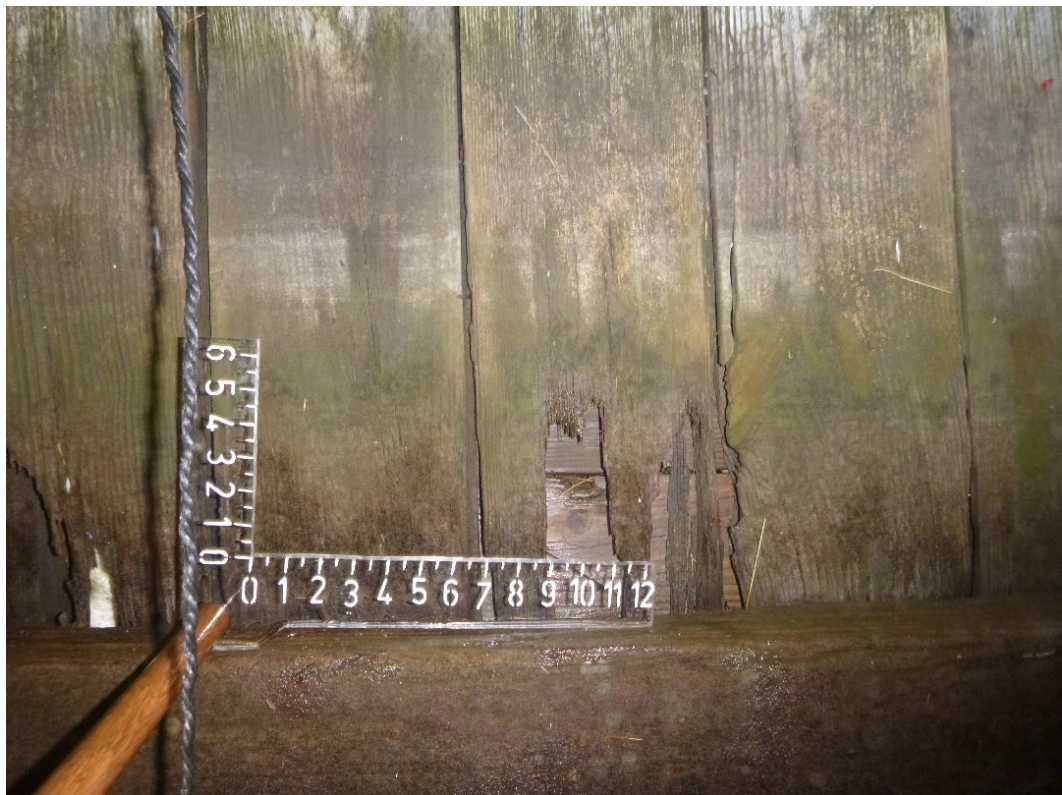
The timber portion of the bulkhead is located at the southern end of the facility from station (Sta.) 0+00 to Sta. 0+17. This section is comprised of 3 inch by 9 inch vertical tongue-in-groove boards supported by two 12 inch by 8 inch wales, one at the top of the structure and the other near mean low water (MLW). Overall, the timber bulkhead is in **poor** condition with widespread fungal decay of the timber boards. The exterior vertical boards typically exhibit large holes near MLW and in the tidal zone (see Photo 4). The recent repairs to this section of bulkhead included digging behind the bulkhead to install horizontal 4 inch by 8 inch pressure treated timbers. It was noted that before the repairs were completed sinkholes were forming behind the bulkhead. The new horizontal boards are in satisfactory condition, but the inspection was limited to what was visible through the holes in the exterior timber bulkhead. While this repair will likely hold for some time, it is recommended to view this as a temporary measure until more permanent repairs can be made to the entire facility.

Photo 4 – Holes in the timber bulkhead in the tidal zone with new timber visible behind.

The recent repairs to the bulkhead have extended its useful life. These repairs however should be considered temporary until a replacement project can be undertaken. We recommend the timber bulkhead be replaced with a new steel bulkhead as part of a larger project to upgrade the facility. Until such time that the timber bulkhead can be replaced, we recommend that loading immediately behind the bulkhead be limited to pedestrians only and that it continues to be inspected for further deterioration or possible movement.

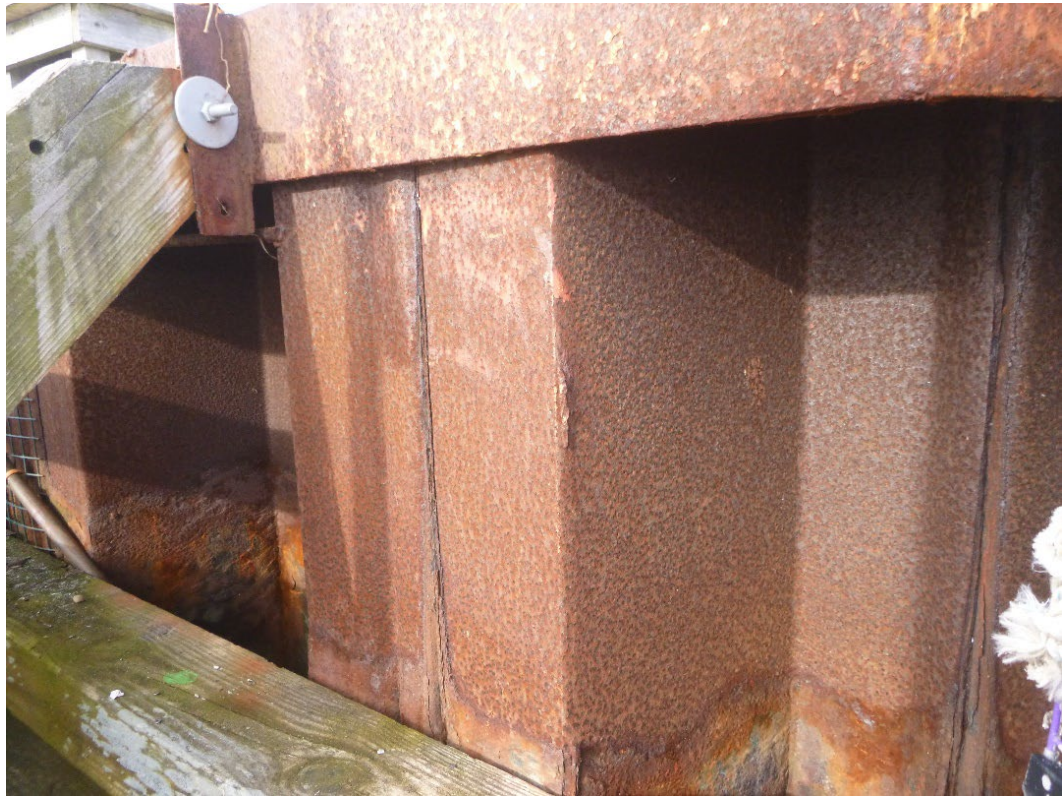
Photo 5 – Close up of typical sheet condition with surface corrosion and wavy steel.

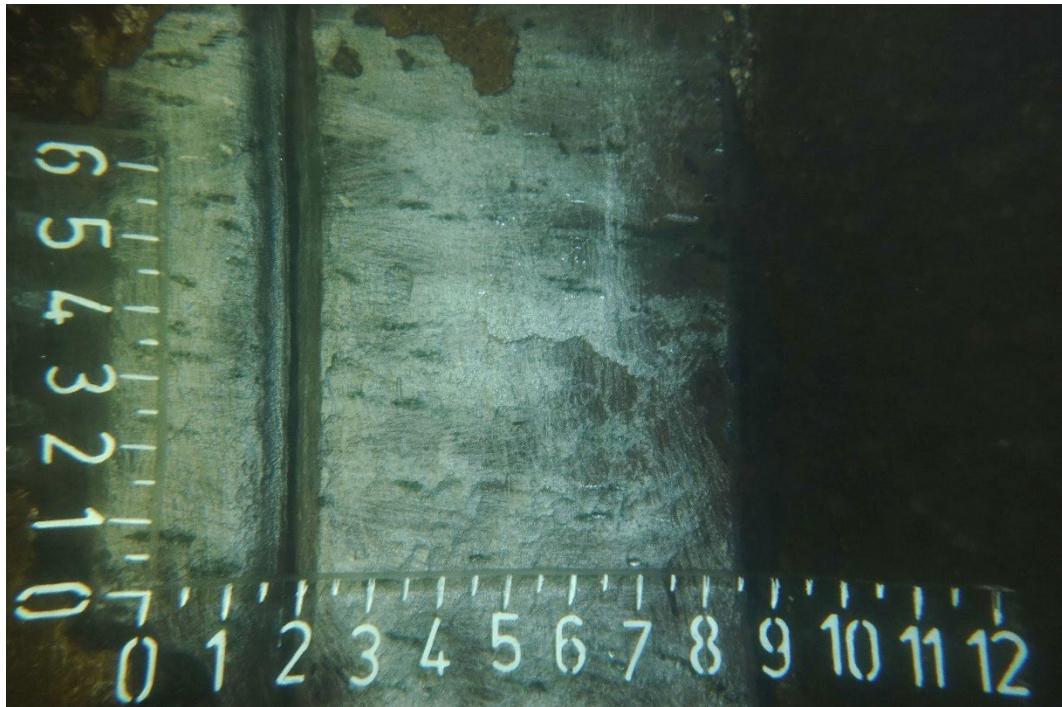
Photo 6 – Underwater view of the cleaned sheet pile with wavy steel.

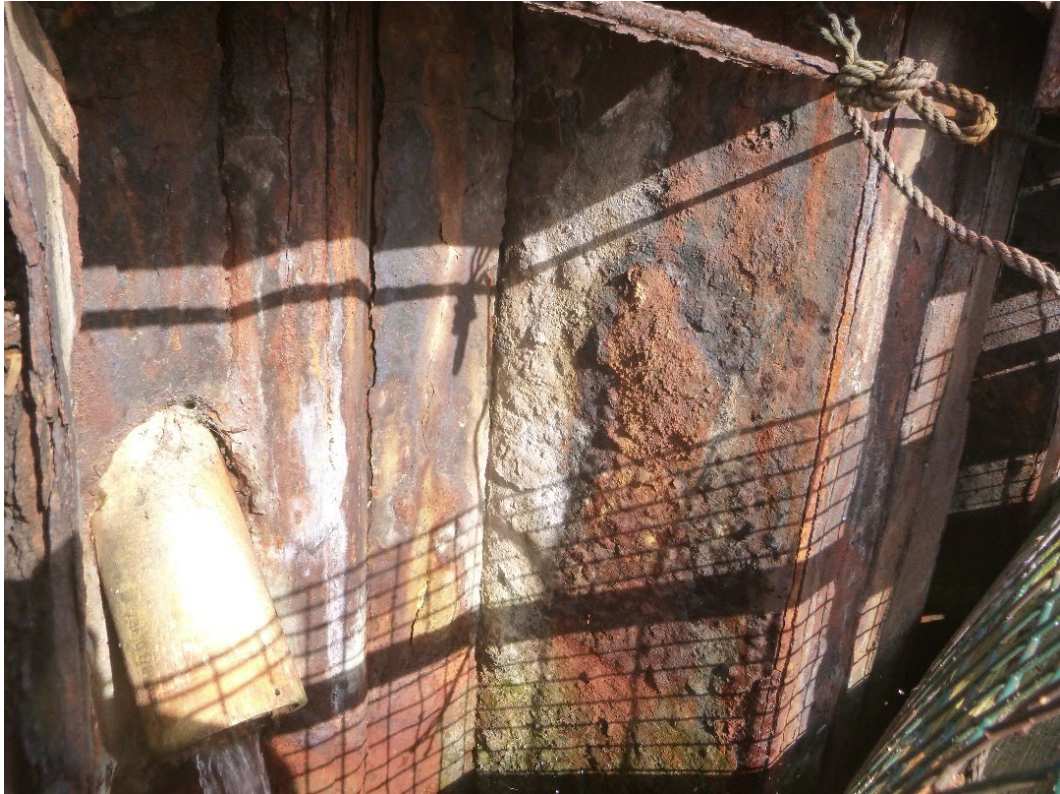
Photo 7 – Close up of the sheet pile with heavy corrosion byproduct.

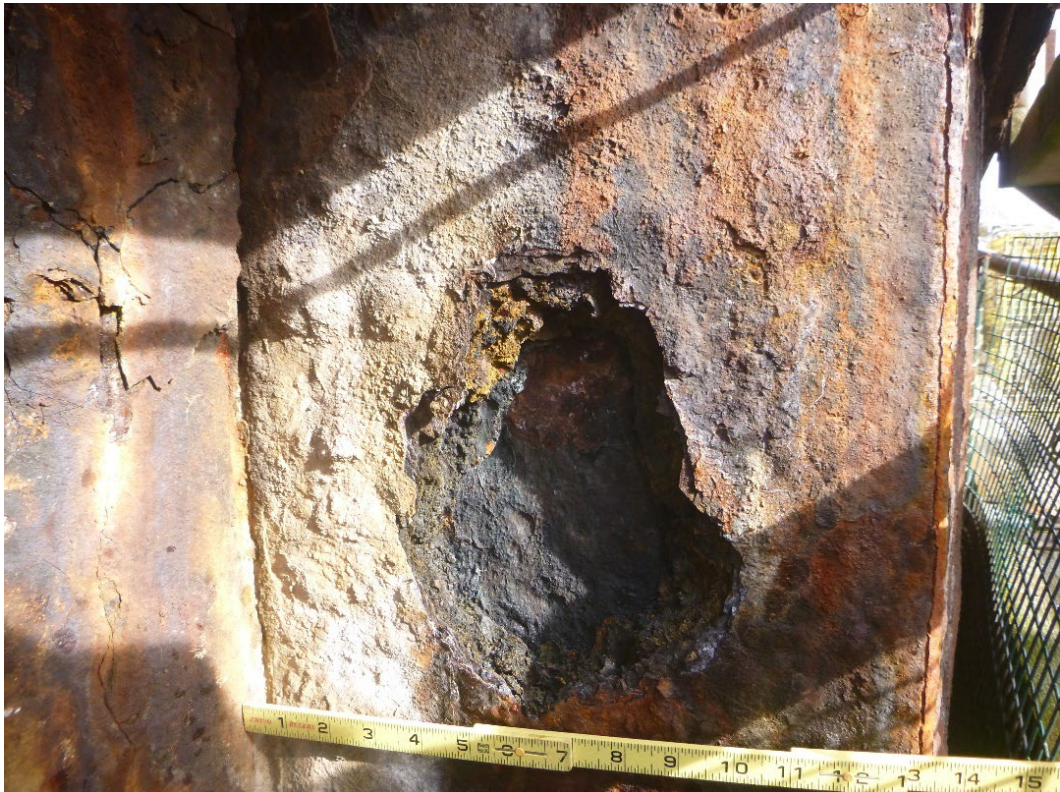
Photo 8 – Cleaned area of the sheet pile with wavy steel and heavy corrosion byproduct.

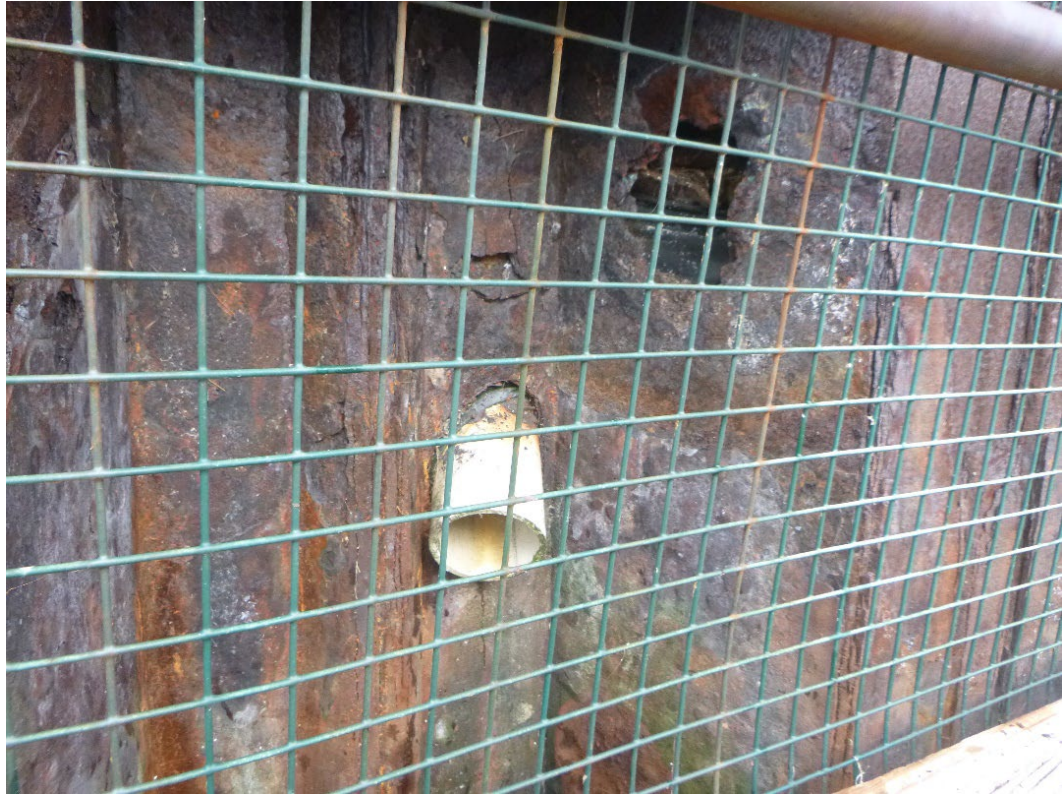
Photo 9 – Corrosion hole above an outfall pipe.

Multiple options are available for possibly increasing the lifespan of the steel sheet pile bulkhead but as stated previously, we recommend that the holes be patched as soon as possible and that all water circulation systems be modified to divert water away from the bulkhead and any other structural element. This effort will reduce the corrosion impacts to the bulkhead. Patching the sheet pile holes would entail removing all deteriorated steel and welding a new steel plate onto the sheet pile. We estimate that this type of repair will be roughly \$600/sqft. Any areas in or above the tidal zone that remain in a state of constant wetting should be cleaned of all corrosion or marine growth and coated with a marine grade underwater epoxy to provide corrosion protection. If the lifespan of the bulkhead were required to reach to the 20-year mark, we would also recommend that the band of corroding steel from roughly 1 foot below MLW to the deck curb be coated with this same epoxy.

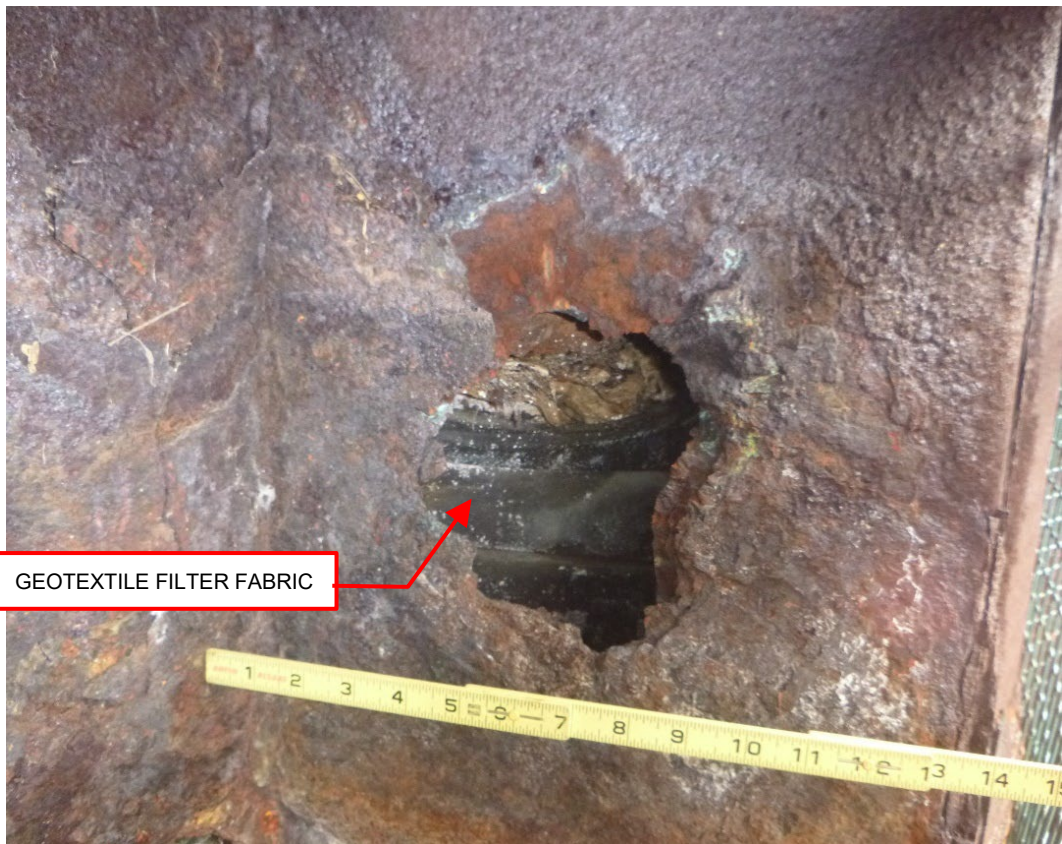
Photo 10 – Close up of corrosion hole in the sheet pile with filter fabric visible

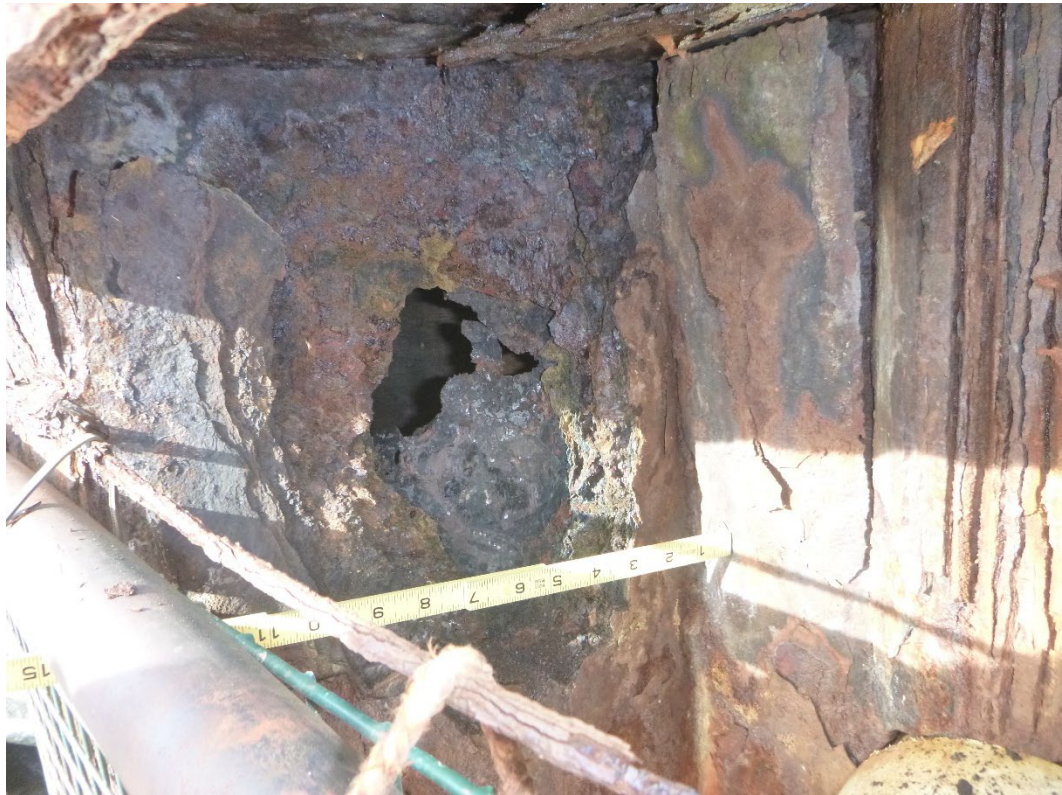
Photo 11 – Larger corrosion hole in the sheet pile web.

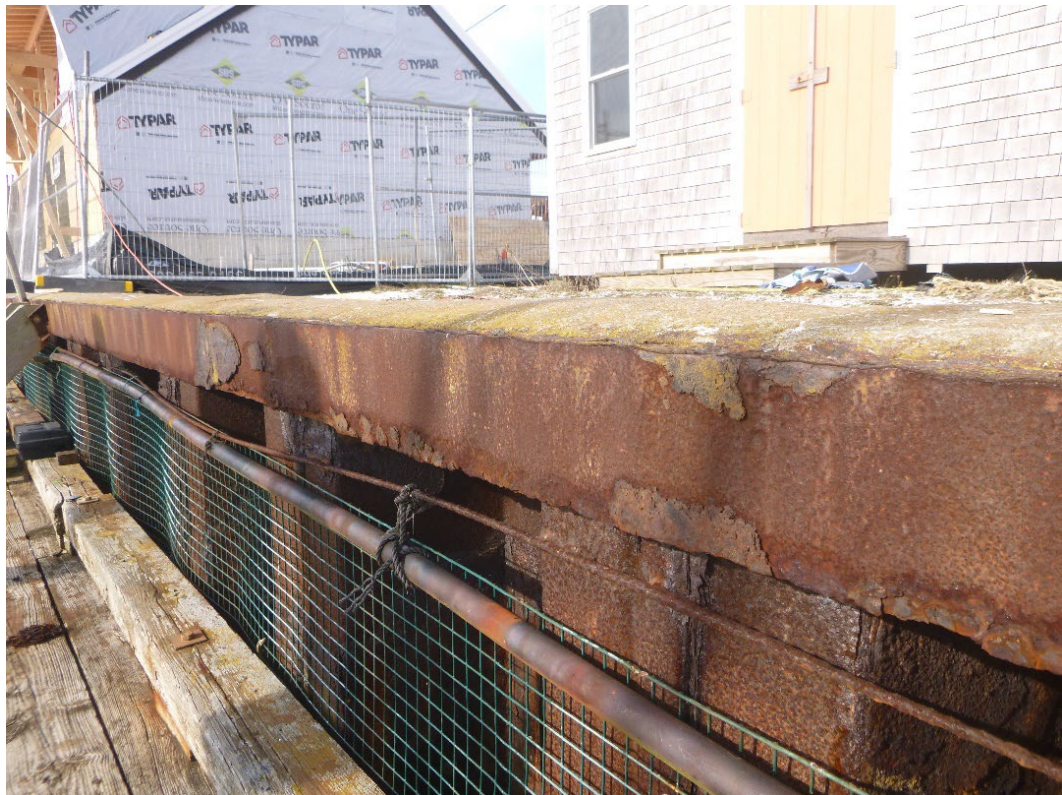
The cap on top of the steel sheet pile consists of a steel W-shape welded to the top of the sheets with the top portion filled with concrete. The cap is 18 inches wide and 7.5 inches tall and is presumed to be a W18x60 section. The cap is typically in **fair** condition with minor to moderate corrosion throughout but no major deterioration (see Photo 12). The W-shape has knife edging and section loss in isolated areas typically found near the wooden access stairs or where stairs were located in the past (see Photo 13). The concrete on the cap is sound with minor deterioration on the edges and transverse cracking but no major spalling (see Photo 14).

Photo 12 – Typical view of the steel sheet pile cap.

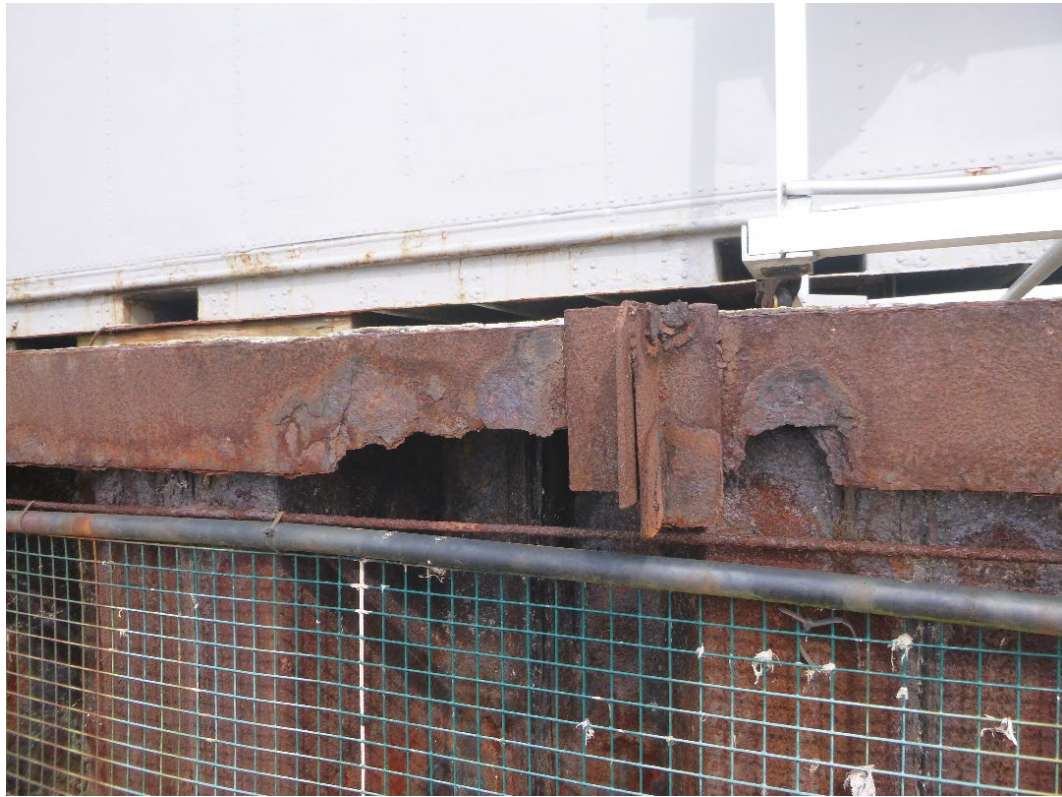
Photo 13 – Steel sheet pile cap with severe knife edging.

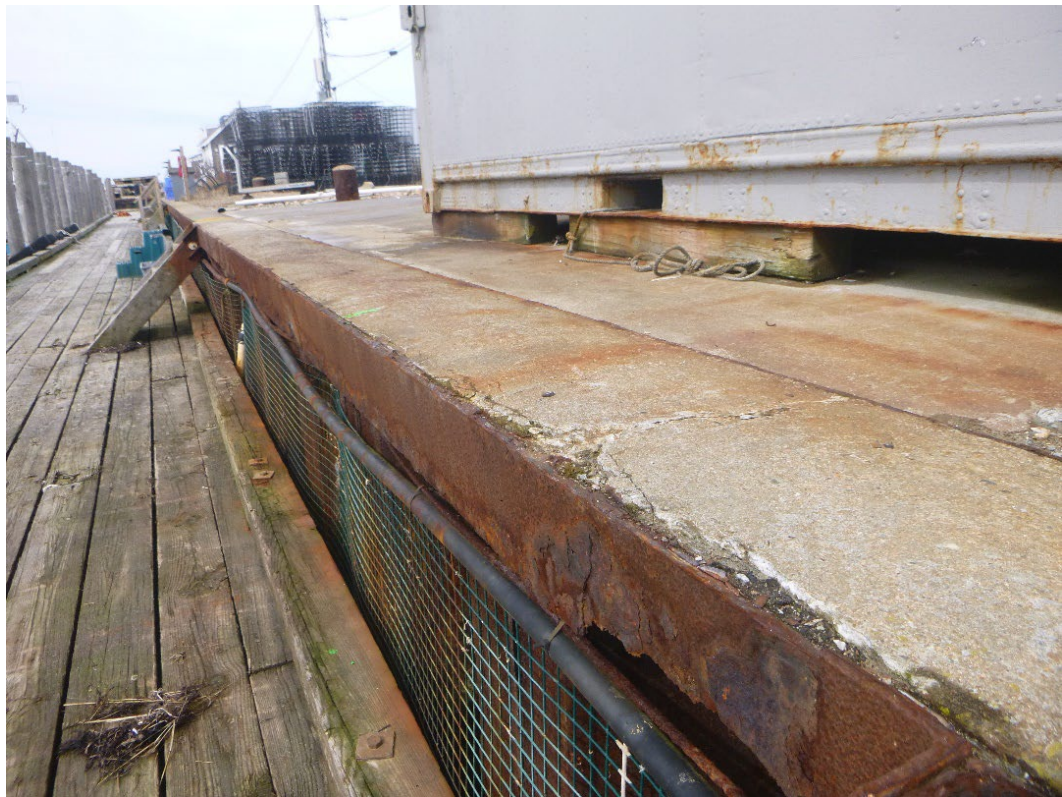
Photo 14 – The concrete with minor deterioration.

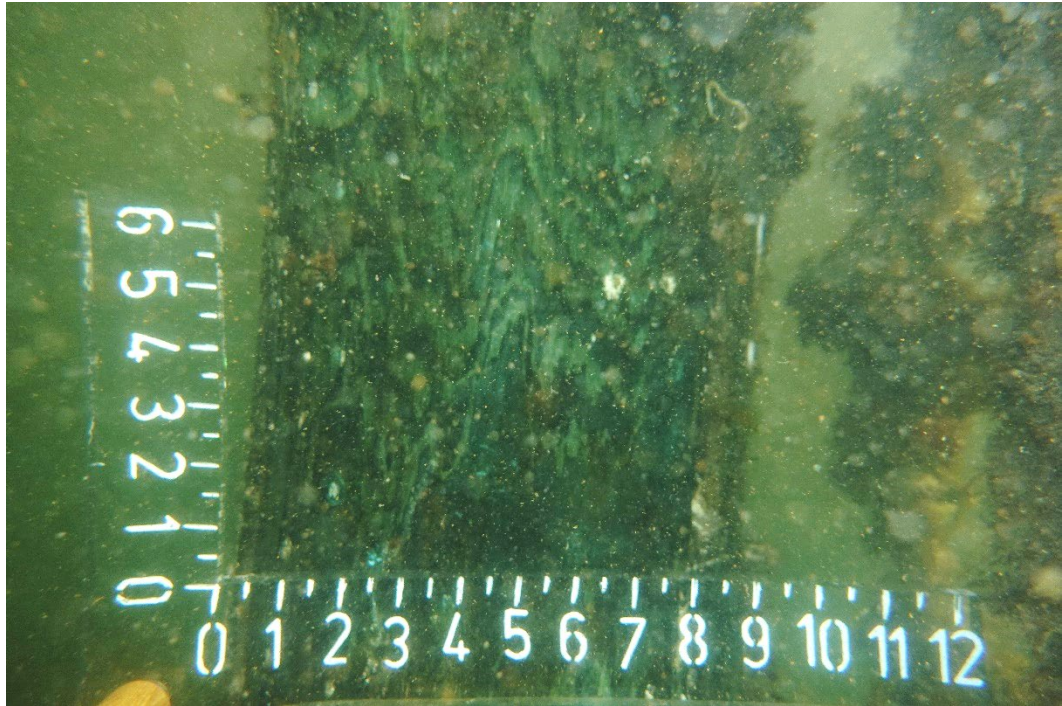
The timber piles support the Commercial Fishing wharf on the outshore face by connecting to the outshore end of the pile caps below the decking. The 10-inch diameter CCA treated piles make up 96 pile bents starting near Sta 0+00 that are spaced approximately 7 feet apart. The piles are generally in **satisfactory** condition with no major defects found. The piles in the water column are typically between $\frac{1}{8}$ inch and $\frac{1}{4}$ inch soft and have only minor marine borer damage that accounts for no significant reduction in cross sectional area (see Photos 15).

Photo 15 – Underwater view of the timber support piles.

We recommend continuing to replace the timber fender piles on an as needed basis. The timber support piles under the wharf show little signs of deterioration and do not warrant repairs at this time. The anticipated lifespan of the existing timber piles is 10 to 15 years.

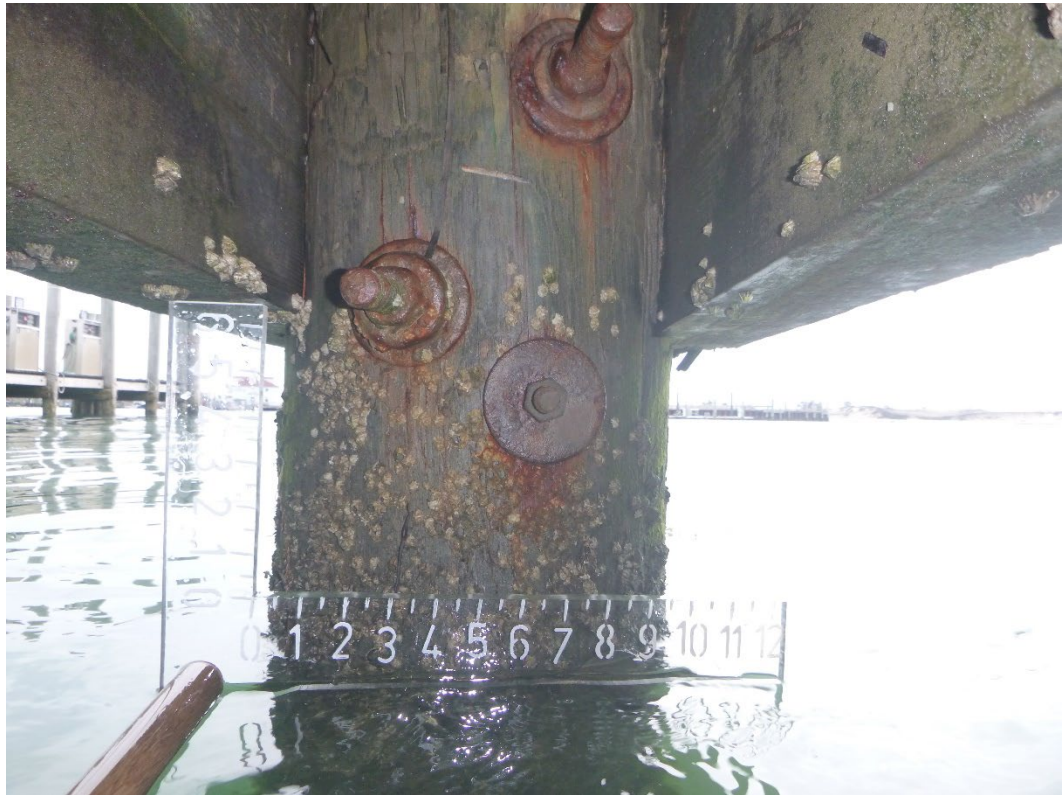
Photo 16 – Timber fender pile connection to the piles supporting the wharf.

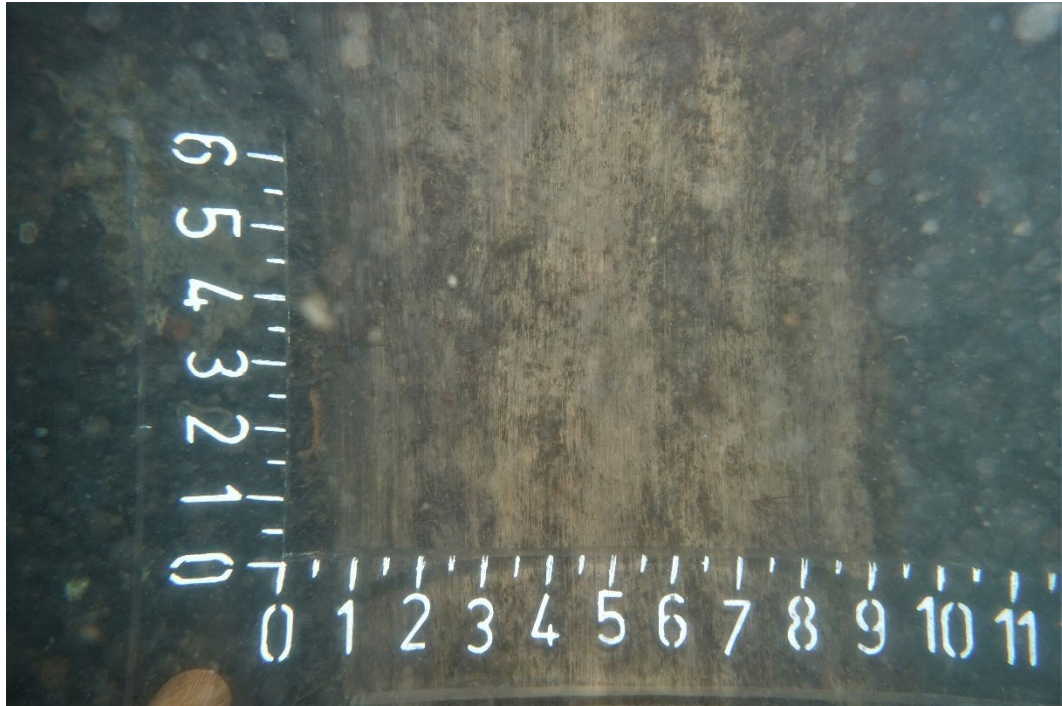
Photo 17 – Underwater view of the greenheart fender piles.

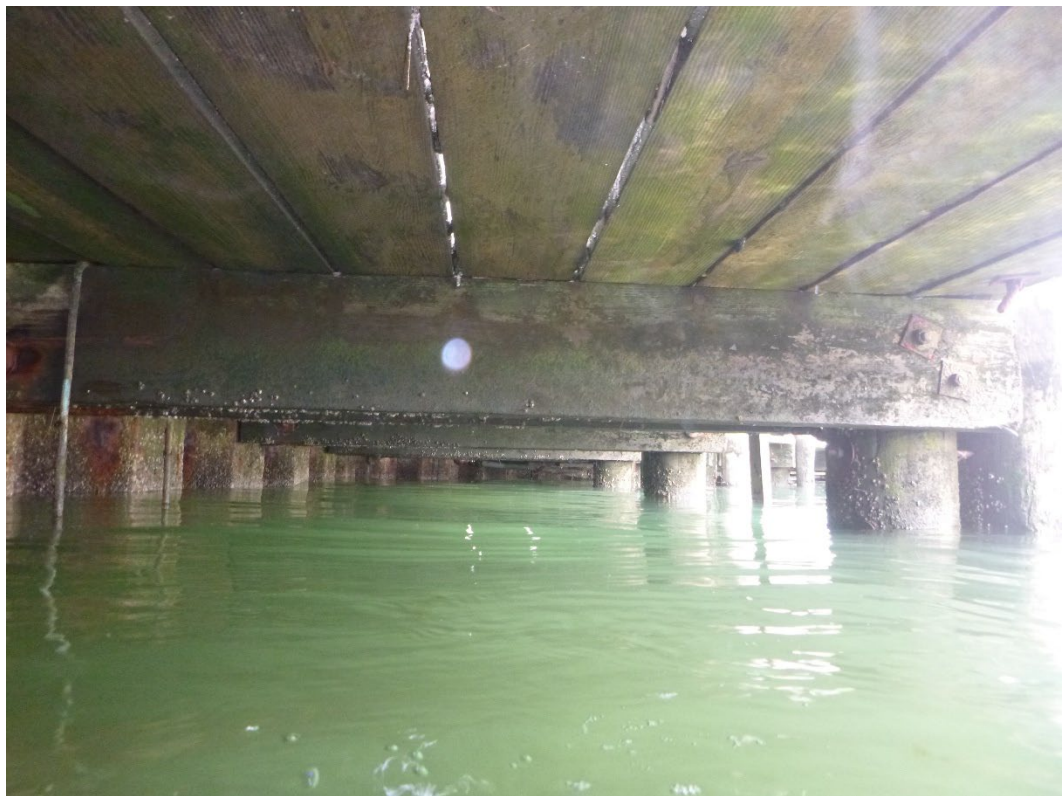
Photo 18 – Underdeck view of the timber split cap.

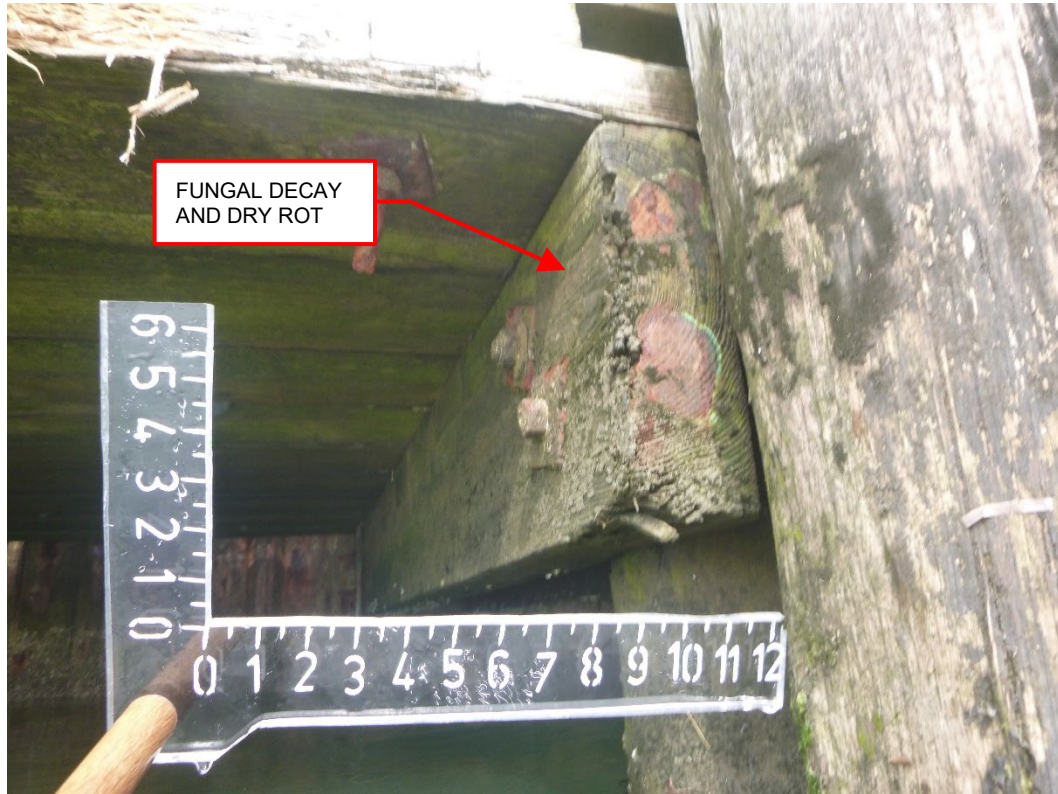
Photo 19 – Fungal decay on the end of the timber pile cap.

We recommend the pile caps be repaired prioritizing the steel channels where the timber connects to the bulkhead. The timber shows signs of deterioration on the ends with fungal decay but overall, the timber does not warrant short term repairs. The steel channels that connect to the sheet pile bulkhead show signs of advanced deterioration and section loss. We recommend replacing the steel channels with a similar support connection. The effort may require removal of some deck boards or completion by a diver depending on contractor access. A cost for this is currently unknown due to the many variables of construction. We estimate the bulk cost of the steel to be in the range of \$10,000 to \$20,000 but acknowledge that the majority of the cost will be in labor. It would also be recommended to apply underwater epoxy on all new welds. We recommend the connection between Bents 5 and 8 and Bents 6 and 9 be replaced to ensure that corner is stabilized. To accomplish this, it will likely be easiest to replace the timber caps in entirety. These repairs can be done in the short term to ensure this corner of the wharf is stable. The anticipated lifespan of the existing timber pile caps and steel connections is 5 years.

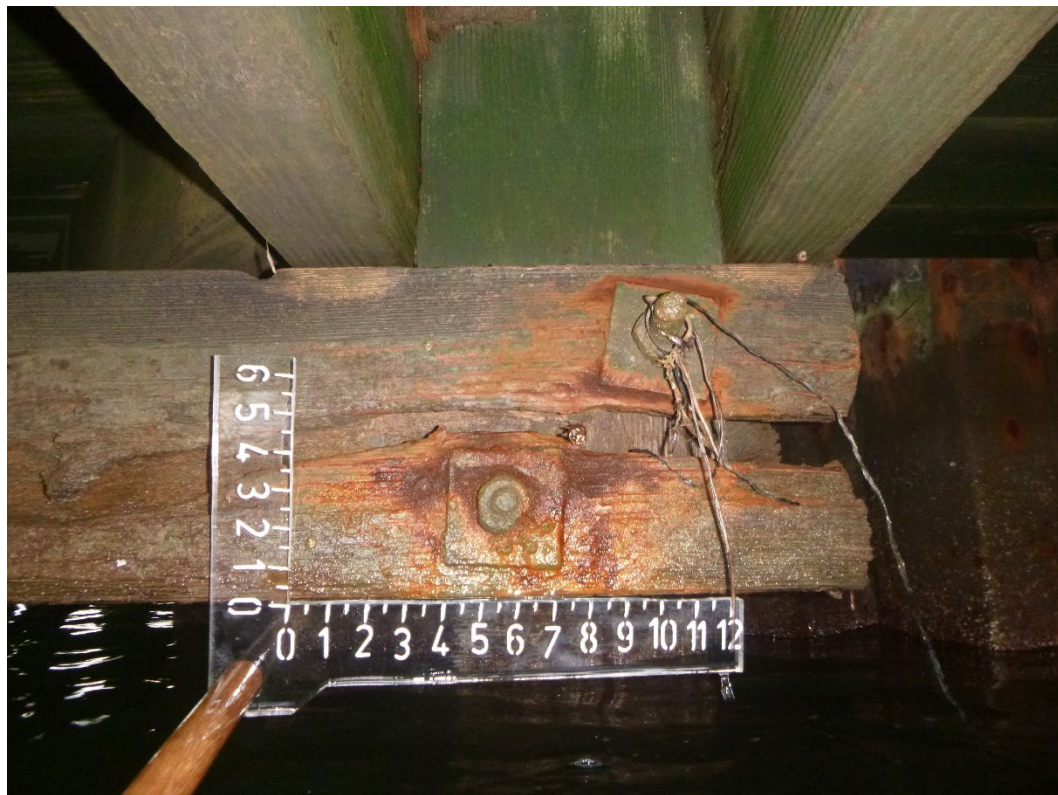
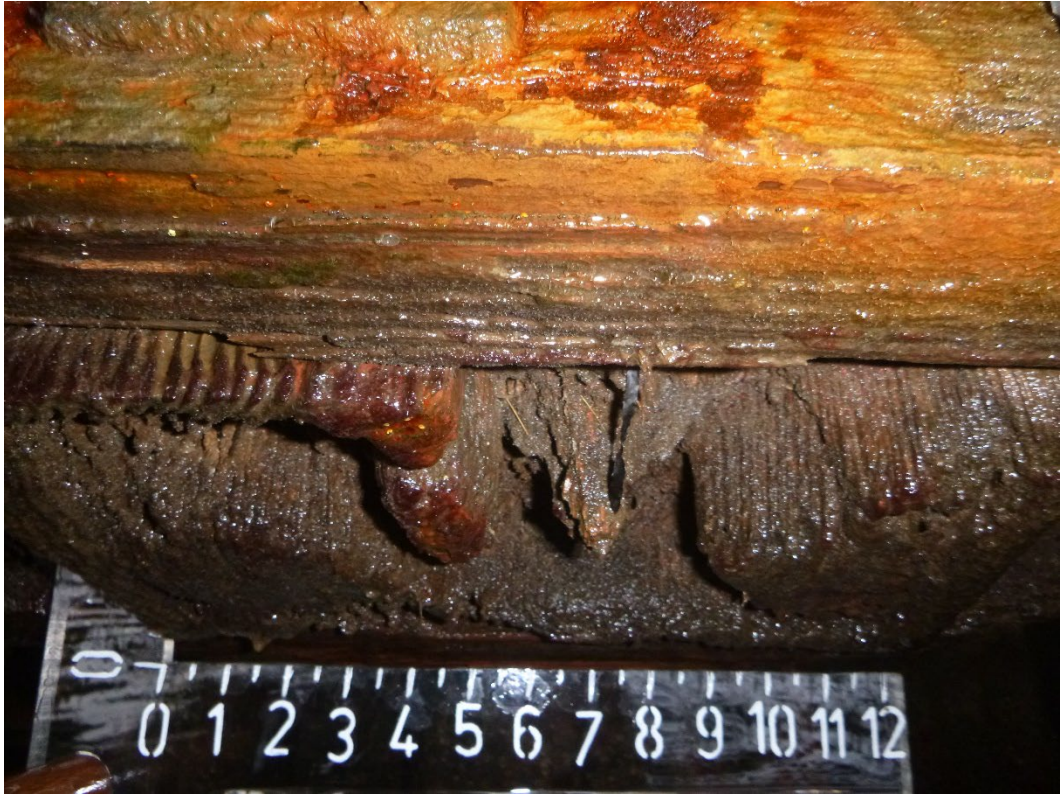
Photo 20 – Fungal decay extending into the connection between Bents 5 and 8.

Photo 21 – Fungal decay extending into the connection between Bents 5 and 8.

- Replacing the Bent 8 to 5 and 6 to 9 connections.
- Patching holes in the sheet pile.
- Modifying the water circulation systems to divert water away from the sheet pile or other structural elements.

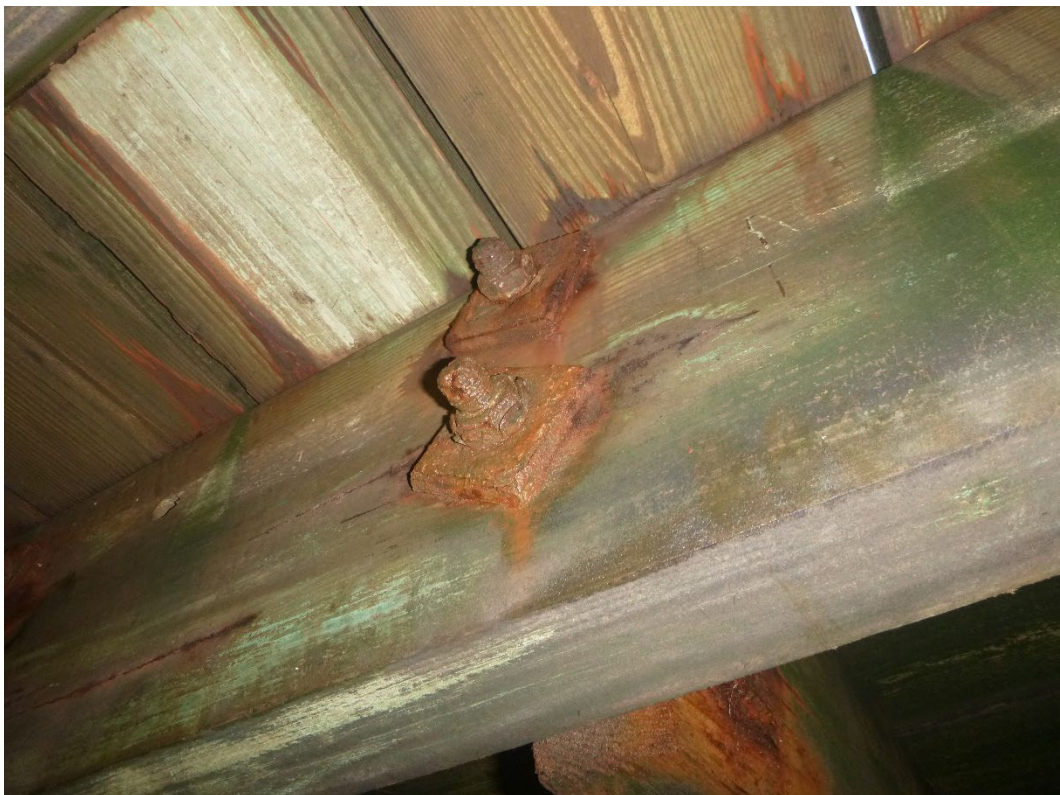
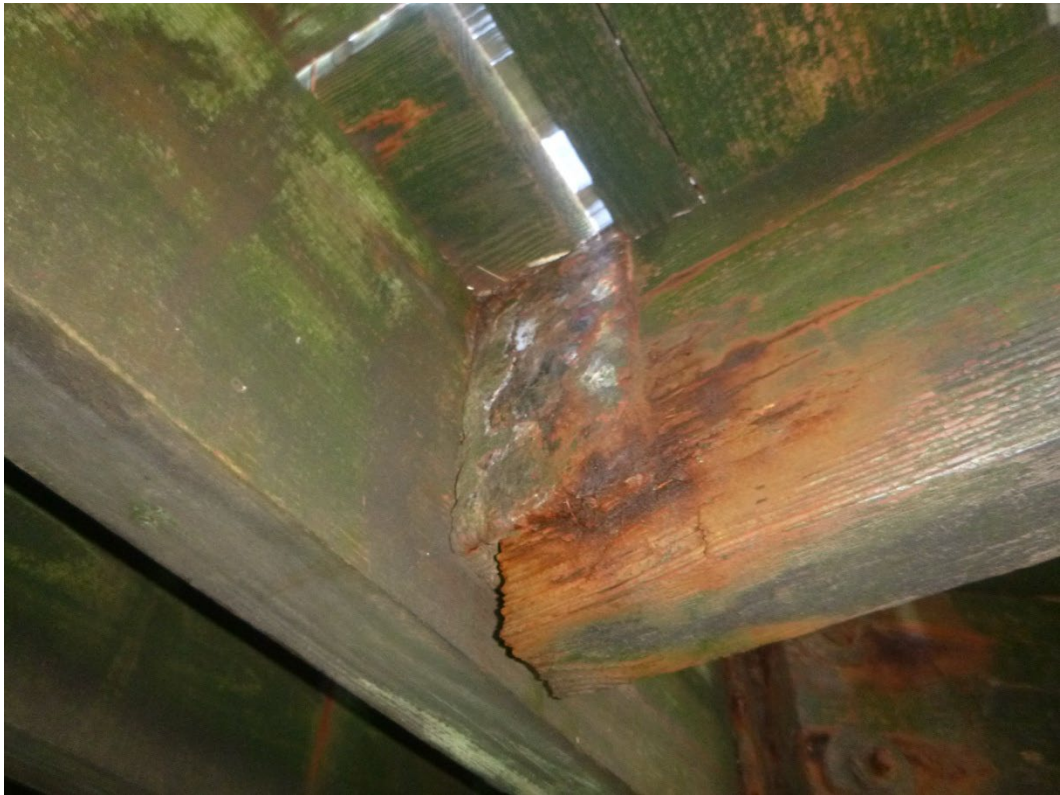
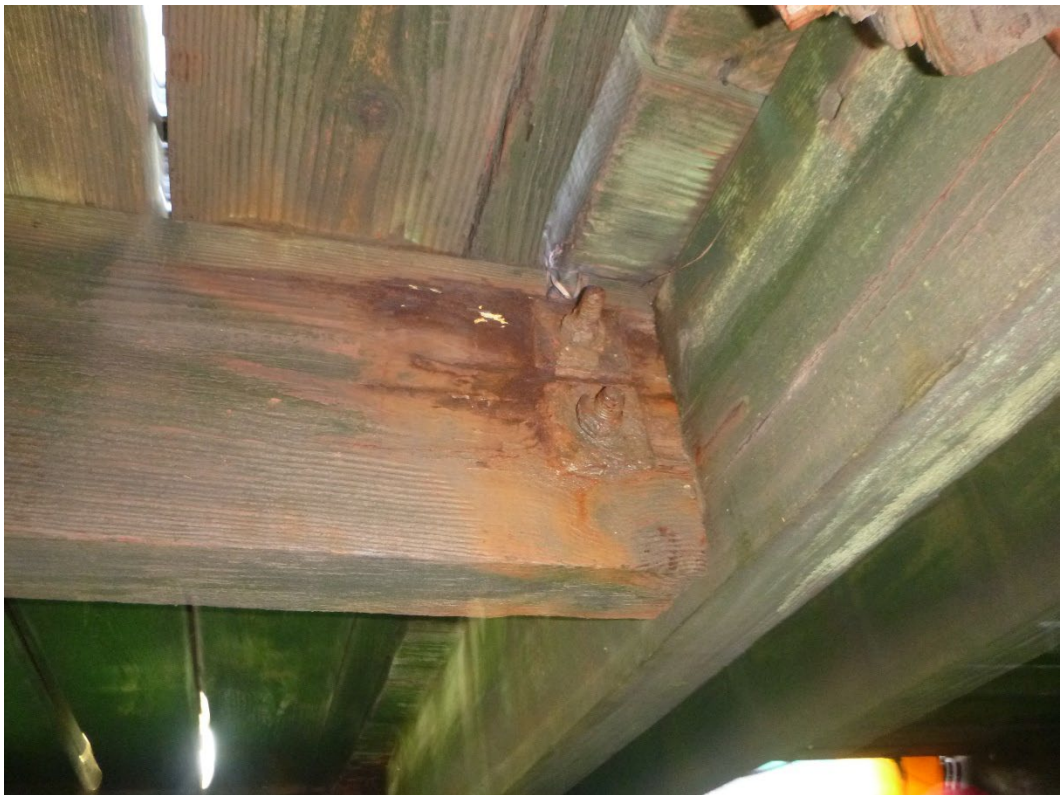
Photo 22 – Close up of the back of the butt connection between Bents 6 and 9.

Photo 23 – Close up of the butt connection between Bents 6 and 9.

Photo 24 – Close up of the butt connection between Bents 6 and 9.
