Menemsha Commercial Fishing Dock Chilmark, MA Waterfront Inspection & Assessment Report

March 2022

Childs Project: 2982-22.00

Inspection Dates: March 10, 2022

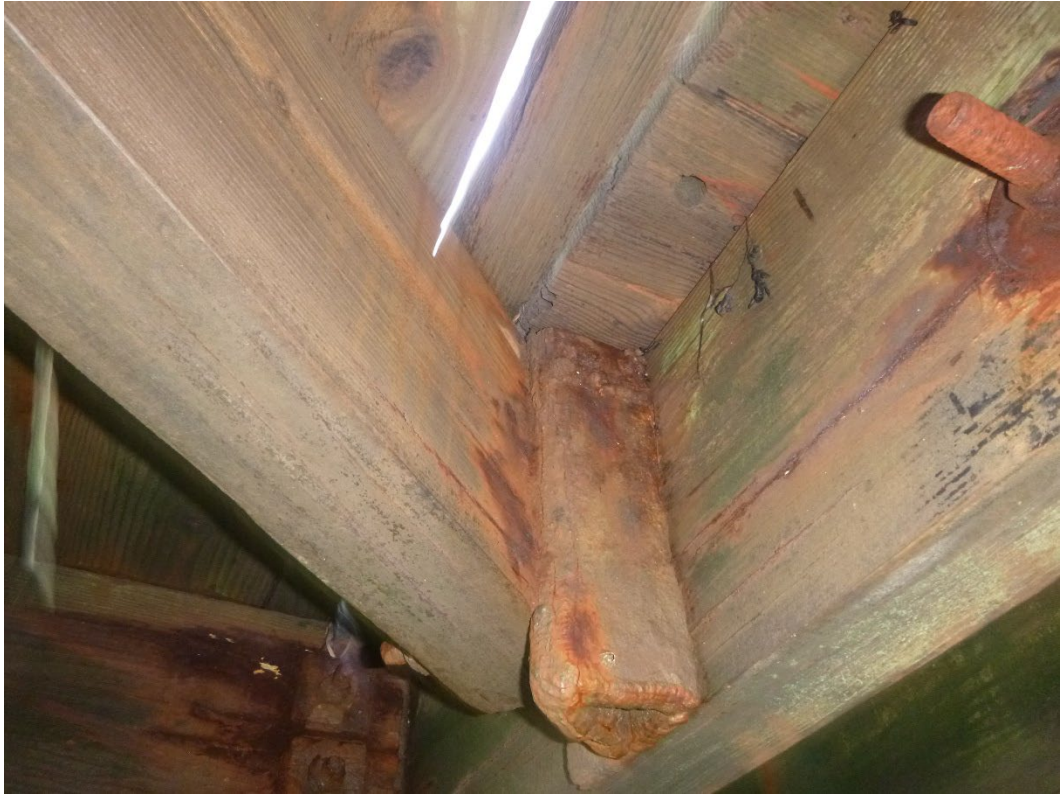
Photo 25 – Underdeck view of the timber split cap.

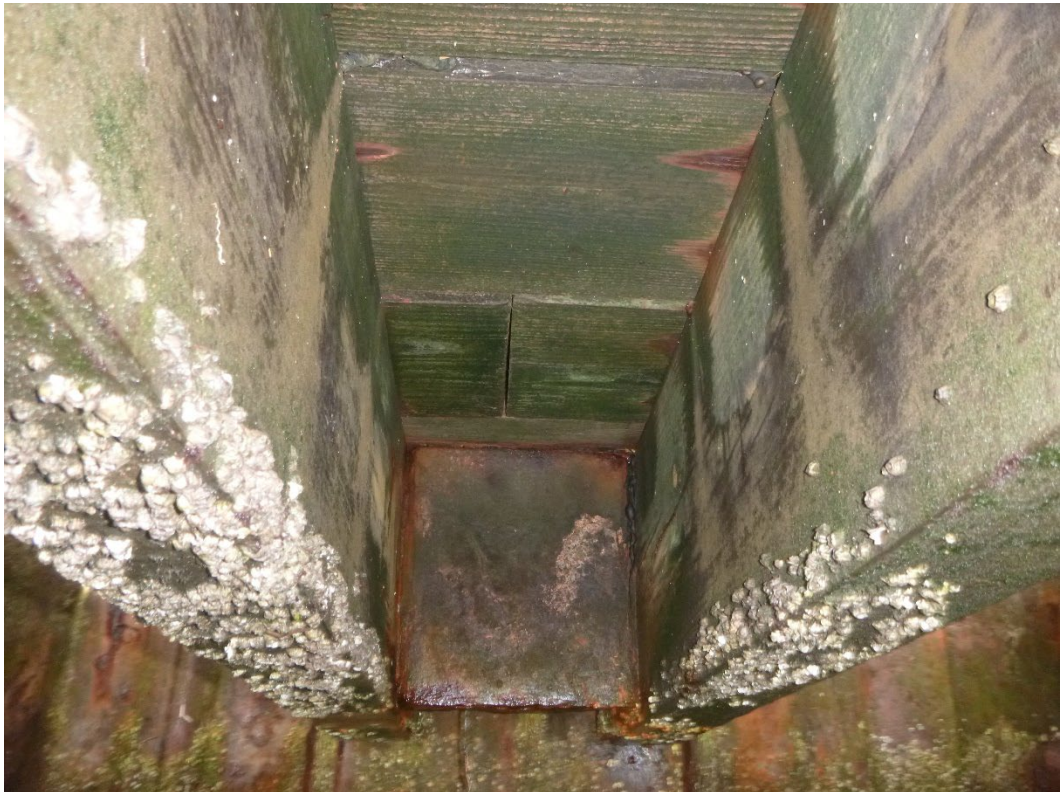
The pile caps are typically connected on the inshore end to the sheet pile with a welded steel channel and a through bolt (see Photos 26 through 28). These brackets are in **poor** condition with moderate defects throughout the facility and localized severe defects noted. While there is currently no evidence of overstressing of the brackets, they appear to be nearing the end of their useful life. The defects include corrosion on all channels with isolated knife edging and section loss causing corrosion holes in isolated areas. It is estimated that the original thickness of the steel channels was $\frac{1}{4}$ inch, our field measurements indicate that typical existing thicknesses range from $\frac{1}{8}$ inch to $\frac{3}{16}$ inch thick. The original thickness of $\frac{1}{4}$ inch is generally considered to be too thin for the marine environment because, while it may provide enough structural capacity initially, it lacks the ability to maintain structural capacity as the thickness is reduced due to corrosion. Typically, an original thickness of $\frac{3}{8}$ inch to $\frac{1}{2}$ inch is more appropriate for the marine

Photo 26 – Typical view of the steel channel connecting to the sheet pile.

We recommend the pile caps be repaired prioritizing the steel channels where the timber connects to the bulkhead. The timber shows signs of deterioration on the ends with fungal decay but overall, the timber does not warrant short term repairs. The steel channels that connect to the sheet pile bulkhead show signs of advanced deterioration and section loss. We recommend replacing the steel channels with a similar support connection. The effort may require removal of some deck boards or completion by a diver depending on contractor access. A cost for this is currently unknown due to the many variables of construction. We estimate the bulk cost of the steel to be in the range of \$10,000 to \$20,000 but acknowledge that the majority of the cost will be in labor. It would also be recommended to apply underwater epoxy on all new welds. We recommend the connection between Bents 5 and 8 and Bents 6 and 9 be replaced to ensure that corner is stabilized. To accomplish this, it will likely be easiest to replace the timber caps in entirety. These repairs can be done in the short term to ensure this corner of the wharf is stable. The anticipated lifespan of the existing timber pile caps and steel connections is 5 years.

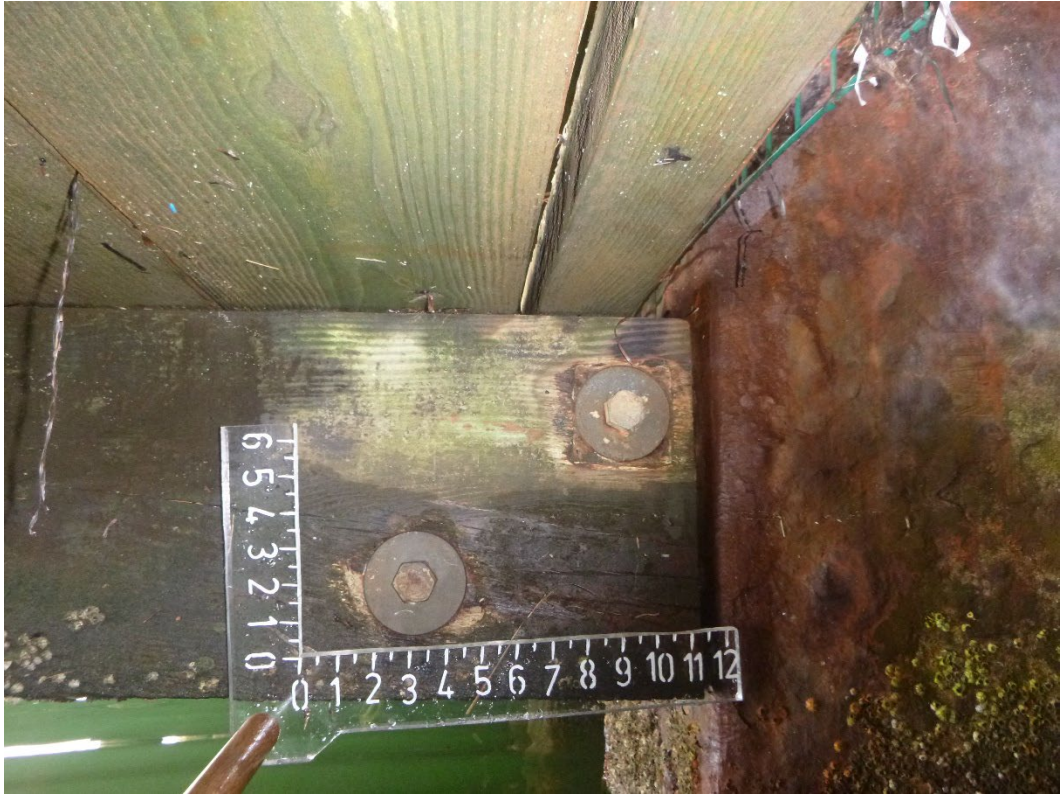
Photo 27 – Through-bolts connecting the pile cap to the channel.

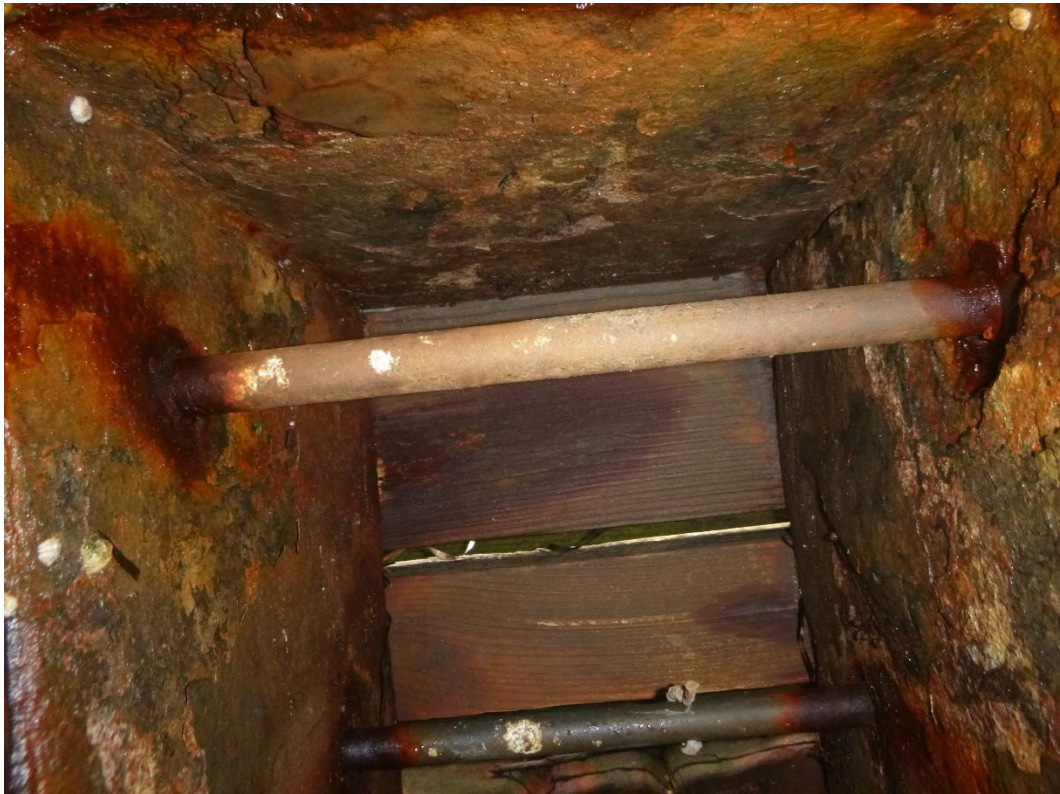
Photo 28 – Corrosion on the inside of the channel looking up.

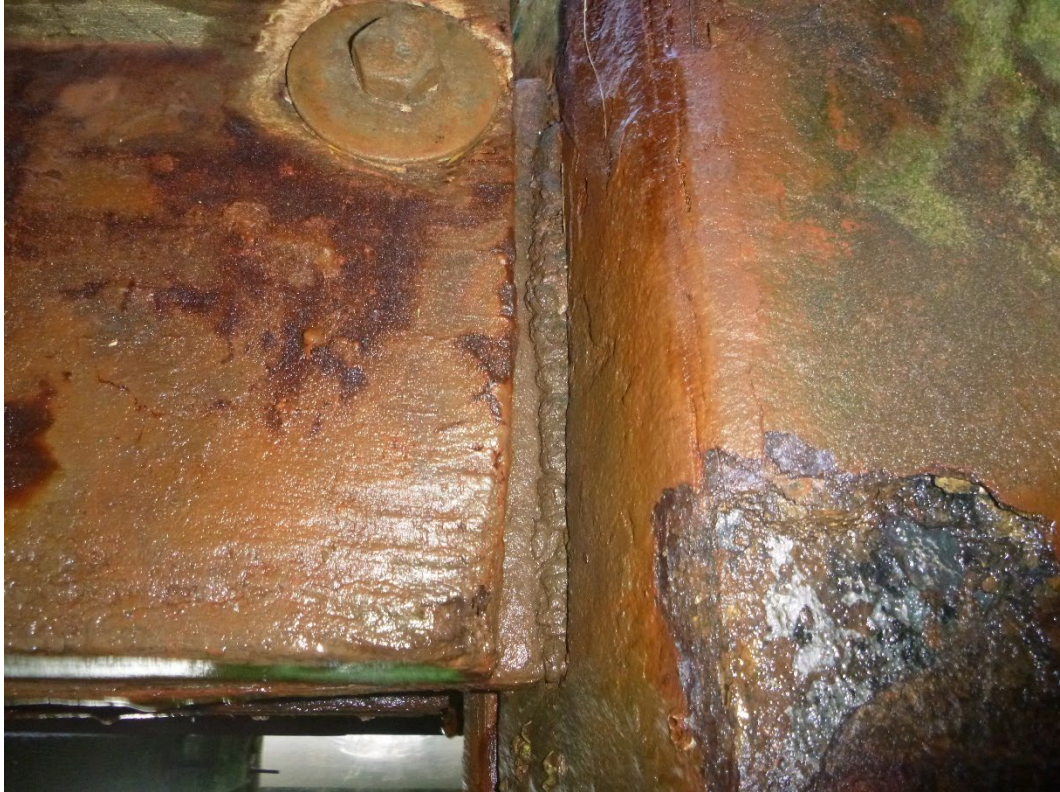
environment. The welds between the channel member and steel sheet pile are in fair condition with corrosion found (see Photo 29). In general, the through bolt connections are in satisfactory condition with no section loss or corrosion and were replaced in 2020, however between Bents 37 and 39 the nuts on the through bolts appear to not have been installed. Childs did not conduct a structural analysis to determine the working load capabilities of the channel members but the reduction in the thickness is a cause for concern; we believe this to be the weak link for the entire waterfront facility due to the likelihood of a reduction in capacity. We estimate that the brackets supporting the pile caps have a remaining lifespan of 5 years or less in isolated locations.

Photo 29 – Close up of the steel channel to sheet pile weld.

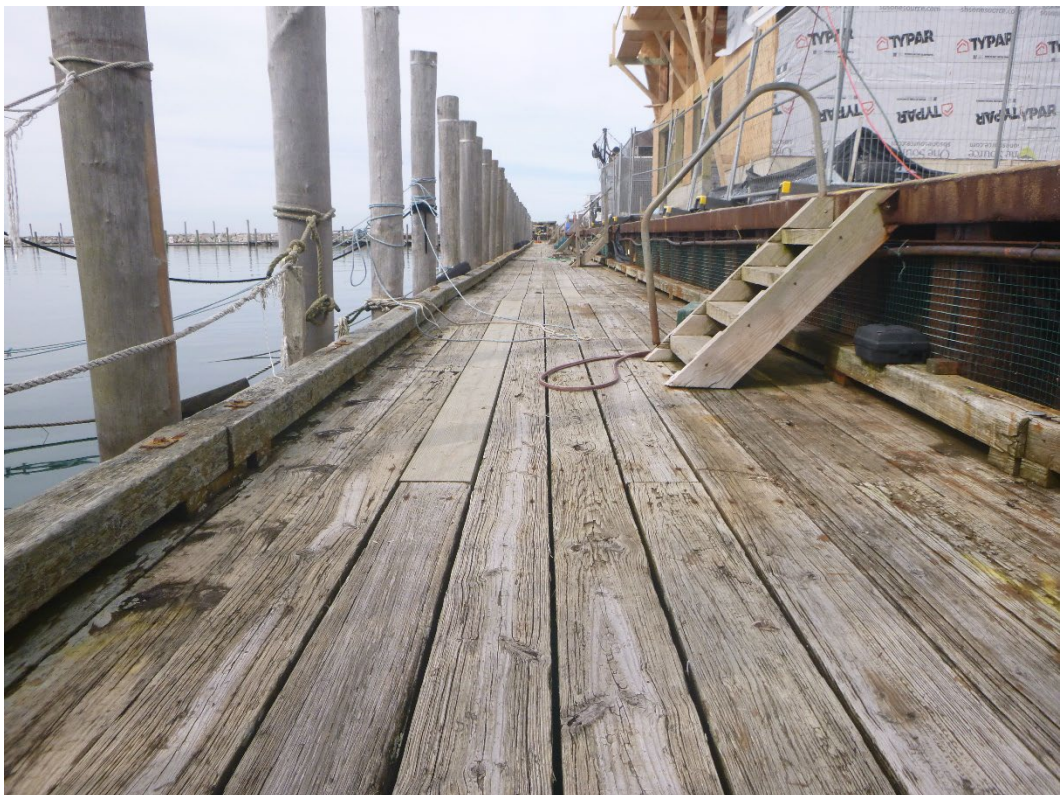
The 3 inch by 8 inch timber decking runs longitudinally along the wharf (see Photo 30). The decking is generally in **poor** condition with fungal decay found throughout that has caused minor section loss (see Photo 31). The fungal decay also makes the deck slippery when it is wet. It appears that the decking is replaced on an as needed basis, evident by the occasional newer deck board located on the wharf. The limiting factor for the decking's capabilities to support load is the spacing at which they are supported. Typical pier design has the decking supported by stringers spaced 16 to 30 inches on center, this type of construction exists on the fueling pier. The main wharf structure decking is only supported by the timber split caps spaced roughly 6 feet on center. The capacity of the installed decking is most likely less due to the support spacing and fungal decay but does not currently warrant a posted load reduction given that the pier typically only sees pedestrian traffic. Reorientation of the decking to be properly supported would be an extensive undertaking requiring the entire timber wharf to be reconstructed and is therefore not currently recommended. We do not recommend that the deck be used to store heavy loads due to the support spacing.

Photo 30 – Timber decking running longitudinally along the wharf.

We recommend continuing to replace the timber deck boards on an as needed basis. The timber deck boards show visible signs of fungal decay throughout. A short-term repair would be to pressure wash the deck to remove the fungus on the surface to prevent the slipperiness when the deck gets wet. The anticipated lifespan of the existing timber decking is 5 to 10 years.

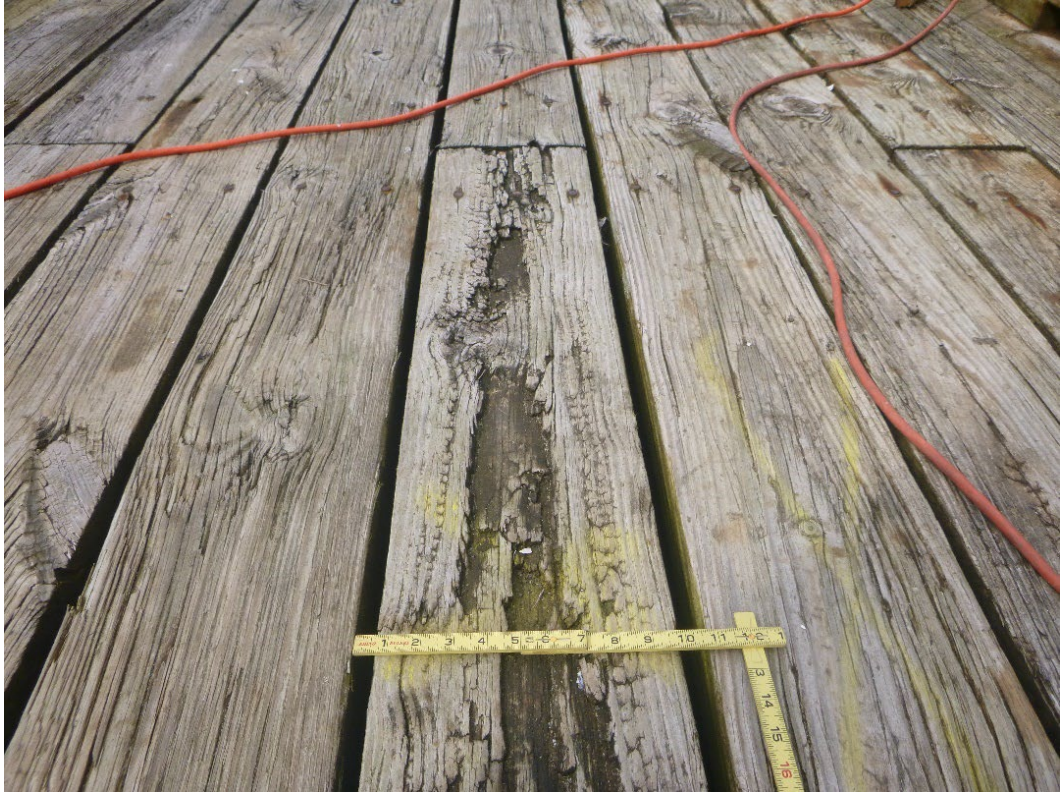
Photo 31 – Close up of the fungal decay on the timber decking.

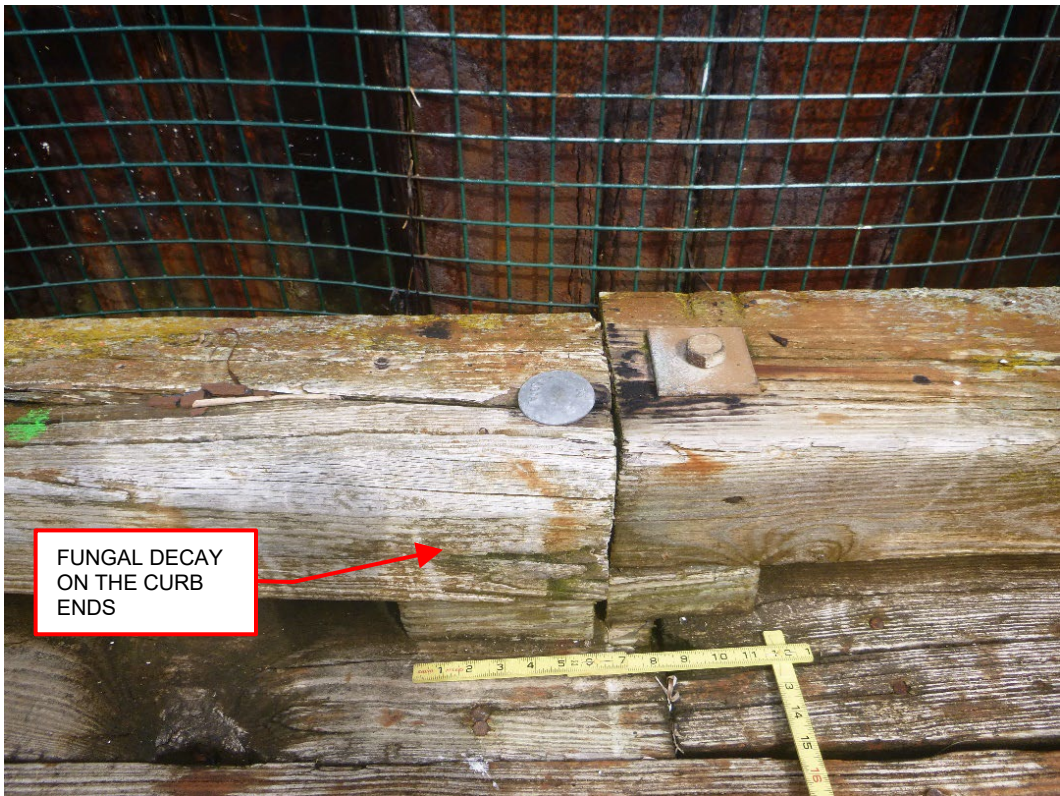
FUNGAL DECAY
ON THE CURB
ENDS

Photo 32 – Close up of the fungal decay on the curb.

We recommend the timber deck curb be repaired by replacing the timber sections topside on an as needed basis. The connections should be replaced within the short team to prevent the curb from coming loose. Currently the inshore timber curb is poorly connected to the 4 inch by 4 inch board underneath. We recommend that the 4 inch by 4 inch board be replaced with a larger section to ensure the timber curb is connected to the wharf. The anticipated lifespan of the existing timber curb is 5 to 10 years.

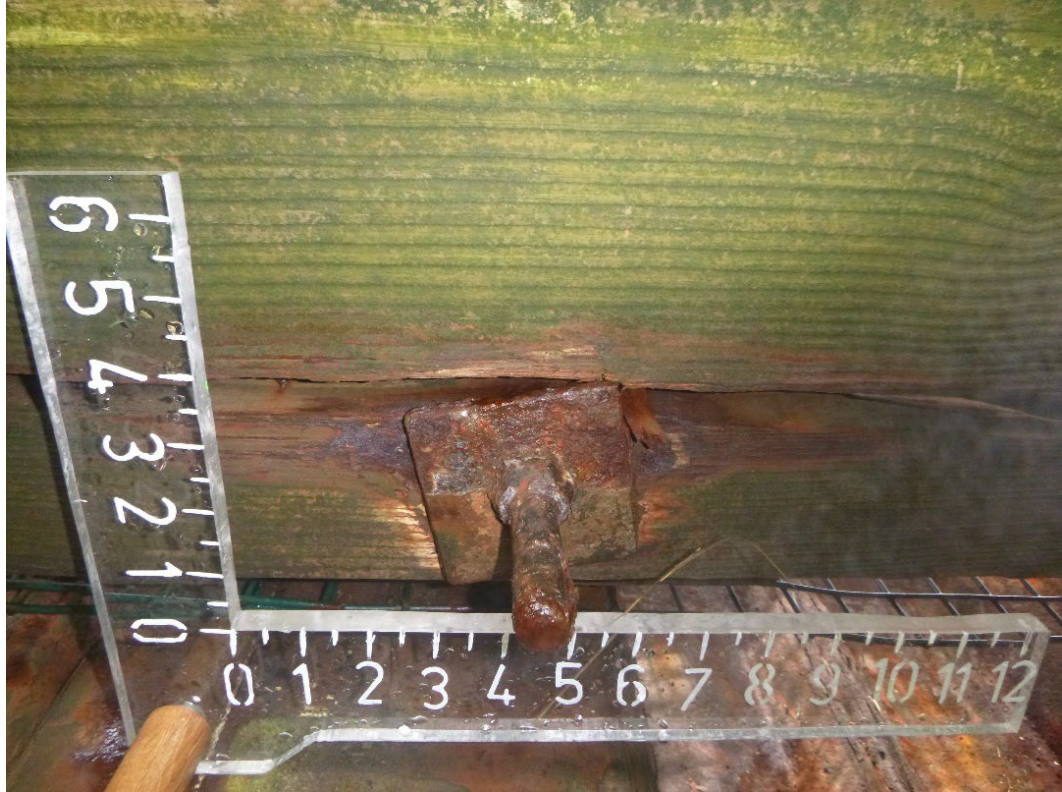
The timber deck curbs run longitudinally along the deck and are constructed of 8 inch by 6 inch timber members supported by 2 inch by 8 inch blocking spaced approximately every 6 feet on center. On the outshore edge of the wharf the deck curb and blocking are through bolted into the timber decking, and on the inshore edge the curb and blocking are through bolted into a 4 by 4 inch board running inshore of the timber decking. Overall, the deck curb is in **fair** condition with minor to moderate defects noted. The defects include fungal decay throughout the facility (see Photo 32). The fungal decay is mostly on the ends of the timber sections. The curb connections on the outshore edge are in satisfactory condition, the connection bolts have moderate corrosion with section loss and no threads visible (see Photo 33). The curb connections on the inshore

Photo 33 – Typical corrosion on the underside of the deck curb connection bolts.

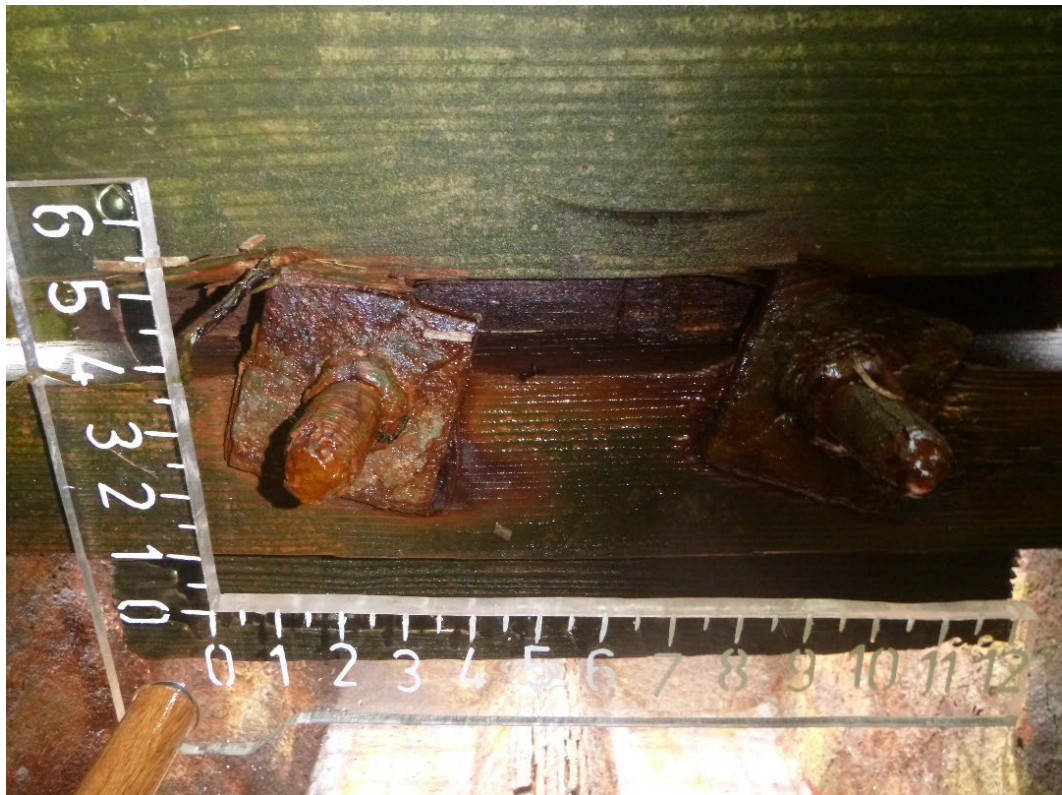
edge are in poor condition because the bolts were not aligned with the 4 inch by 4 inch connection board, and are on the edges or not connected to board (see Photo 34).

Photo 34 – The inshore deck curb connections do not go through the 4 inch by 4 inch board.

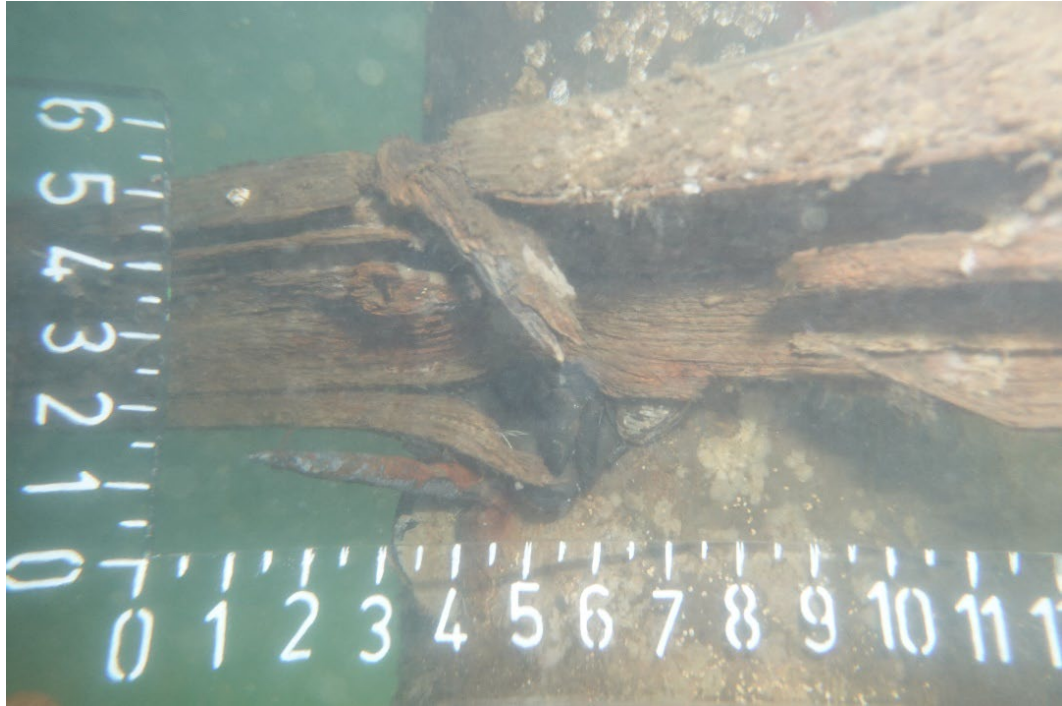
The timber wale is a 4 inch by 8 inch member running longitudinally inshore of the timber support piles at approximately MLW. The wale overall is in **critical** condition with major defects noted. The wale is missing large sections throughout the wharf, and the portions of the wale that are present have severe deterioration with major section loss (see Photo 35). The purpose of the wale is to provide longitudinal bracing between piles. Based on our understanding of the design intents of the wharf, the bracing was providing little lateral support and is therefore not a high priority to repair.

Photo 35 – Close up of the severe deterioration of the wale.

We recommend the timber wale and connections be replaced in-kind throughout the length of the wharf. In its current state the wale is providing little benefit to the wharf structure. This repair is low priority at this time and should be completed when other work is done to save on cost.

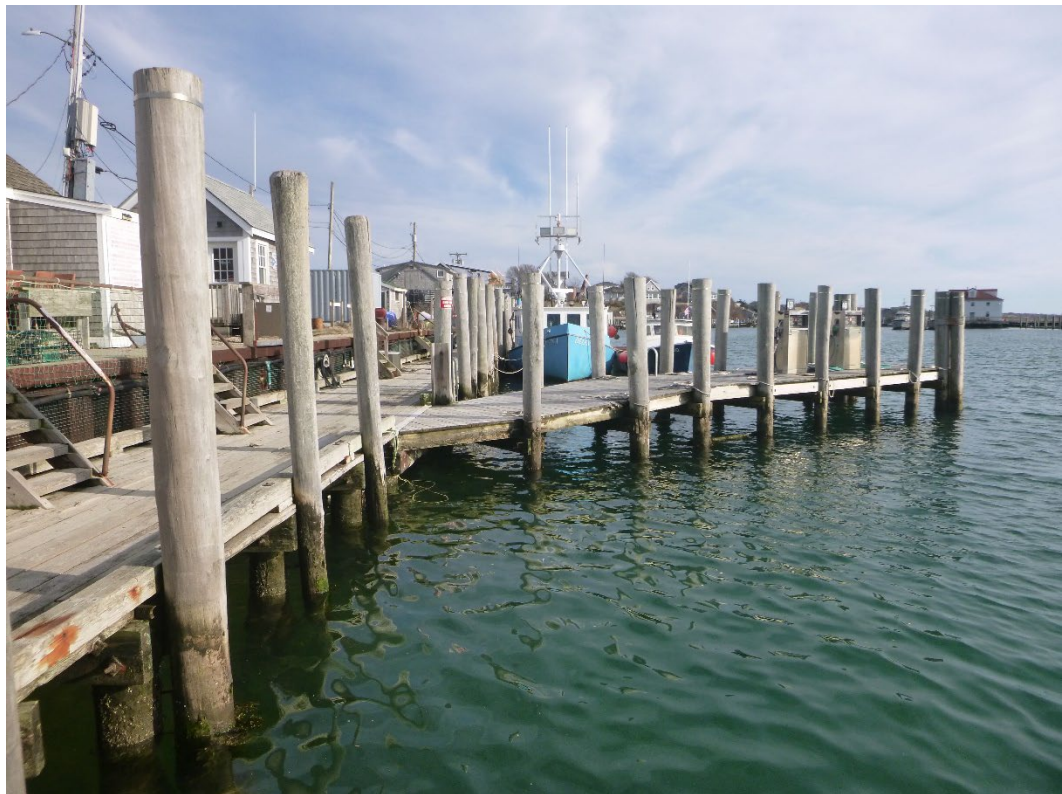
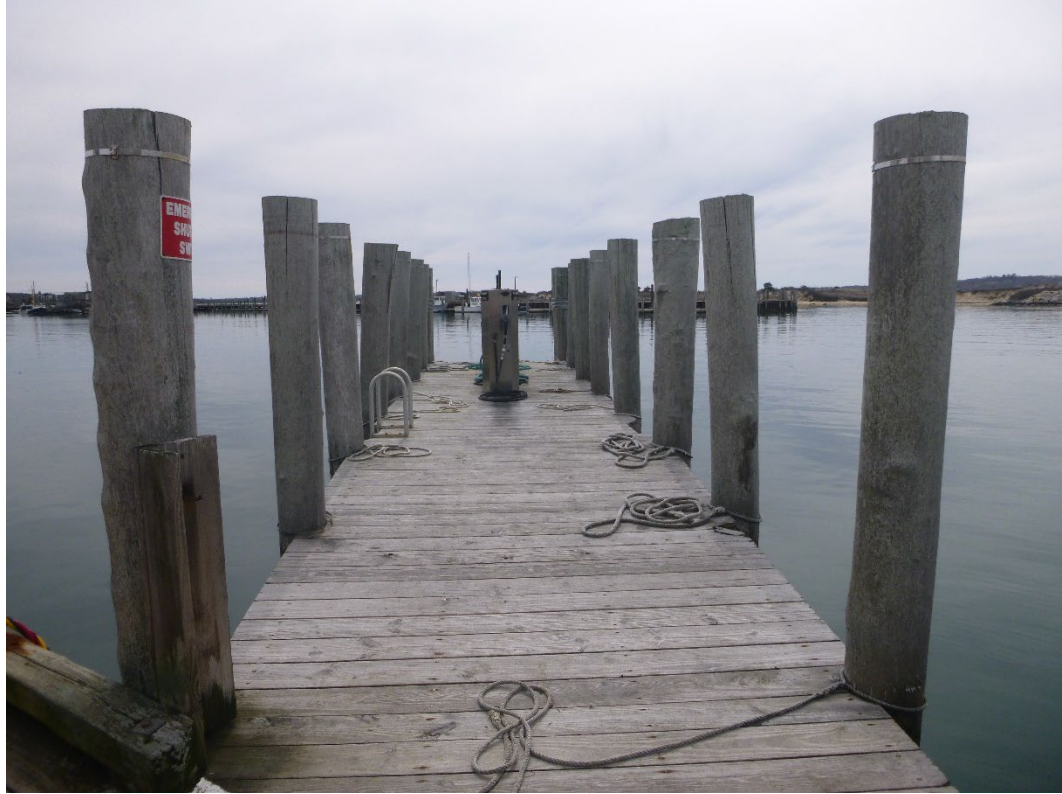
The purpose of the Fuel Pier is to support the fuel pumps and provide temporary docking for vessels during refueling. The pier is of typical light duty pier design and construction, consisting of 8 pile bents with 12 inch diameter timber support piles, 3 inch by 10 inch transverse split pile caps supporting the 3 inch by 10 inch longitudinal timber stringers, and 2 inch by 8 inch transverse timber decking. The greenheart timber support piles also provide fendering capabilities in conjunction with the two 3 pile clusters on the offshore end of the pier. The Fuel Pier is in **satisfactory** condition overall with no defects noted. All timber elements are sound with minor weathering that does not constitute any significant section loss or expected reduction in capacity (see Photo 36 and 37).

Photo 36 – Overall view of the Fuel Pier.

Photo 37 – Overall view of the Fuel Pier.

We have no recommended repairs for the Fuel Pier at this time. The Fuel Pier showed little signs of deterioration and appears to be functioning as intended. As mentioned above it is recommended the fender piles, deck boards, and deck curb be replaced in-kind on an as needed basis. The anticipated lifespan of the Fuel Pier is 15 years.

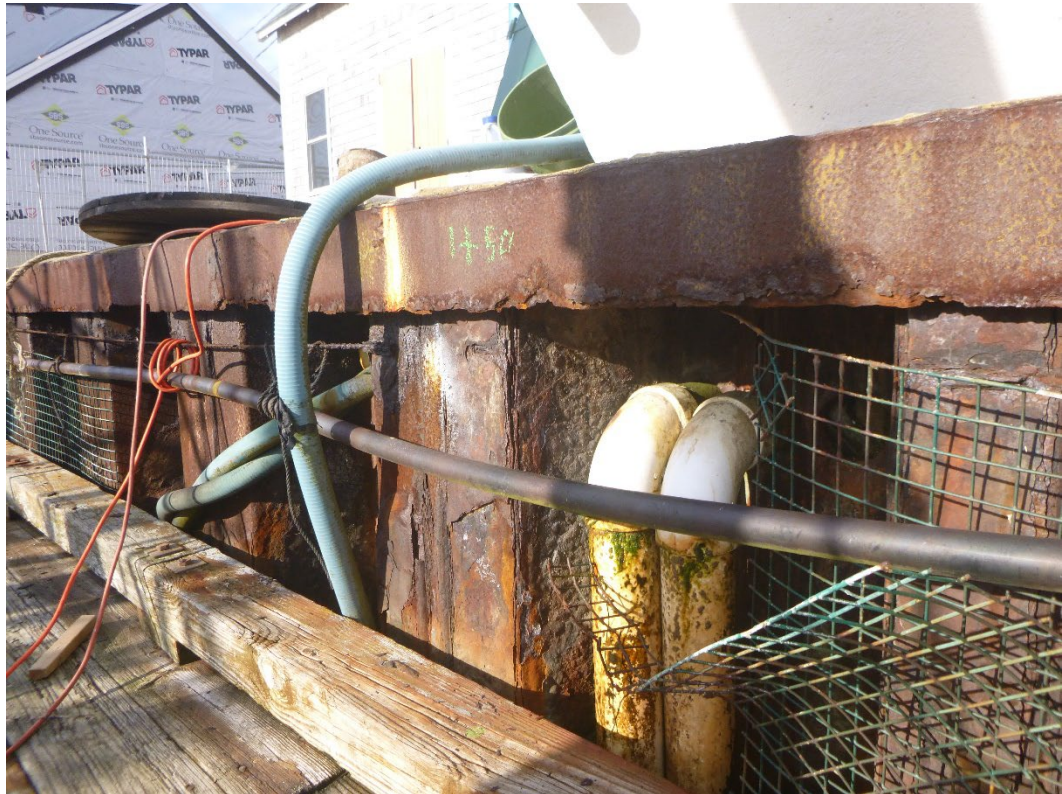
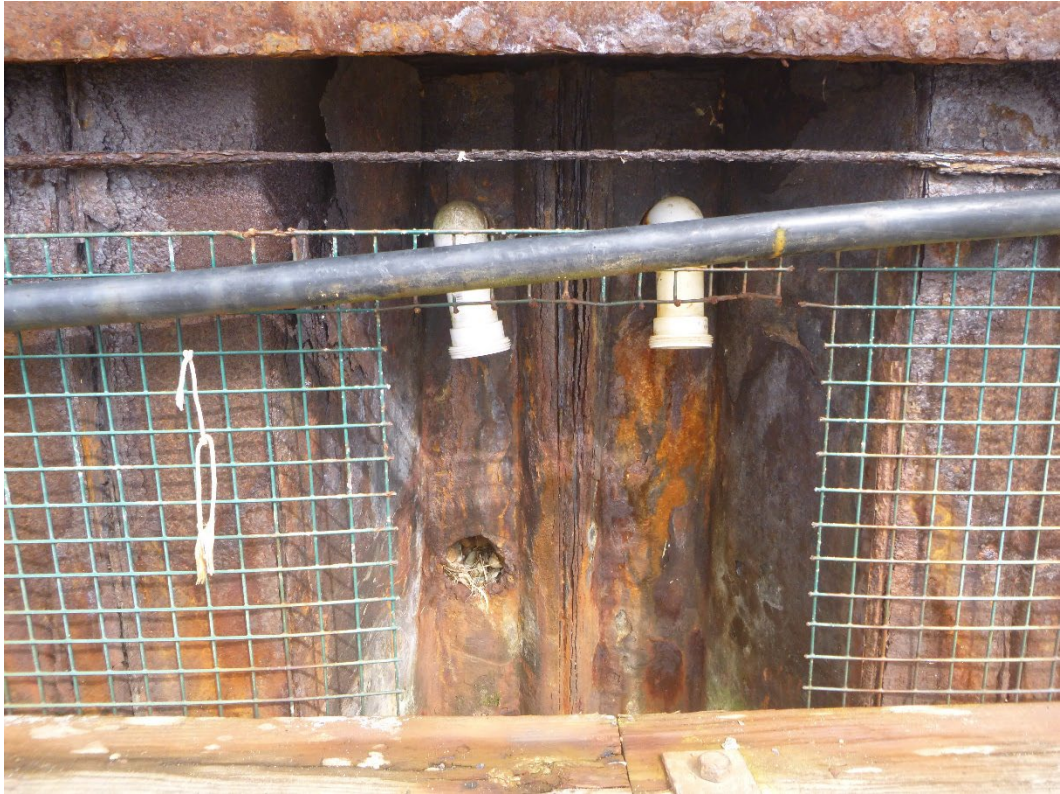
Photo 38 – Intake and outfall pipes through the sheet pile.

Photo 39 – Intake and outfall pipes through the sheet pile.

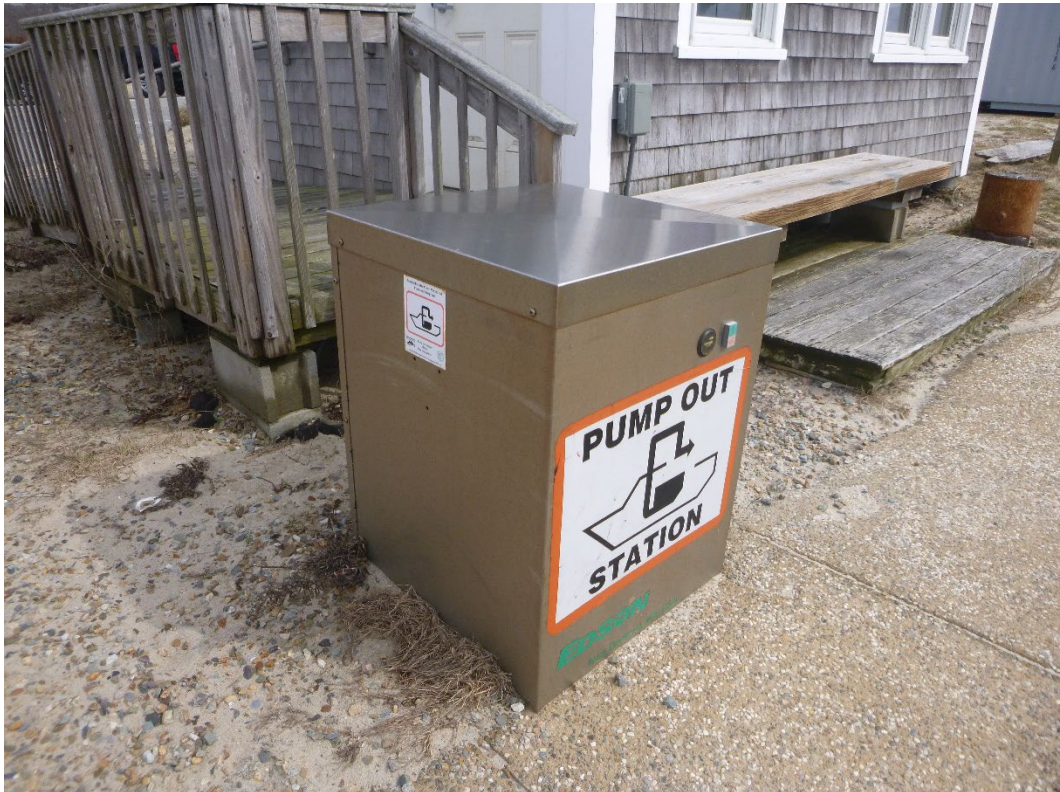
line providing access to the pump out station by Edson Pumps (see Photo 40). The pump out station empties into an underground tank located across Basin Road. The fuel pier in front of the Texaco station near Sta 4+47 supports two fuel pump stations with all the associated fuel and electrical lines extending into the bulkhead near the corner of the sheet pile. The pedestals between Sta. 5+00 and 6+58 were recently installed and in satisfactory condition (see Photo 41). Two large electrical transformers are located behind the sheet pile providing electrical service to the wharf and adjacent floating docks (see Photo 42).

Photo 40 – Pump out station behind the bulkhead.

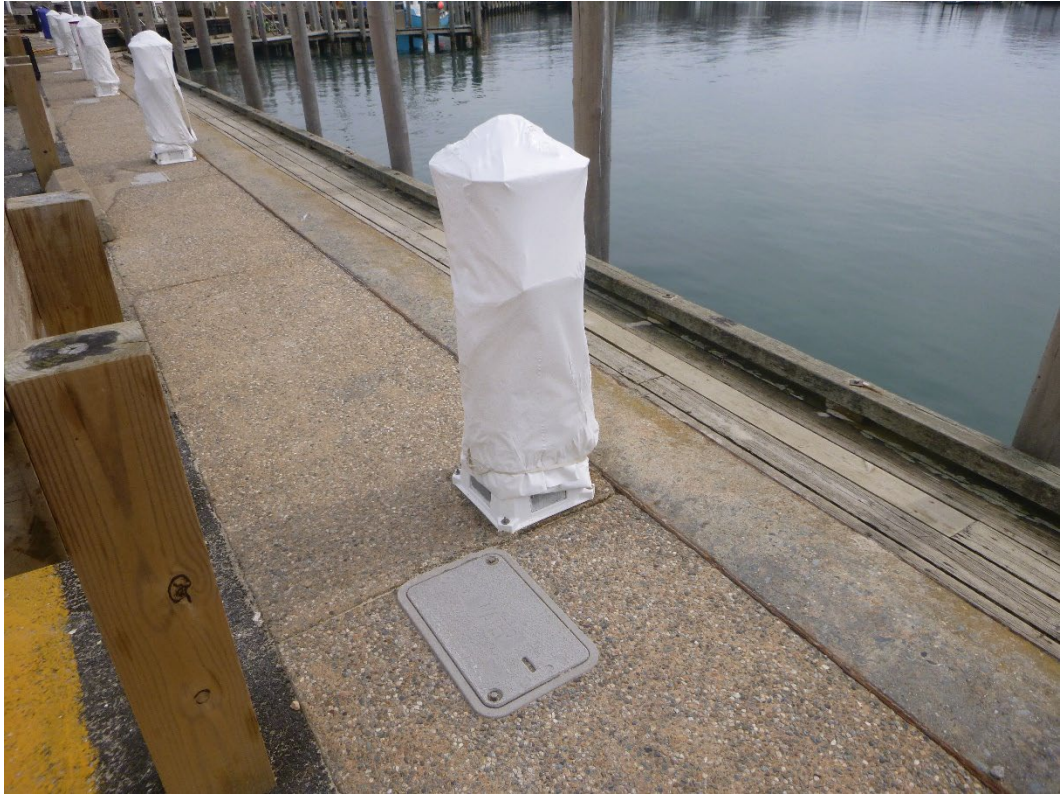
Photo 41 – Shore power pedestal.

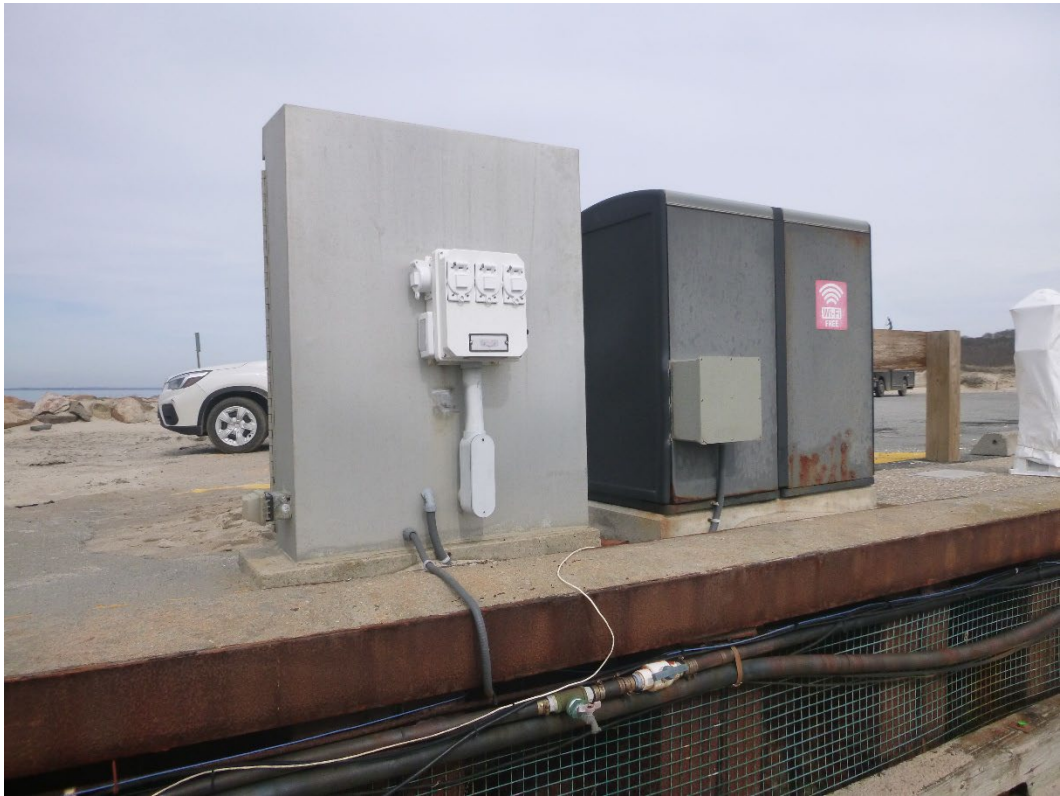
Photo 42 – Electrical transformer providing power to the floating docks.
