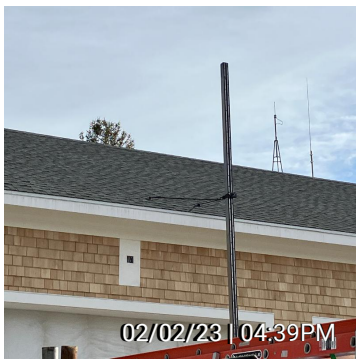
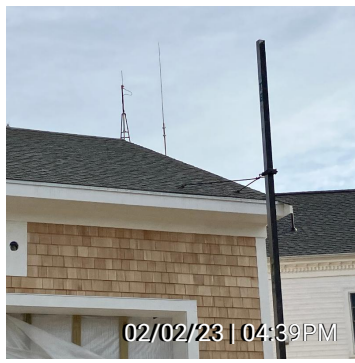
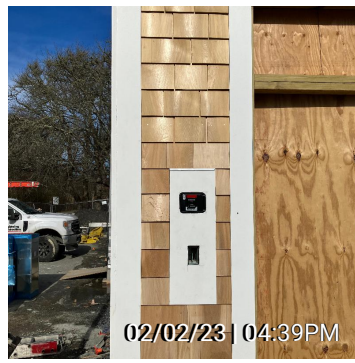
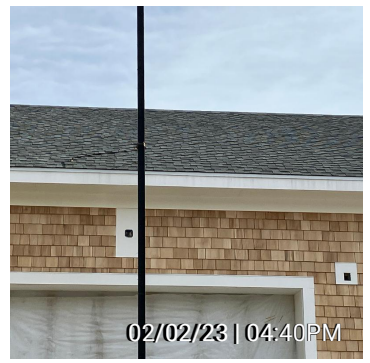
There were 4 carpenters working on exterior trim at the FH .
I noticed some poor quality work at the FH Trim . I went and got Jim Watt he and I walked around and looked at the work at the FH . Jim and I also noticed some shingle nails not properly place , I will be making sure that it is fixed . I will send a note to Mike Owen tonight . I also noticed that the Carpenters have nailed the pump jack brackets in 4 locations at the front of the FH right through the finished roof . I will ask them to remove 2 courses and install new shingles

1. Mike Leon was on site for Dellbrook today .Mike and I talked about the different ideas for the Propane tank . I did talk to Mike about removing two rows of roof shingles from front of FH to repair where Carpenters nailed brackets through finished roof .
