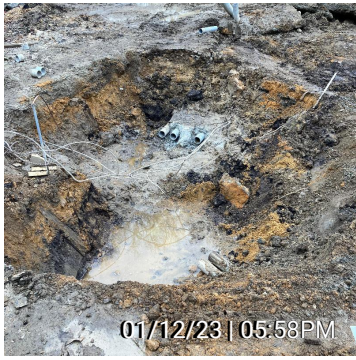
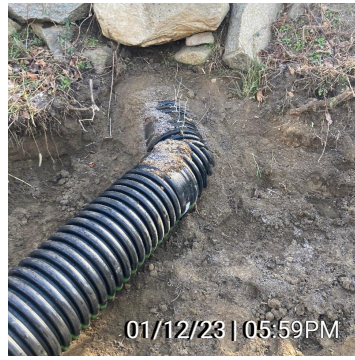
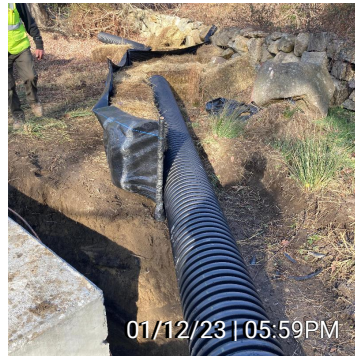
The wetland between the two buildings has been put back together . I am going to talk to Mike Leon and see if we can talk to CONCOM regarding leaving temporary culvert in place for long term . This would divert water from the electrical structure.

Two photos show the Culvert diverted and one picture is for my records because Farland and the Electricians moved several pipes that were incased in Concrete .

If there is a problem later as they pull wires I will understand what is going on .

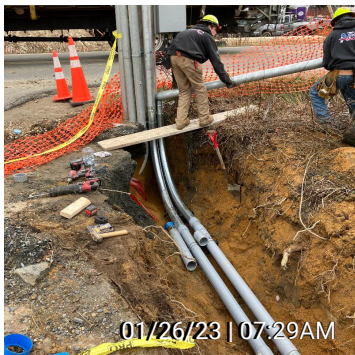
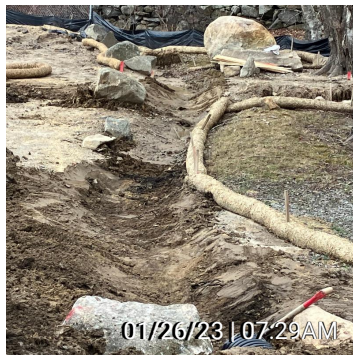
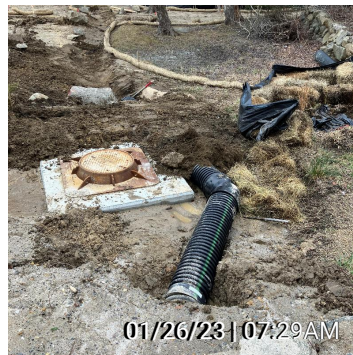
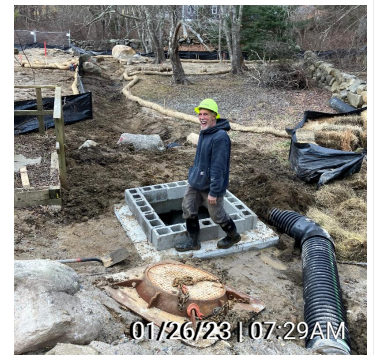
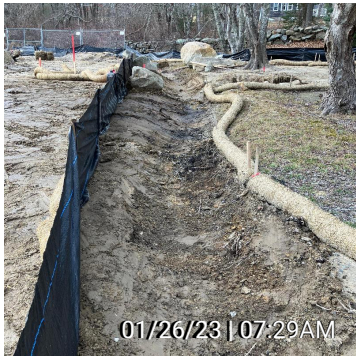
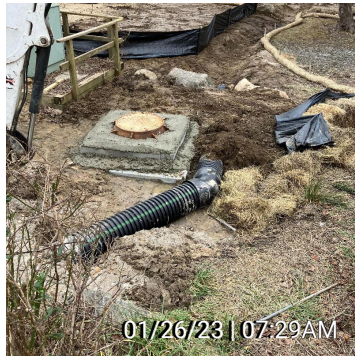
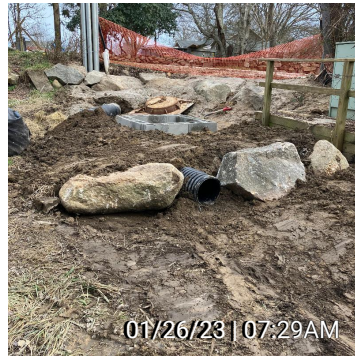
2. THE RISERS AT THE MIDDLE ROAD ENTRANCE TO THE EMS AND SOME SHOTS OF THE AREA AT THE ENTRANCE TO THE TH FROM MIDDLE ROAD
