399 Middle Road Chilmark, Massachusetts 02535

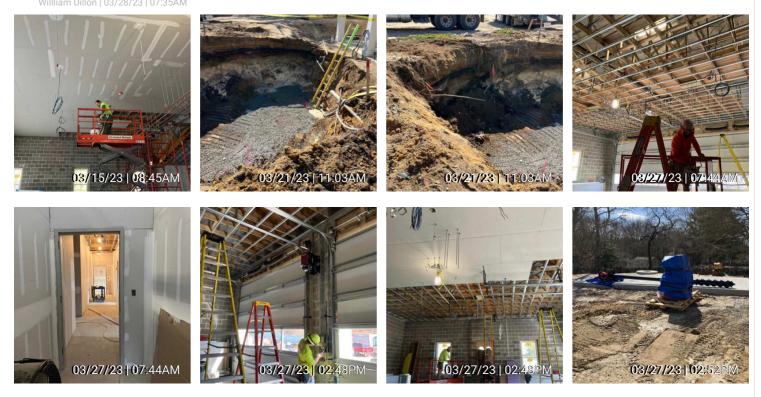
The steel erection workers did not show up as expected ,Mike says they will be in tomorrow to fabricate the steel bent . Briggs engineering will be out on Wednesday to X-ray welding . The plan is to X-ray one side and if there is no porosity we will not X-ray the other side.

Marshall Puffer the Structural Engineer is coming on Wednesday to look at structure, if all meets his approval the shoring can be removed and apparatus bay finished.

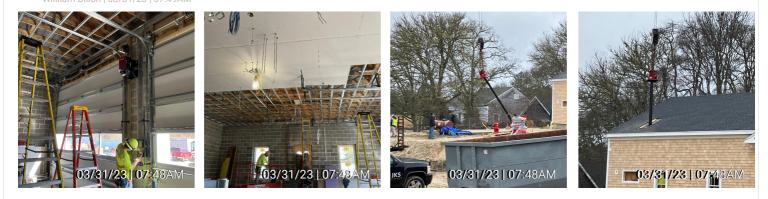
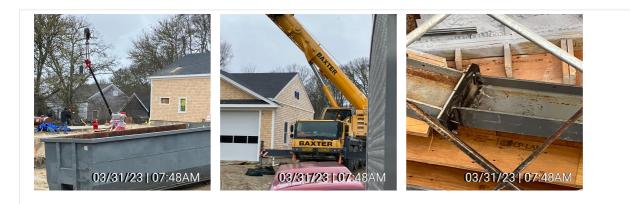
2. Sprinkler turbine install and steel beam repair

I left the FH at 5:00 and one beam was up and repaired ,everything must be final welded and ready for Xray test next Tuesday . They told me they will be on site till Saturday afternoon.
