COASTAL PROCESSES SPECIALIST  
WOODS HOLE SEA GRANT | CAPE COD COOPERATIVE EXTENSION  
[gberman@whoi.edu](mailto:gberman@whoi.edu) | [gberman@barnstablecounty.org](mailto:gberman@barnstablecounty.org)  
508-289-3046 | 193 Oyster Pond Road, MS #2, Woods Hole, MA 02543-1525

February 26, 2014

RE: Town of Chilmark Squibnocket Beach and Parking Area Project

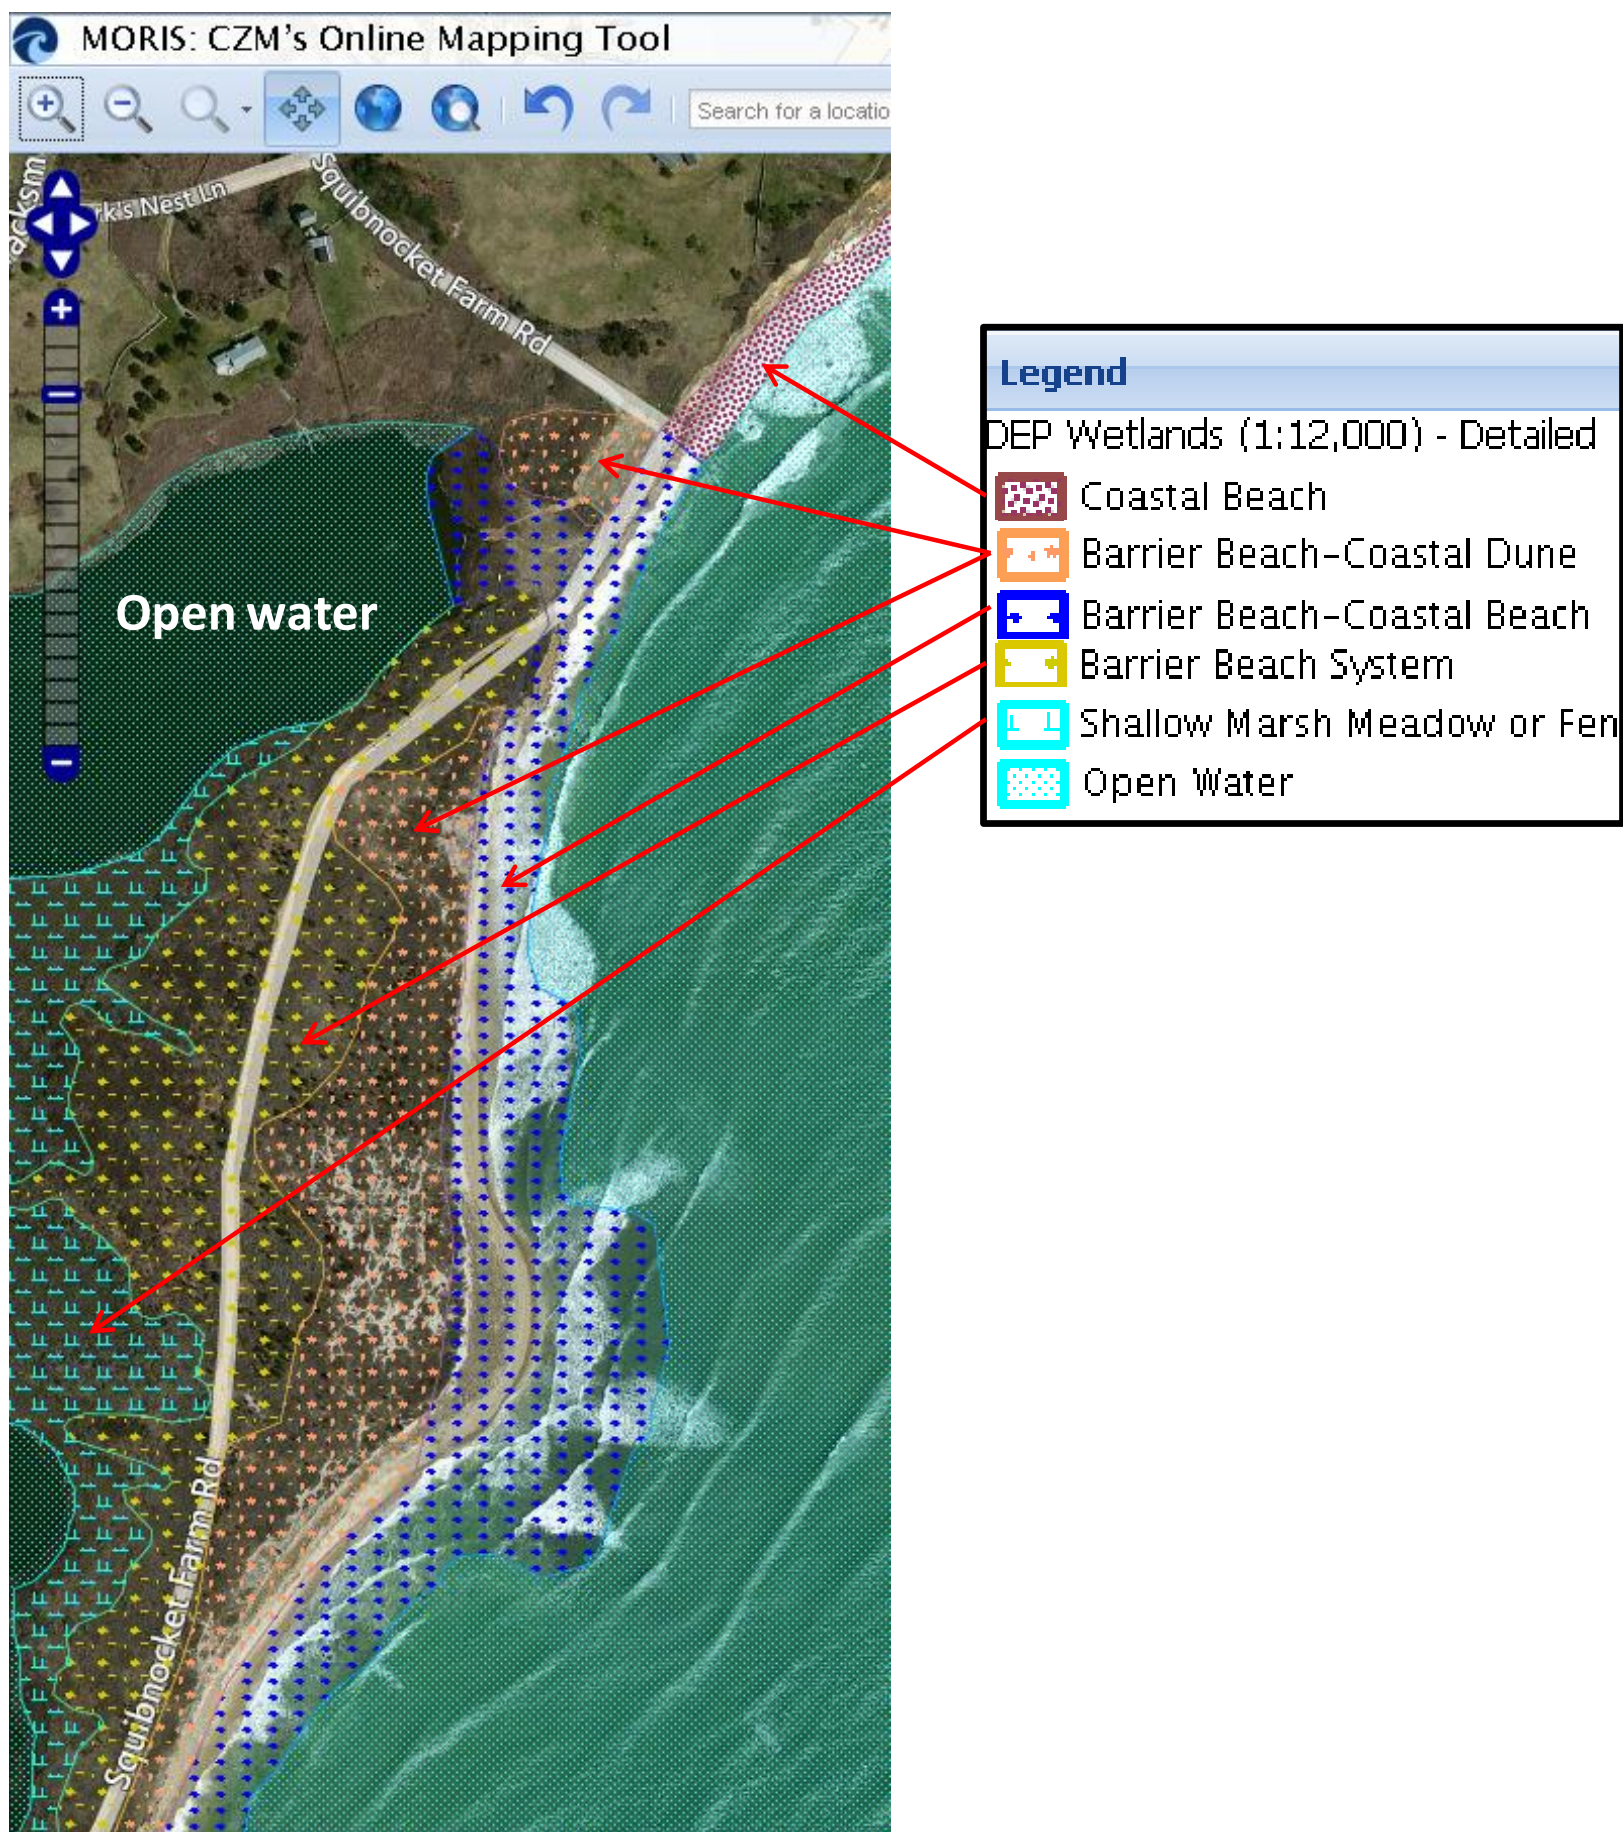
There are multiple natural resource areas at this location that have been delineated by DEP (Figure 5). To the north of the revetment there are coastal banks, although they are not shown on the

DEP datalayer. The land that has been classified as Barrier Beach-Coastal Dune extends to the road at the site of the proposed parking area, although this is not the case further south.

Figure 5. The image below is a screen shot from MORIS focused on the Squibnocket project area. The polygons presented are the 2009 DEP Wetlands (1:12,000) datalayer, indicating coastal resource areas.

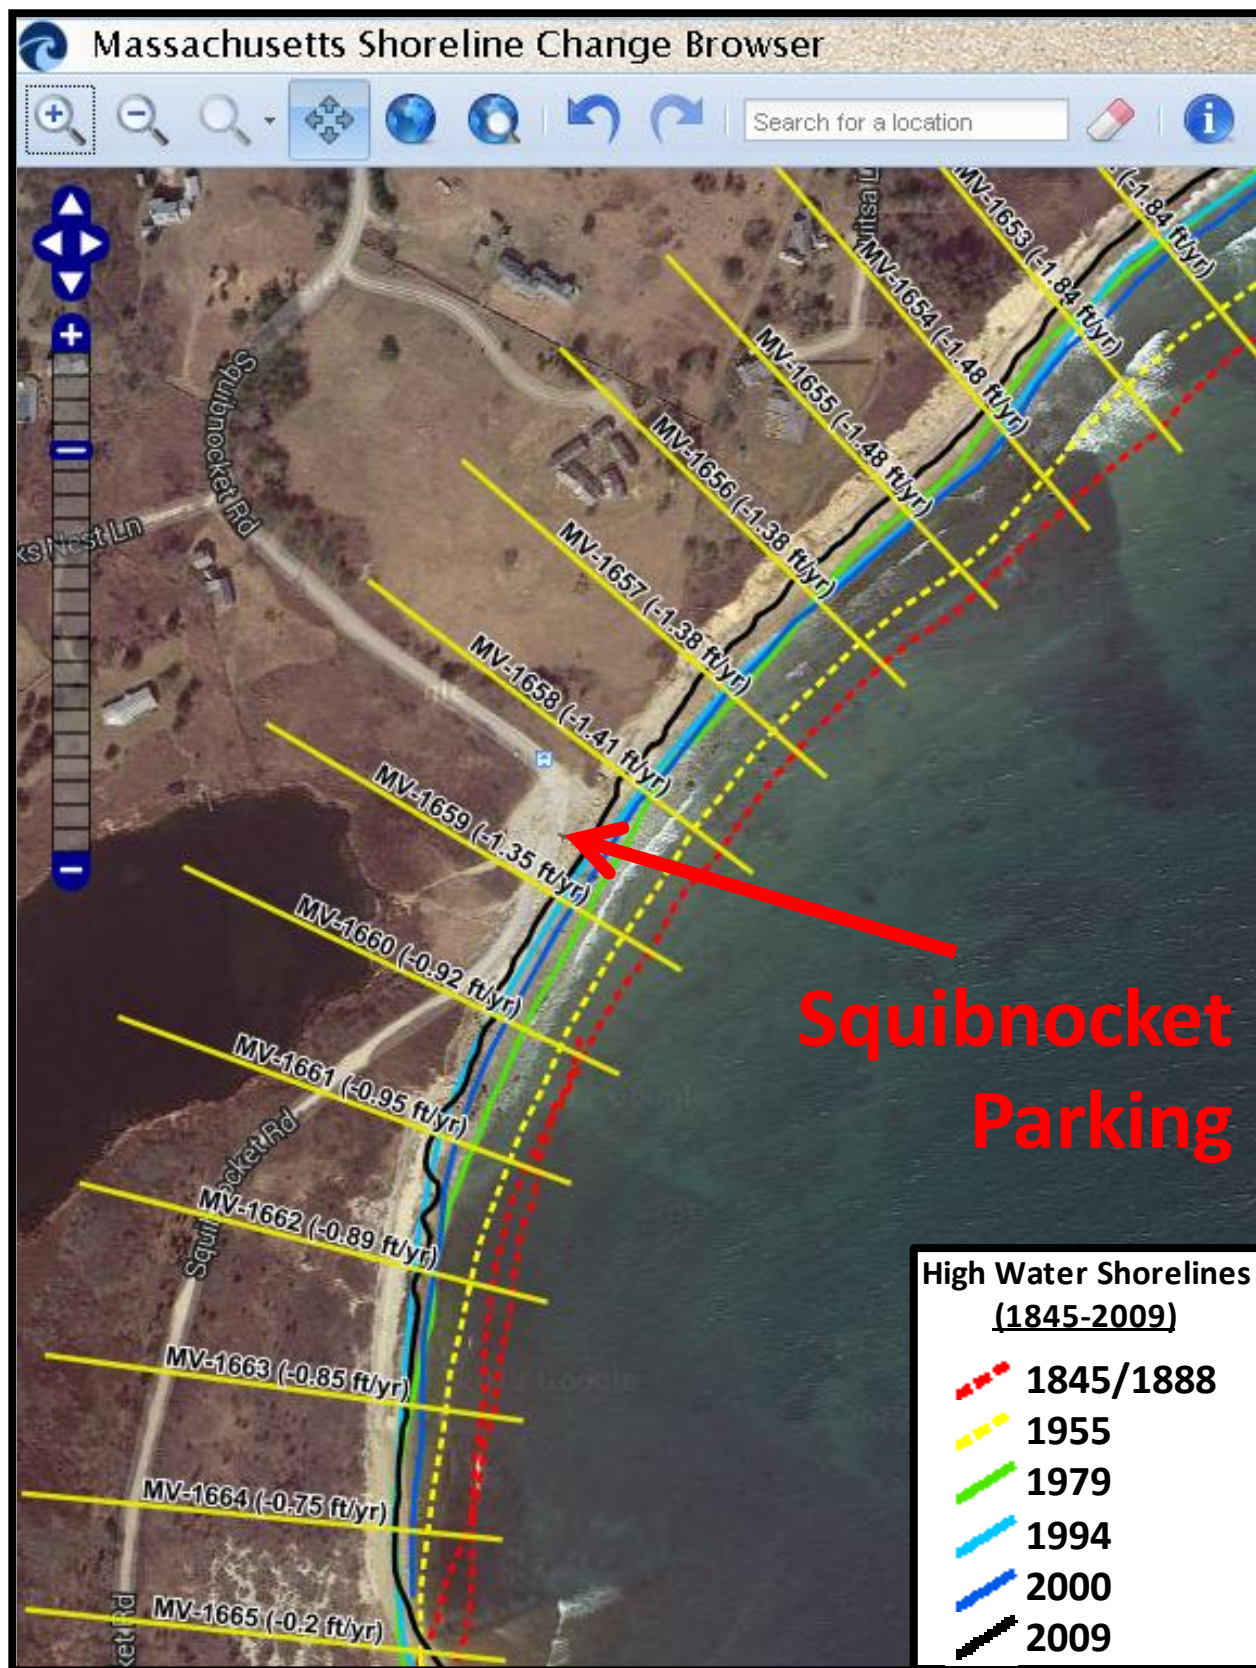
**Squibnocket Parking**

Shoreline change transects for Squibnocket, called out in Figure 6 and Table 1, indicate both the long-term (1845-2007) and short-term (1979-2007) rates of change as well as the associated uncertainty. The estimated long-term rate is variable along this section of shoreline. The transects closest to the parking lot (MV-1658 and MV-1659) are in a rapidly eroding section of this shoreline at approximately 1.4’ of erosion per year (the actual erosion range is between 1.0’ and 1.8’ of erosion per year) while the transect at the Mussel Bed area (MV-1665) shows an erosion rate of approximately 0’ (the actual range is between 0.2’ and -0.6’ per year). Short-term erosion rates are more variable but still show similar patterns, that there is a decrease in erosion to the south. The parking area short-term erosion rate (1.7’ per year) is consistent with the long term rates. The Mussel Bed area indicates accretion, however the high levels of uncertainty associated with the short-term make it difficult to confidently determine if the shoreline is eroding (negative values in table) or accreting (positive values in table). For example, while the “best guess” at MV-1665 is accretion of 1.4’/yr it actually could be anywhere between erosion of 2.3’/yr or accretion of 5.0’/yr. It may be reasonable to use the long-term erosion estimate (~0’/yr) until such a time that additional site specific data is collected that indicates that a different erosion rate is more appropriate.

While it may be reasonable to use the long-term erosion estimate (~1.4’/yr at the existing parking lot, ~0’/yr at the Mussel Bed) for the area, this assumes there are no major (or even medium) storm events within the next few years. This is a MAJOR assumption and one of the failings of using a long-term rate to attempt to predict short-term erosion. Also, changing location conditions (ex. wind/wave regime, bank composition, etc.) as well as global conditions (ex. Sea level rise) can have impacts on the longevity at this site. Short-term rate erosional range extremes along this section of shoreline were up to 3.7’/yr but cannot be considered a “worst-case-scenario”, as these rates could definitely be experienced during one day in a storm event.

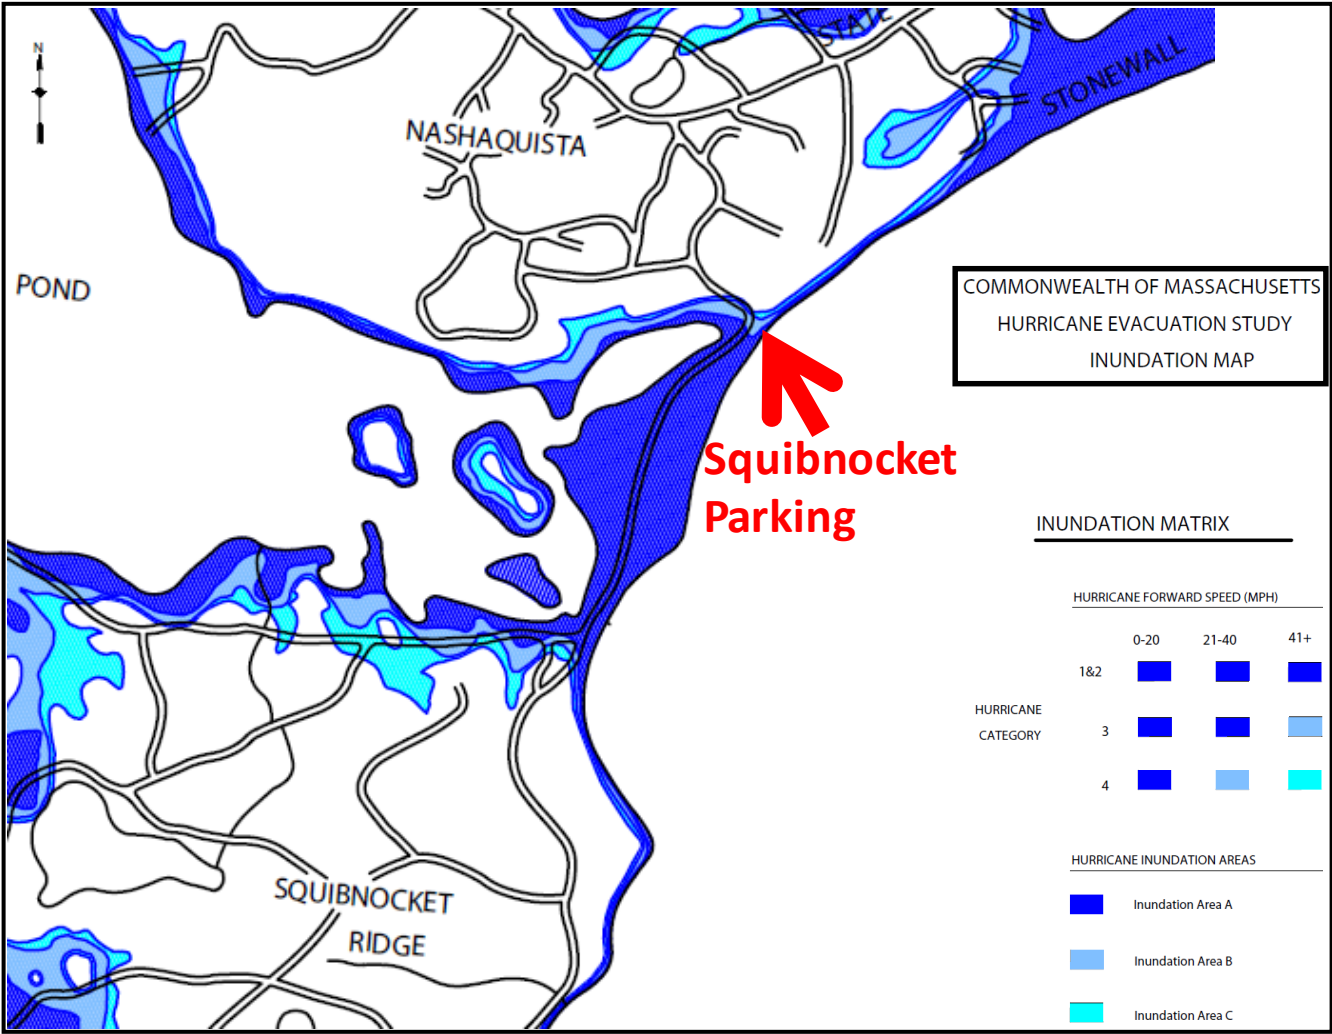
The USACE finalized the Southern Massachusetts Hurricane Evacuation Study in 1997, to provide the Massachusetts Emergency Management Agency and the coastal communities in southern Massachusetts with realistic data quantifying the major factors in hurricane evacuation decision-making. The map (Figure 7) provides information on the extent and severity of potential flooding from hurricanes, the associated vulnerable population, and impacts to evacuation roadways. According to the inundation matrix, any category 1 (or greater) hurricane will flood the entirety of the proposed land to be leased (as Inundation Area A). Due to its higher elevation the current parking lot is Inundation Area B, and would only flood during a fast moving category 3 (or greater) hurricane.

Figure 7. The image below has been adapted (and existing Squibnocket parking area called out) from the Commonwealth of Massachusetts Hurricane Evacuation Study Inundation Map for the town of Chilmark. The original map was prepared by the U.S. Army Corps of Engineers, New England Division in cooperation with the Federal Emergency Management Agency, Region I for the Massachusetts Emergency Management Agency.

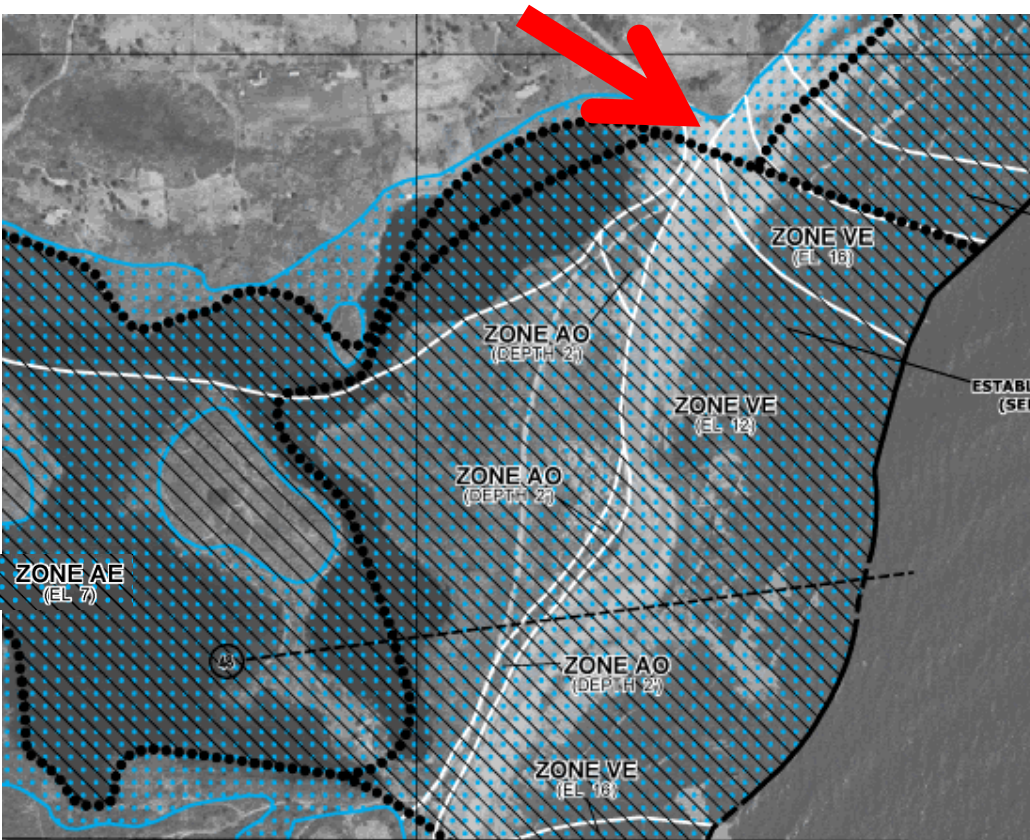
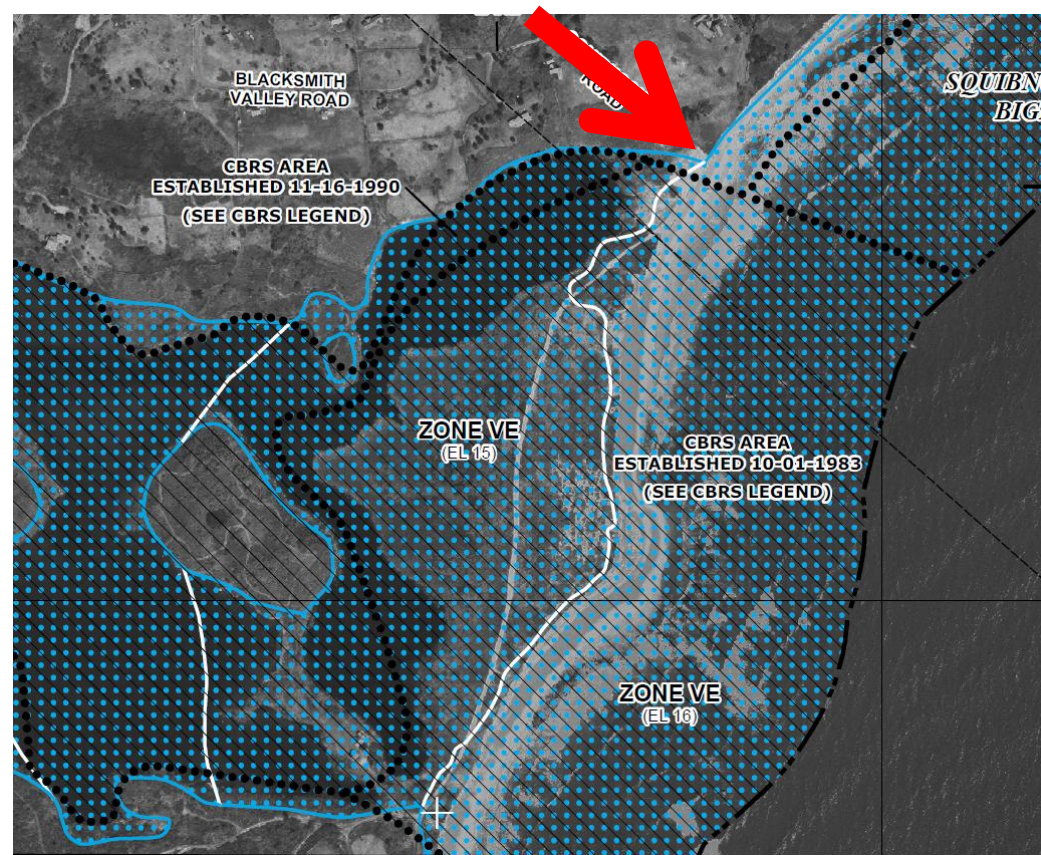
The FEMA NFIP FIRM for the area shows a similar delineation. Significant changes have been made to the Special Flood Hazard Area (SFHA) boundaries from the 2010 effective map to the 2013 preliminary map (Figure 8). Some of the existing parking lot has been removed from the SFHA that has at least a 1% annual chance of flooding (the blue line with blue dots on Figure 8), however now instead of being in an AO zone that could flood to a depth of about 2' due to overwash, portions of the existing parking lot are now in a VE zone which can experience waves of >3'. Additionally, in the 2010 map the upland portion of the proposed lease area was either an AO zone or AE (EL 7), now this area is VE (EL 15). Consistent between the two maps is the Coastal Barrier Resources System (CBRS) area (black dotted line on Figure 8) boundary. The existing parking lot is not in the CBRS, however the entire proposed lease area is CBRS. This designation does not forbid privately financed development; however it does not allow federal financial assistance (ex. NFIP flood insurance, FEMA post disaster assistance funding, etc.) within the CBRS.

Figure 8. The images below were extracted from the NFIP Flood Insurance Rate Maps for Dukes County. Map # 25007C0159H, Effective Date July 6, 2010 is on the left, Map # 25007C0159J, Preliminary Date June 3, 2013 is on the right. The existing Squibnocket parking area is called by the red arrow.

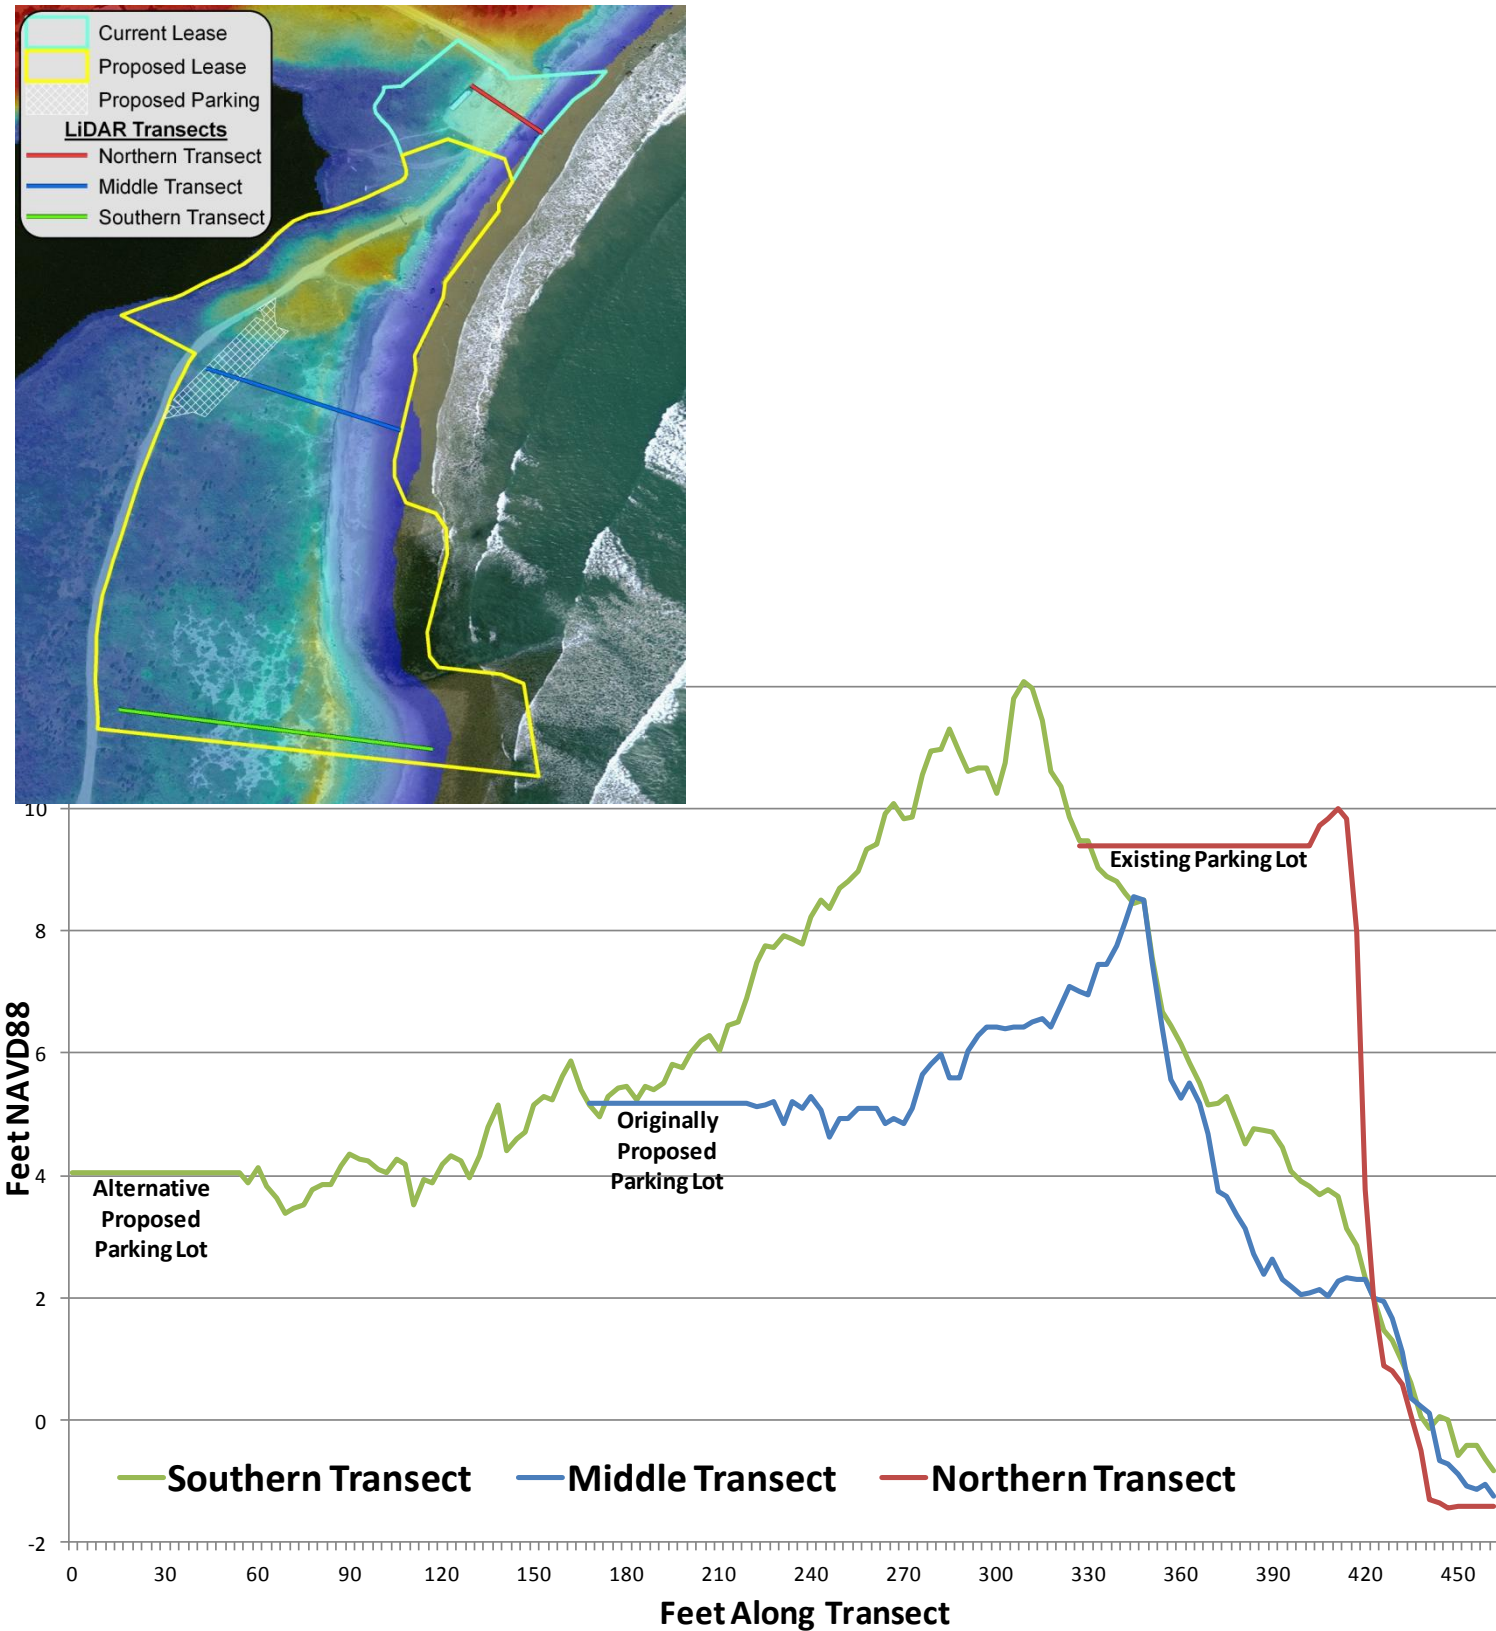
Collecting topographic surveys were outside the scope of this assessment; however there is freely assessable 2012 Post Sandy USACE LiDAR data. LiDAR is an optical remote sensing technology that uses lasers to detect the distance to an object or surface, thereby obtaining detailed elevation data. This data was downloaded from NOAA Digital Coast and three topographic profiles were extracted to represent the existing parking lot (red line on Figure 9), the proposed parking area (blue line on Figure 9), and an alternative site at the southern extreme of the proposed leased land (green line on Figure 9). Each of these topographic profiles have been graphed (bottom of Figure 9) in order to show their relative elevation and distance from the Atlantic Ocean shoreline (which would be on the right side of the graph). It is clear that the existing parking lot would be the closest to the water and at the highest elevation of the three transects. The alternative southern location would be the furthest from the water the lowest elevation; however it would have high dunes for wave protection and to add volume to the beach during storms. The originally proposed location is in the middle for both of these parameters.

There is a significantly higher dune system, a wider beach, and a slower erosion rate (near zero) at the southern extent of the proposed lease area. For these reasons it is likely that the southern site should be considered as a potential location of the parking area. While the originally proposed parking area (blue on Figure 9) is slightly higher than the southern location (green on Figure 9) it is likely that both sites would be flooded during a major storm event, and therefore erosion and not temporary flooding should be one of the key characteristics when determining the new parking location. Additionally, the currently proposed parking area is located in an area that has been classified as Barrier Beach-Coastal Dune, further to the south the land is classified more generally as a Barrier Beach System, which might make it easier to permit (Figure 5).

Figure 9. Three topographic profiles were extracted from 2012 Post Sandy USACE LiDAR data (downloaded from NOAA Digital Coast) along transects, represented by colored lines in the figure below. The topographic profile for the existing parking lot (red in both the map and graph), the originally proposed parking lot (blue in both the map and graph), and the alternative parking lot location (green in both the map and graph), all intersect at the elevation 2' NAVD88. The topographic profiles have also been smoothed along the existing or proposed parking lots to help identify these areas.

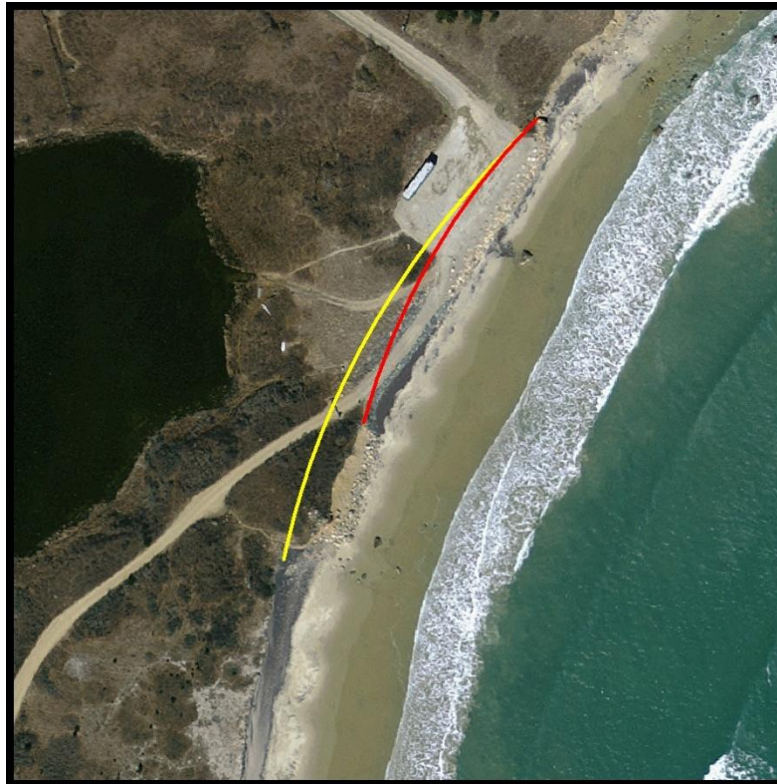
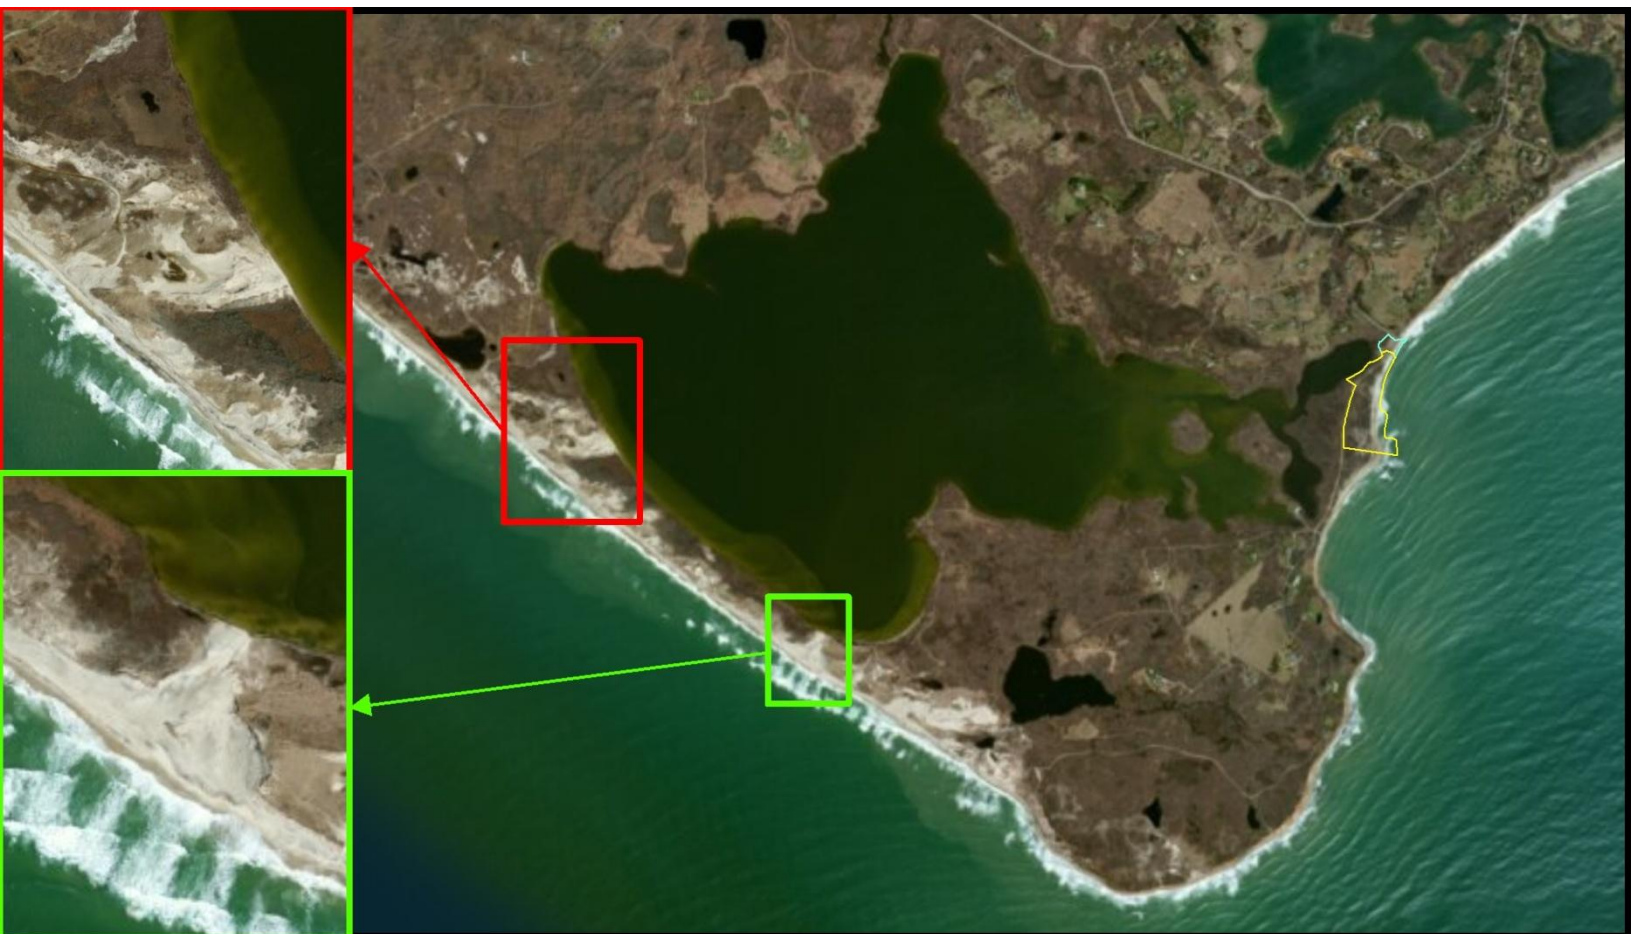
**A13-14:** Estimates of short-term shoreline position (red/yellow lines on Figure 10) are over 60' away from the paved Squibnocket Road. If erosion continues at 1.4' per year there would still be over 40 years until the paved road was threatened. This is a VERY rough estimate as the exact position of the road may be part of another project design, and the town's plan for maintenance (and the budget of said maintenance) of the proposed new landforms is still uncertain. As shown in Figure 11, some of the revetment could be re-aligned in order to protect the road connection points to the proposed raised roadway.

Figure 10. The top image shows a shoreline position, in line with the rest of the coast, after removing just the revetment (red line) or the revetment and the boulders to the south (yellow line) that are shown in Photograph 3. The bottom image shows areas of overwash along the western barrier beach of the pond.

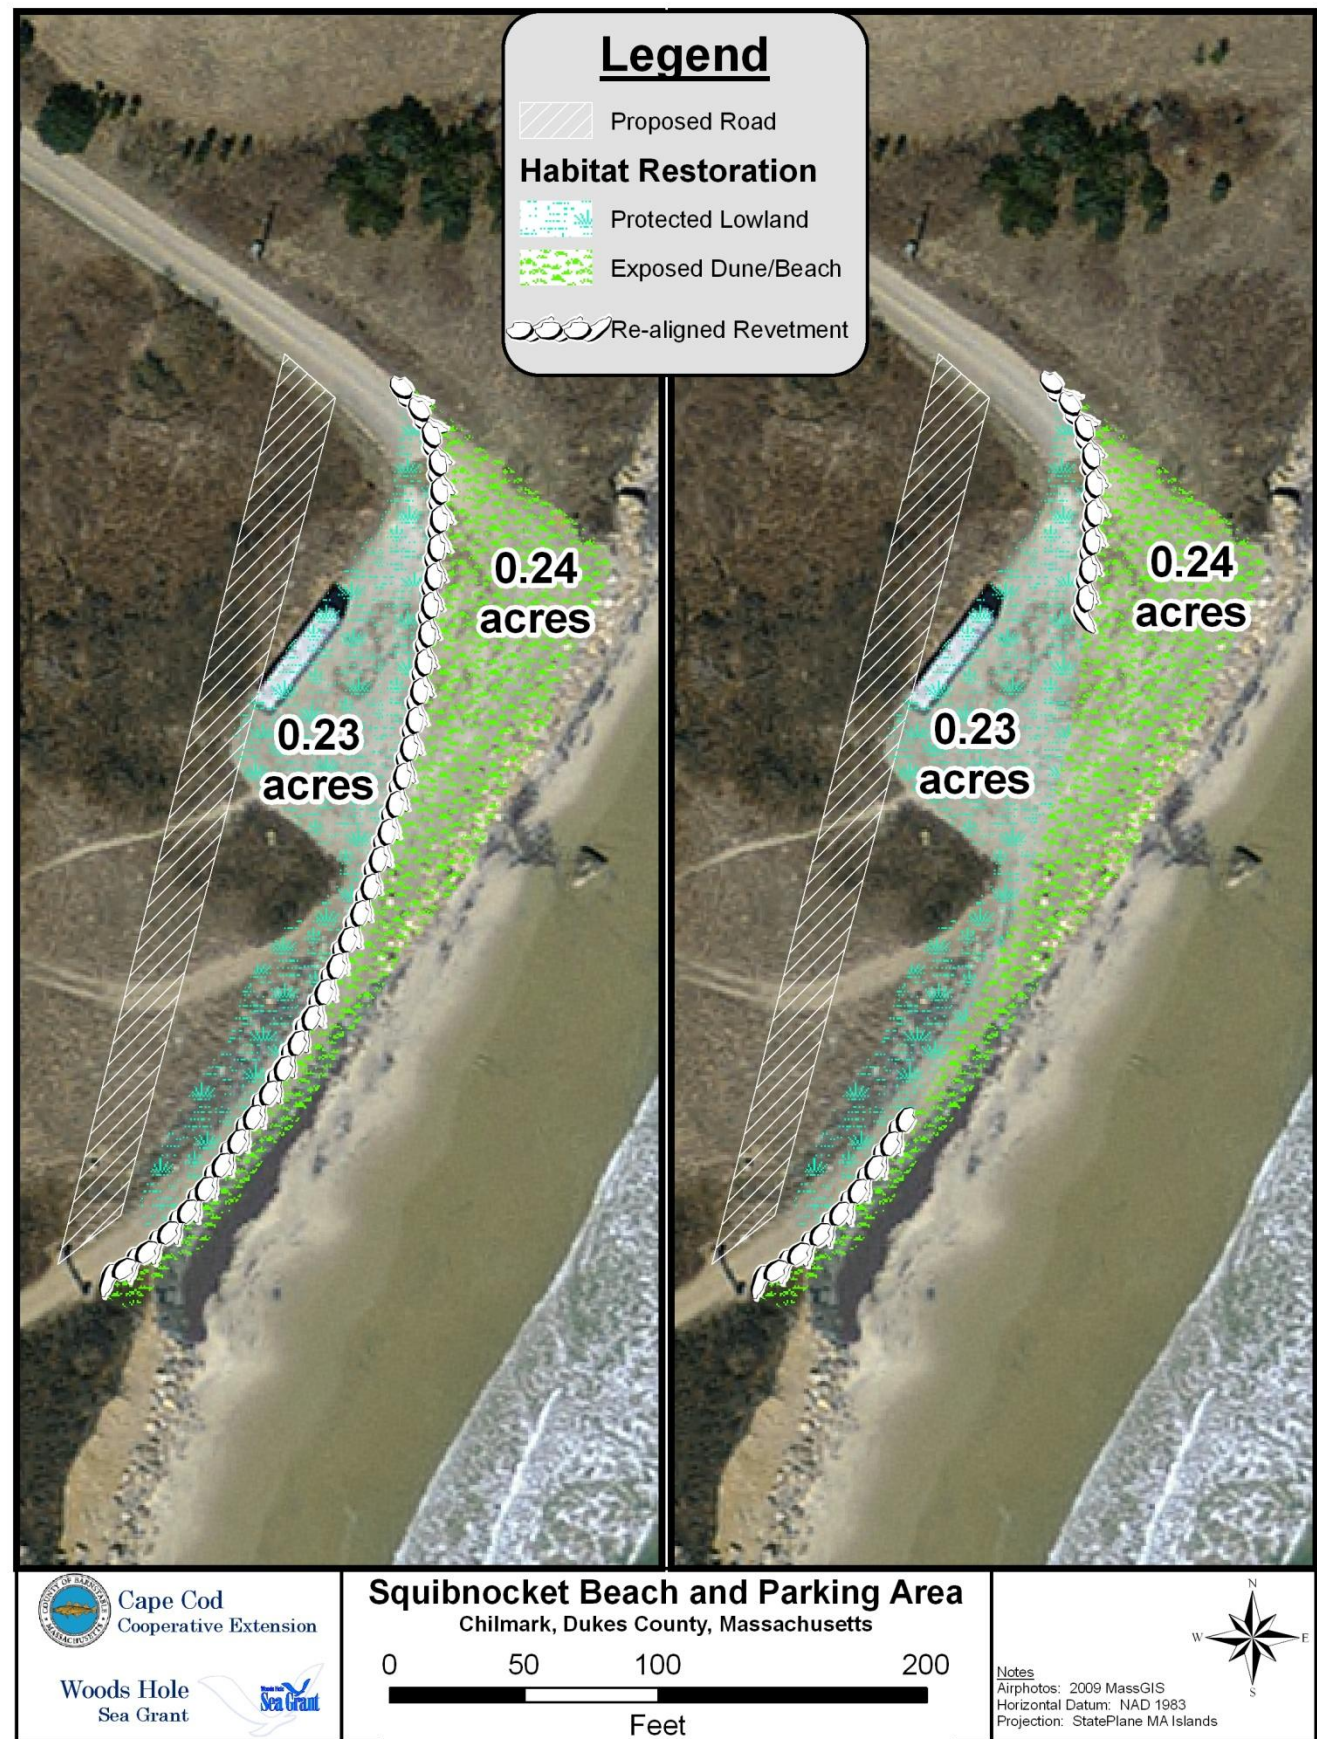
Figure 11. The map below shows two potential restoration conceptual designs. These should not be considered preferred designs, simply examples to consider when designing the restoration of the existing parking lot. The left image shows a re-aligned contiguous revetment, while on the right there is a gap in the revetment. The rough estimate of restored resource area in this example is about 0.5 acres.

A potential alternative to complete revetment removal is leaving some of the revetment in place and/or realign the stones. Figure 11 shows two potential restoration conceptual designs. These should not be considered preferred designs, simply examples to consider when designing the restoration of the existing parking lot. Both designs show approximately 0.5 acres of restored area with different habitats on each side of a potential revetment. The revetment in these designs could be covered with dune material such that it would only be exposed after a storm, which could be a trigger for renourishment. The top elevation is not indicated, and would need to be considered. This structure could be a revetment matching the height of the current revetment, or it could be a low sill. The left image shows a realigned contiguous revetment. This type of configuration would protect the habitats behind the revetment, and may prevent new inlet formation while still allowing overwash. The right image shows a realigned revetment with a gap. This type of configuration would protect some of the habitat behind the revetment, and would allow new inlet formation and overwash. The connection points to a potential new raised roadway would be protected, while the restored dune/beach in front of the revetment would likely be lost, in either configuration. A third configuration could be if all the revetment stones were removed, which would still provide the 0.5 acres of habitat restoration, but might eventually endanger access to the road. While these are examples of what might be considered at the site, the town will likely need a more robust (engineering) analysis of all feasible alternatives in order to weigh its options.

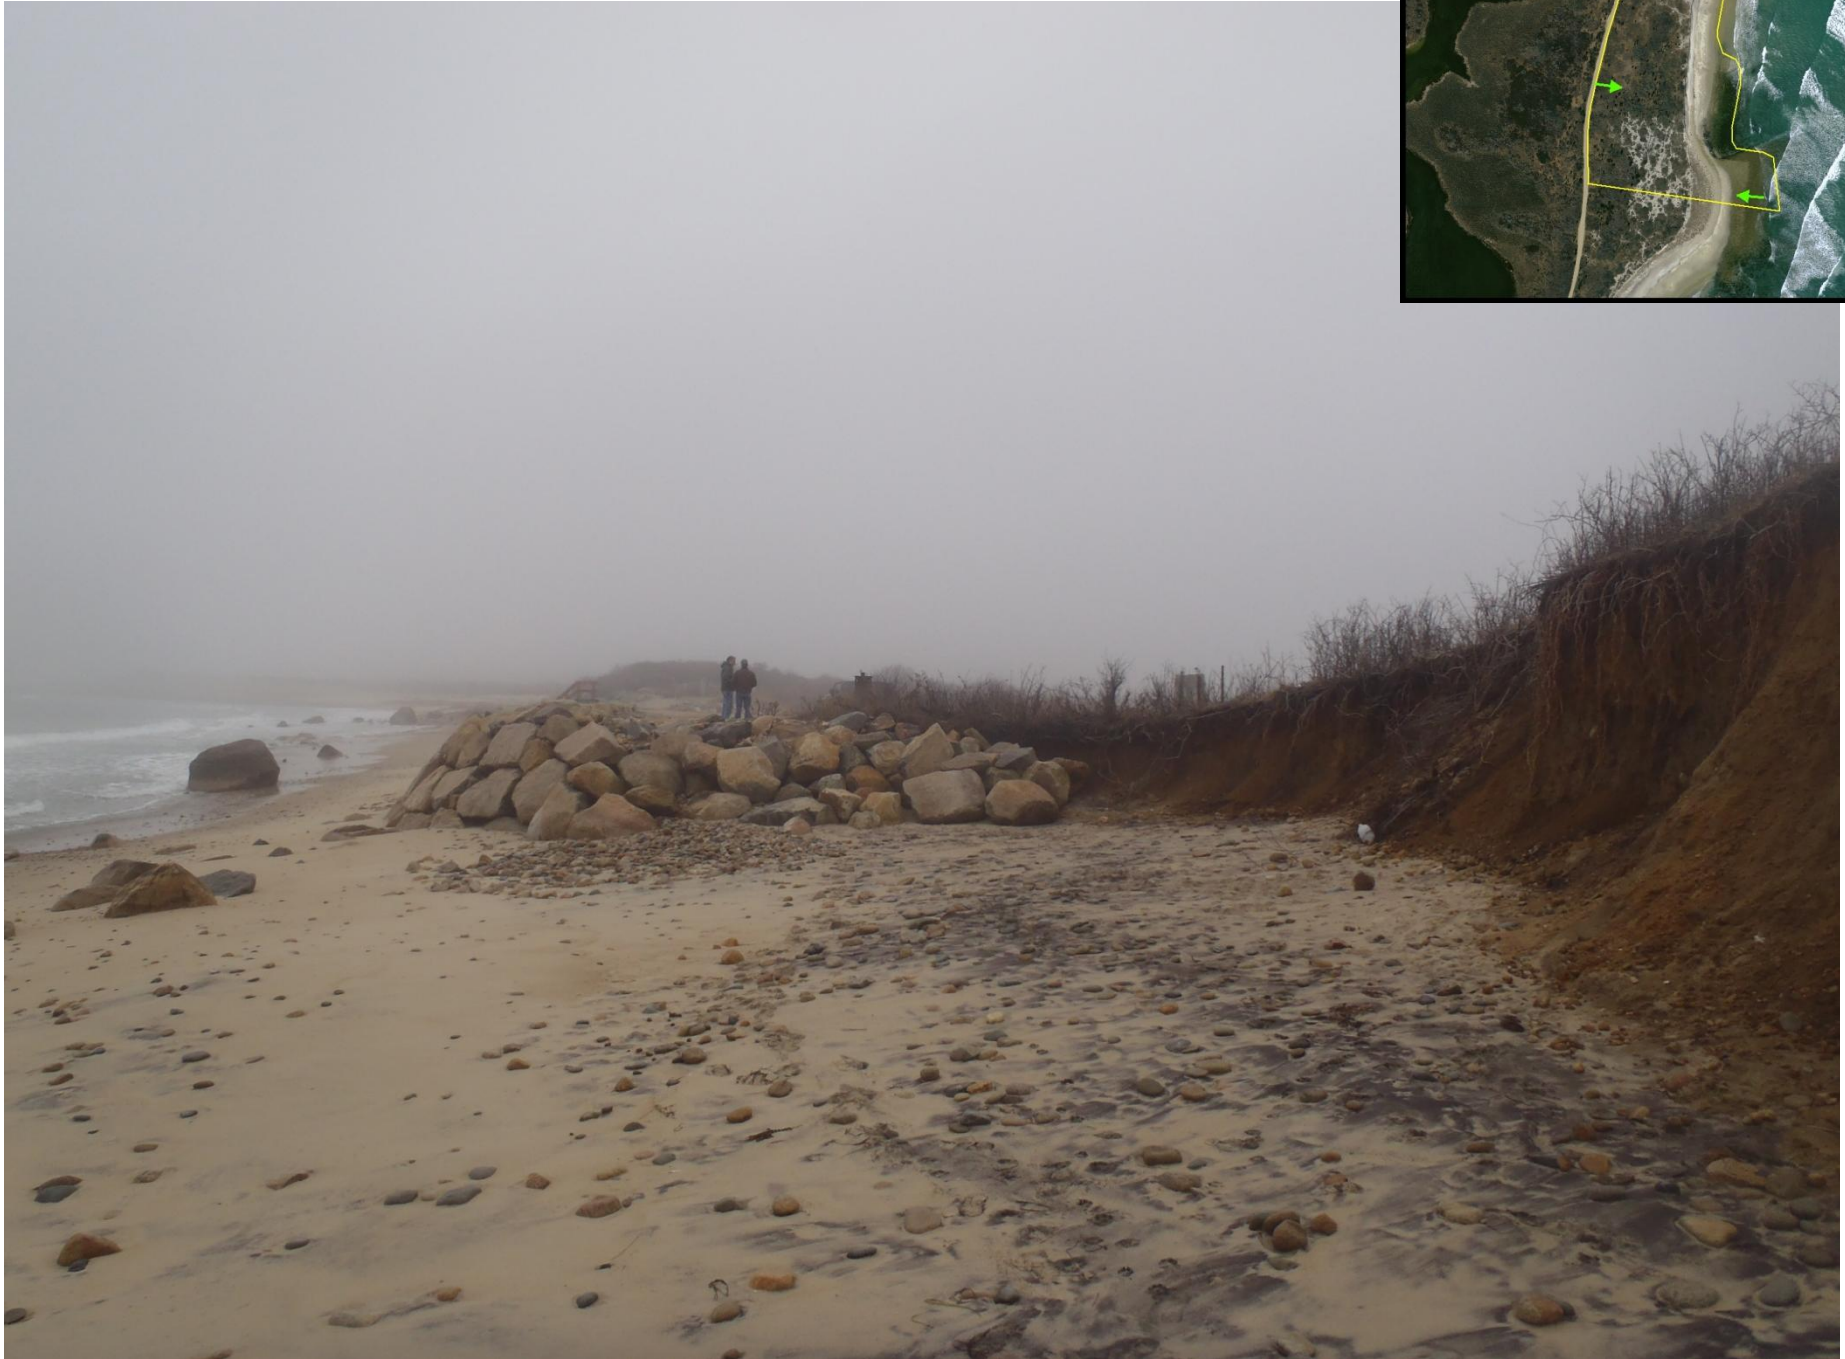
**Site Photographs:** A series of photographs (Appendix A) was collected the site on 01/16/2014. Each of the photographs called out in this section have been selected to highlight potential issues or conditions that might be associated to the erosion at these sites. Photograph 1 shows the erosion of the coastal bank north of the parking lot revetment. The bank is currently too steep to support a vegetated slope and will likely experience more erosion soon. The most recent high tide reached the toe of the bank and there was likely no dry beach in front of the revetment. Photograph 2 shows the narrow access road leading from the parking lot southward towards the proposed parcel to lease. The beach extends from the ocean to the revetment, and on the other side (to the right on the photograph) is a low elevation marsh with some sand and cobbles that have likely been washed over the revetment. During storms, it is only this revetment that prevents a direct hydrologic connection with the pond at this location. Photograph 3 shows an area of erosion south of the existing revetment, some disorganized boulders are located seaward of the eroding coastal bank. Photograph 4 shows the intertidal cobbles of the “Mussel Bed” area. This area appears to have a much higher elevation beach than anywhere up to some distance north of the parking lot. Photograph 5 shows the approximate area of the proposed parking lot, looking towards the ocean from the road. The area between the ocean and road has low dunes and is vegetated by grasses, shrubs, and trees.

**A10-11:** Storm surge and tidal effects on Squibnocket Pond are discussed under **A12**. The coastal banks that are adjacent to the revetment are experiencing erosion (Photographs 1 and 3, Figure 6 and Table 1). Already the toe of the revetment, and the adjacent coastal banks, get wet during many high tides. As the revetment currently extends further seaward than the coastal bank to the east it is highly likely that any shoreline stabilization, by way of placing sediment, will experience erosion equal to or greater than what is being experienced by the adjacent coastal bank (-1.4'/yr from Figure 6 and Table 1). If an inlet were to form, for any significant length of time, it would certainly affect longshore sediment transport and could generate eddies and other flow phenomena that will have an impact on the beach and coastline. As much of the re-nourishment sediment will be transported along the shoreline adjacent properties may see some minor storm protection from this project.

Photograph 1. The photograph below shows the erosion north of the parking lot revetment. The image to the right indicates the location and direction of the photograph below (red arrow) as well as the other photographs in the series (green arrows).
