COASTAL PROCESSES SPECIALIST  
WOODS HOLE SEA GRANT | CAPE COD COOPERATIVE EXTENSION  
[gberman@whoi.edu](mailto:gberman@whoi.edu) | [gberman@barnstablecounty.org](mailto:gberman@barnstablecounty.org)  
508-289-3046 | 193 Oyster Pond Road, MS #2, Woods Hole, MA 02543-1525

February 26, 2014

RE: Town of Chilmark Squibnocket Beach and Parking Area Project

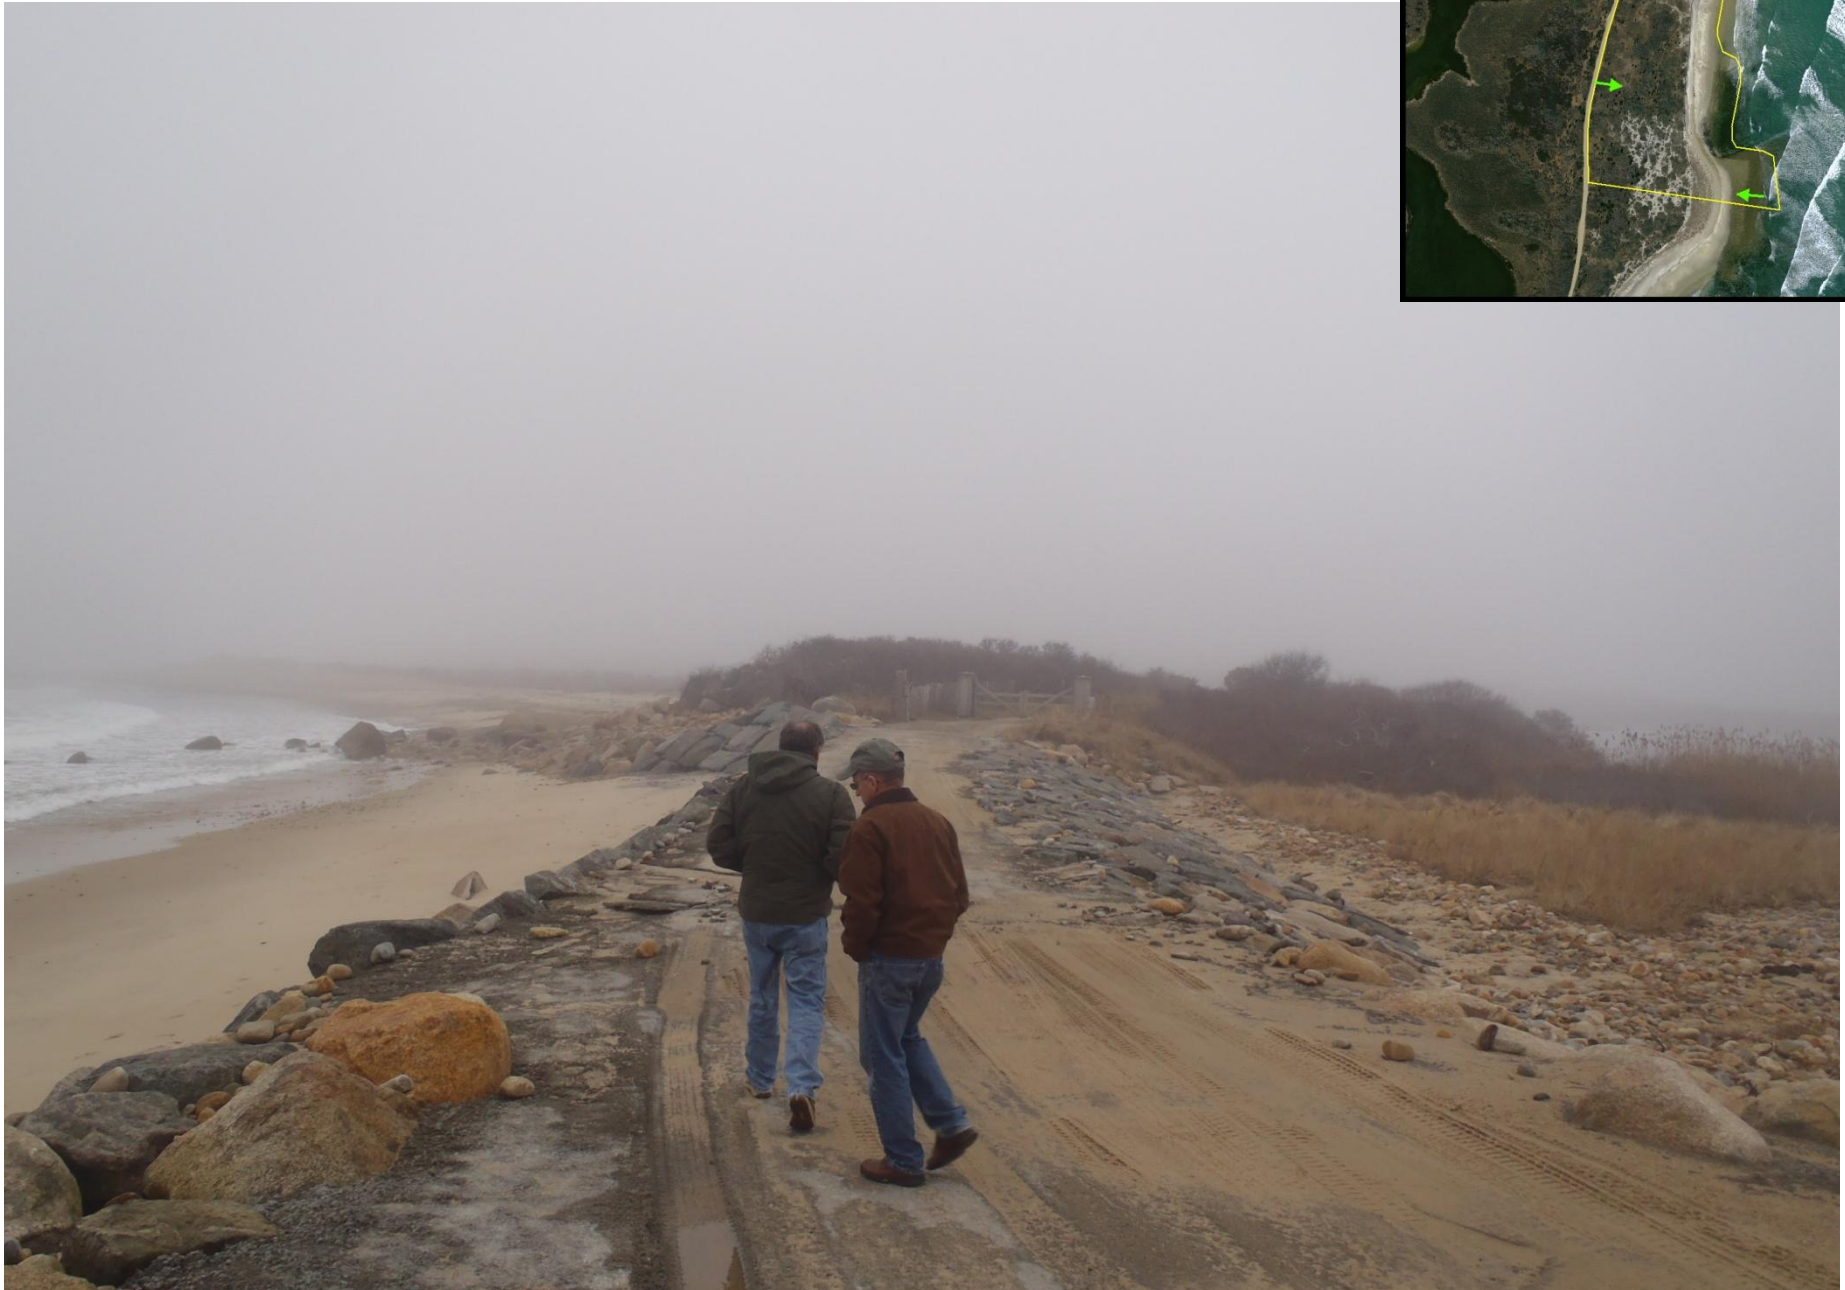
Photograph 2. The photograph below shows the narrow roadway from the parking lot to the south. The image to the right indicates the location and direction of the photograph below (red arrow) as well as the other photographs in the series (green arrows).

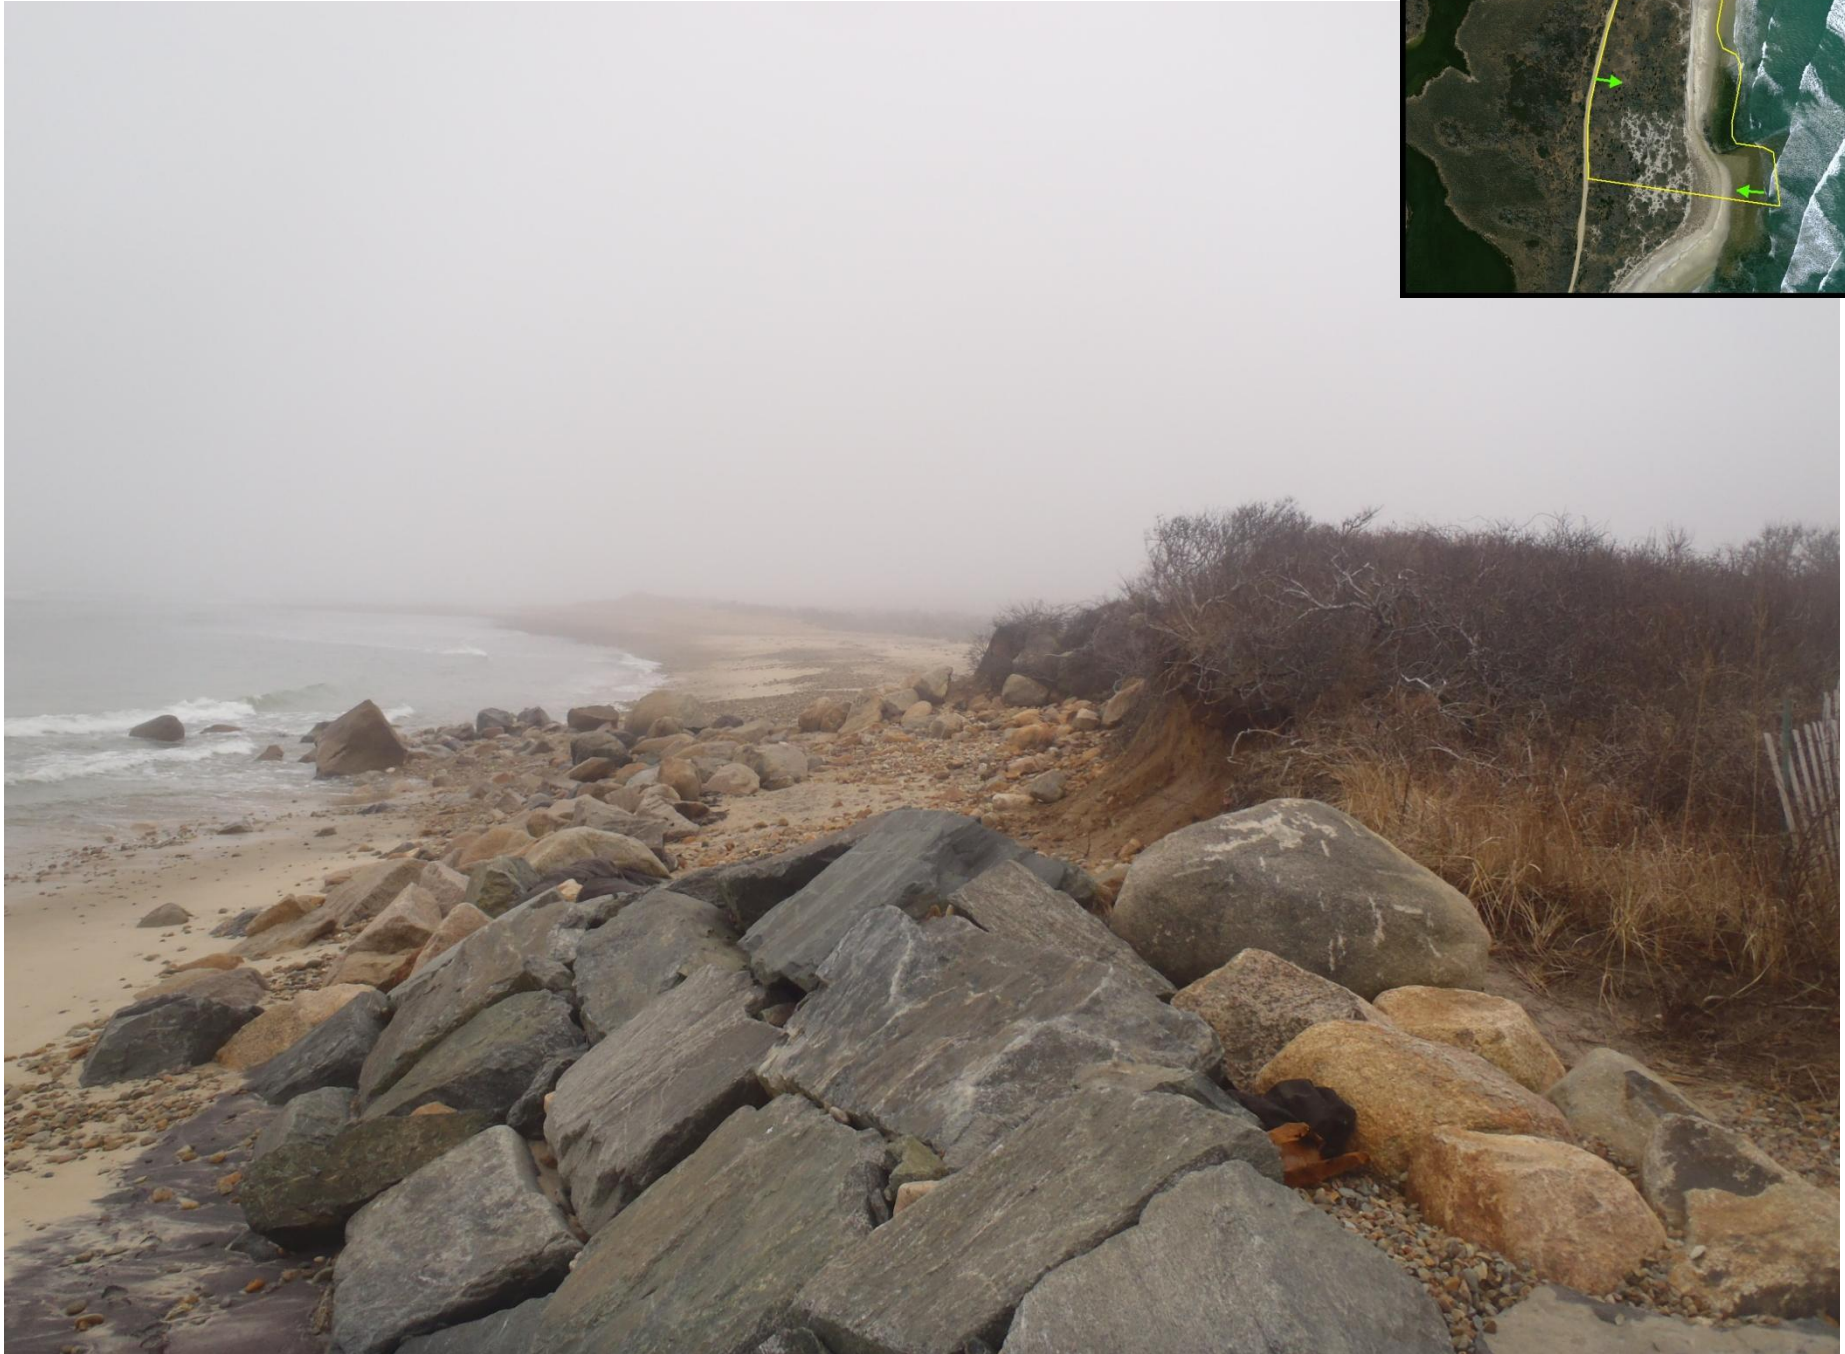
**A10-11:** Storm surge and tidal effects on Squibnocket Pond are discussed under **A12**. The coastal banks that are adjacent to the revetment are experiencing erosion (Photographs 1 and 3, Figure 6 and Table 1). Already the toe of the revetment, and the adjacent coastal banks, get wet during many high tides. As the revetment currently extends further seaward than the coastal bank to the east it is highly likely that any shoreline stabilization, by way of placing sediment, will experience erosion equal to or greater than what is being experienced by the adjacent coastal bank (-1.4'/yr from Figure 6 and Table 1). If an inlet were to form, for any significant length of time, it would certainly affect longshore sediment transport and could generate eddies and other flow phenomena that will have an impact on the beach and coastline. As much of the re-nourishment sediment will be transported along the shoreline adjacent properties may see some minor storm protection from this project.

Photograph 3. The photograph below shows the erosion south of the revetment. The image to the right indicates the location and direction of the photograph below (red arrow) as well as the other photographs in the series (green arrows).

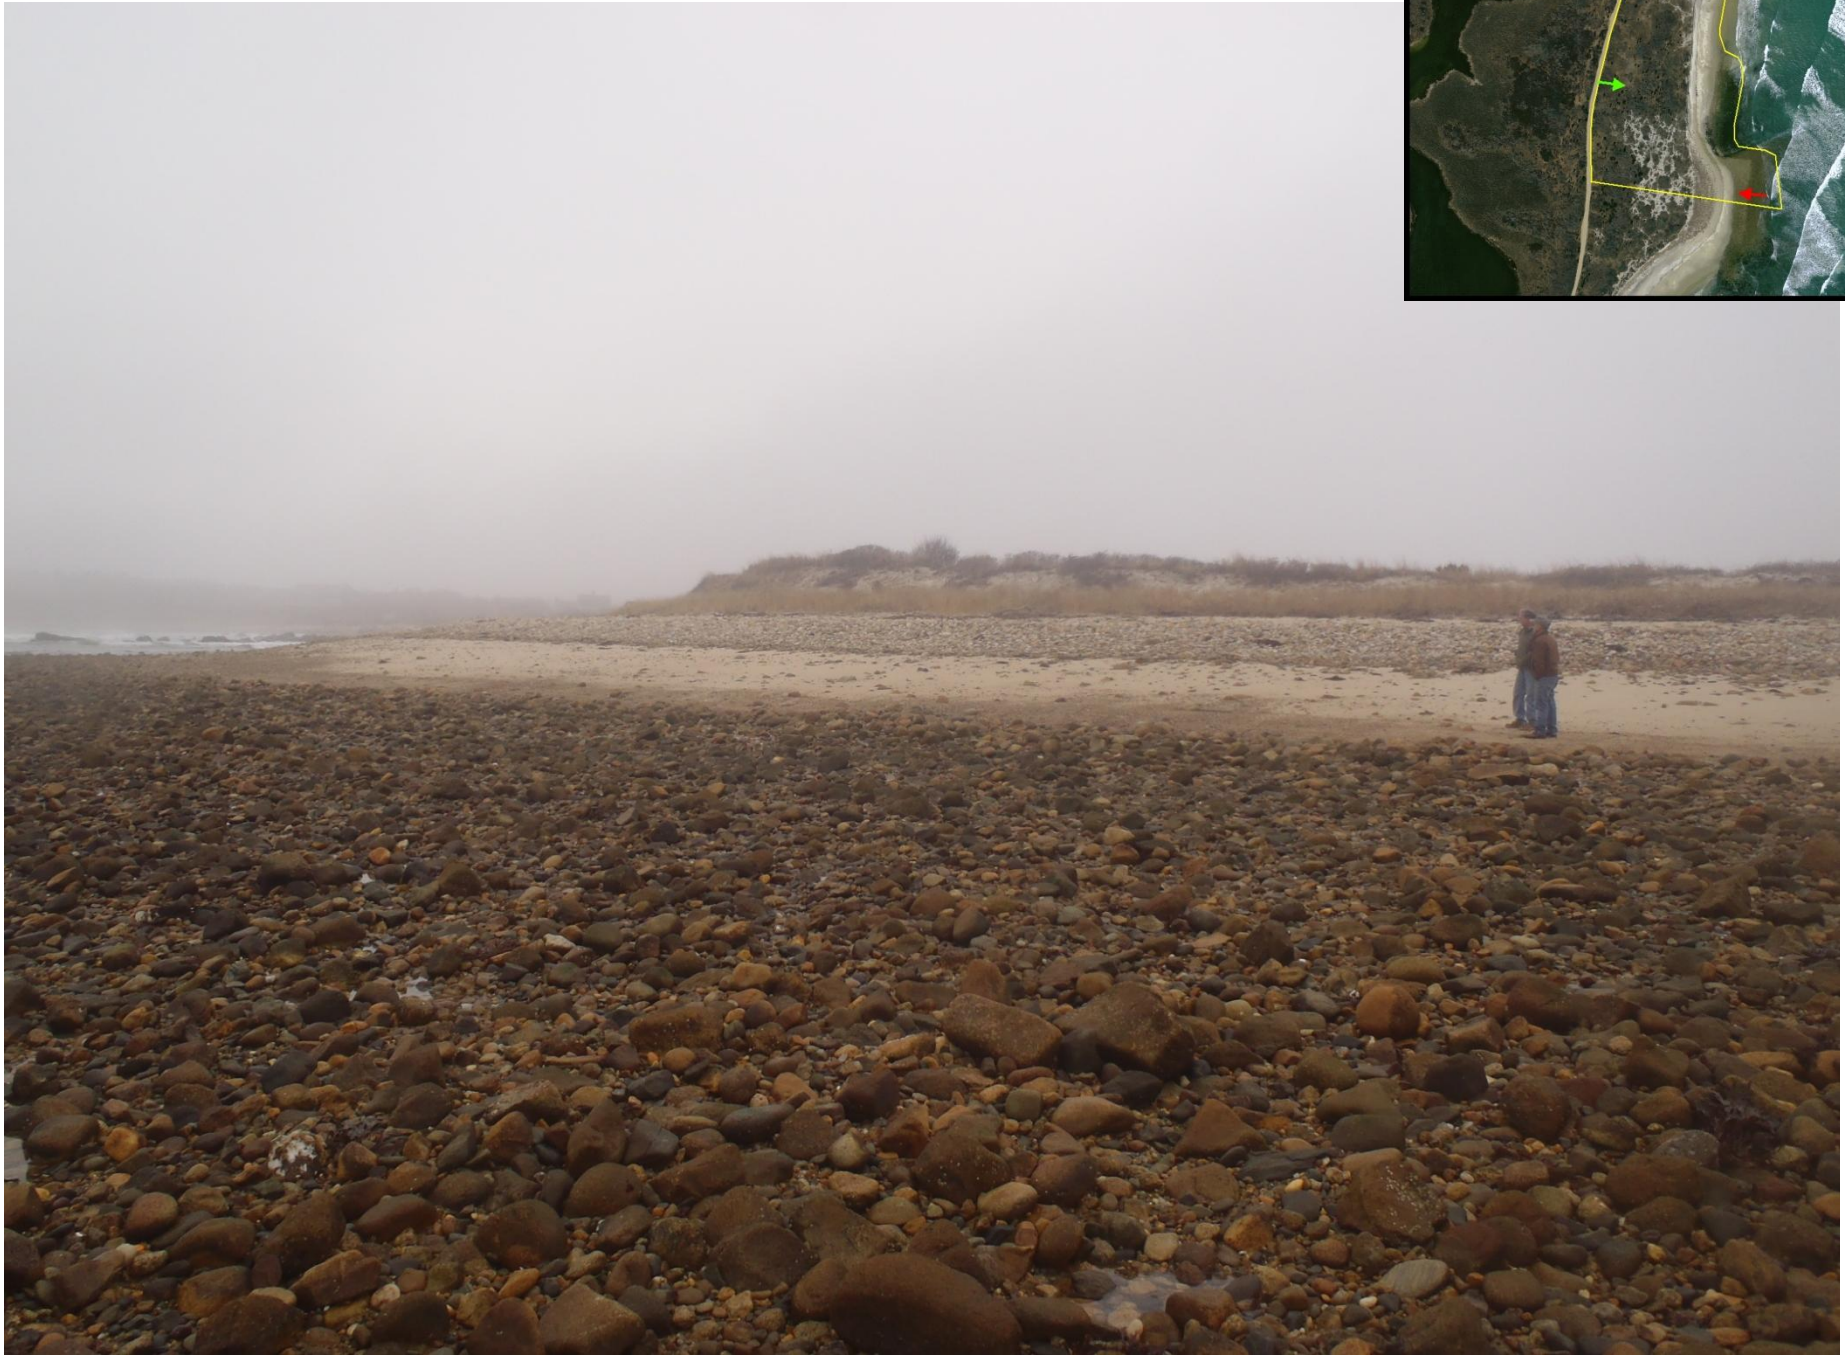
Photograph 4. The photograph below shows the “mussel bed” headland area looking towards the upland areas. The image to the right indicates the location and direction of the photograph below (red arrow) as well as the other photographs in the series (green arrows).

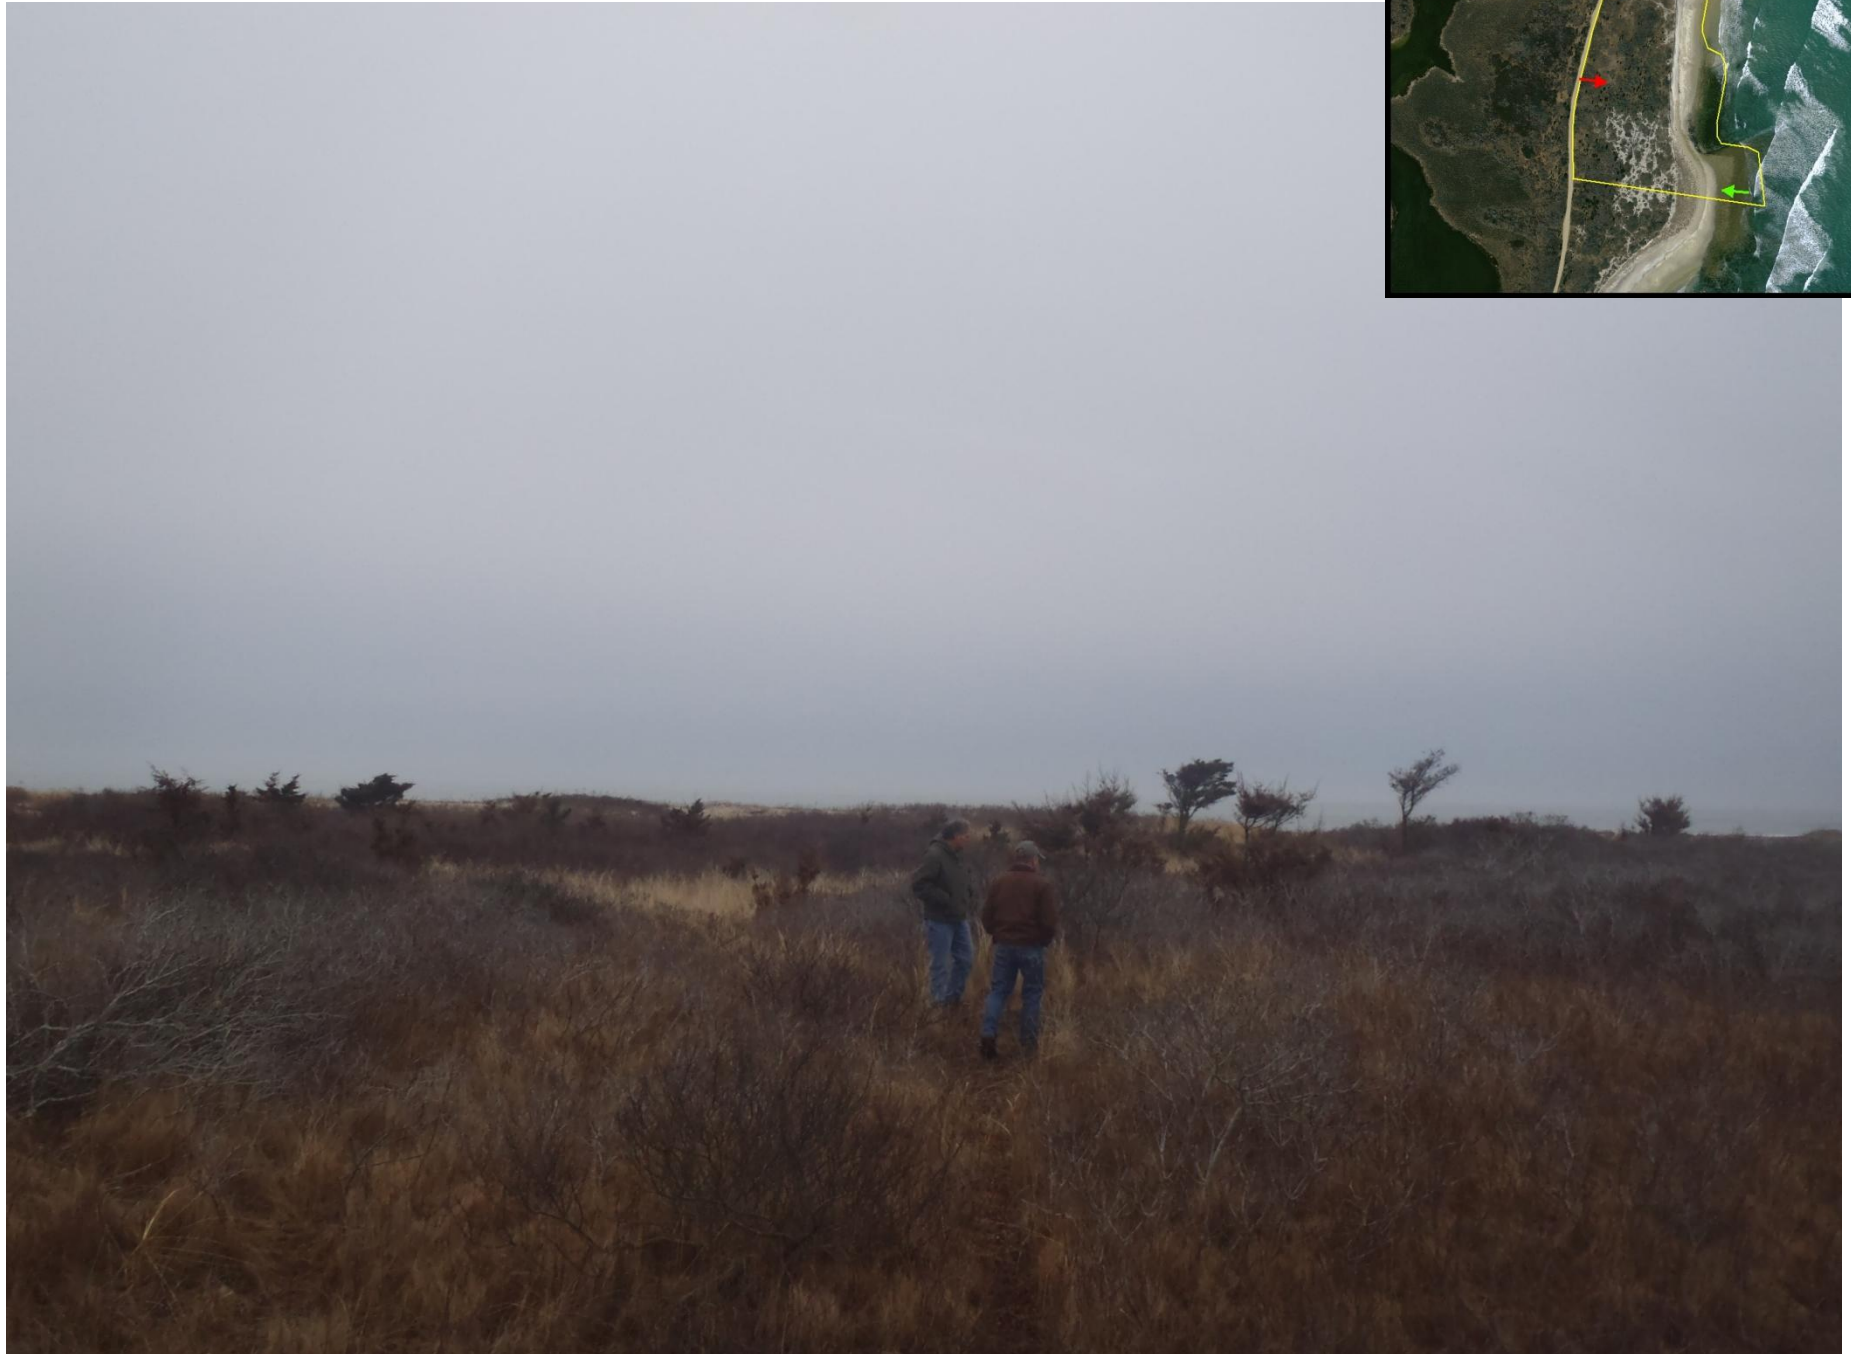
**A4:** The vegetation observed during the site visit appeared to be healthy and robust (Picture 5). This type of salt-tolerant vegetation with extensive root systems helps hold sediment in place, helping to stabilize the area. Also, reducing runoff erosion and trapping windblown sand, these plants are increasing the ability of the coastal resource area to buffer inland areas from storm waves, erosion, and flooding. The vegetation will likely remain healthy unless impacted by human activity or coastal erosion during a storm event. Erosion rates were presented in the previous section.

Photograph 5. The photograph below shows the approximate area of the proposed parking lot, looking towards the ocean from the road. The image to the right indicates the location and direction of the photograph below (red arrow) as well as the other photographs in the series (green arrows).
