B. PROJECT DESCRIPTION

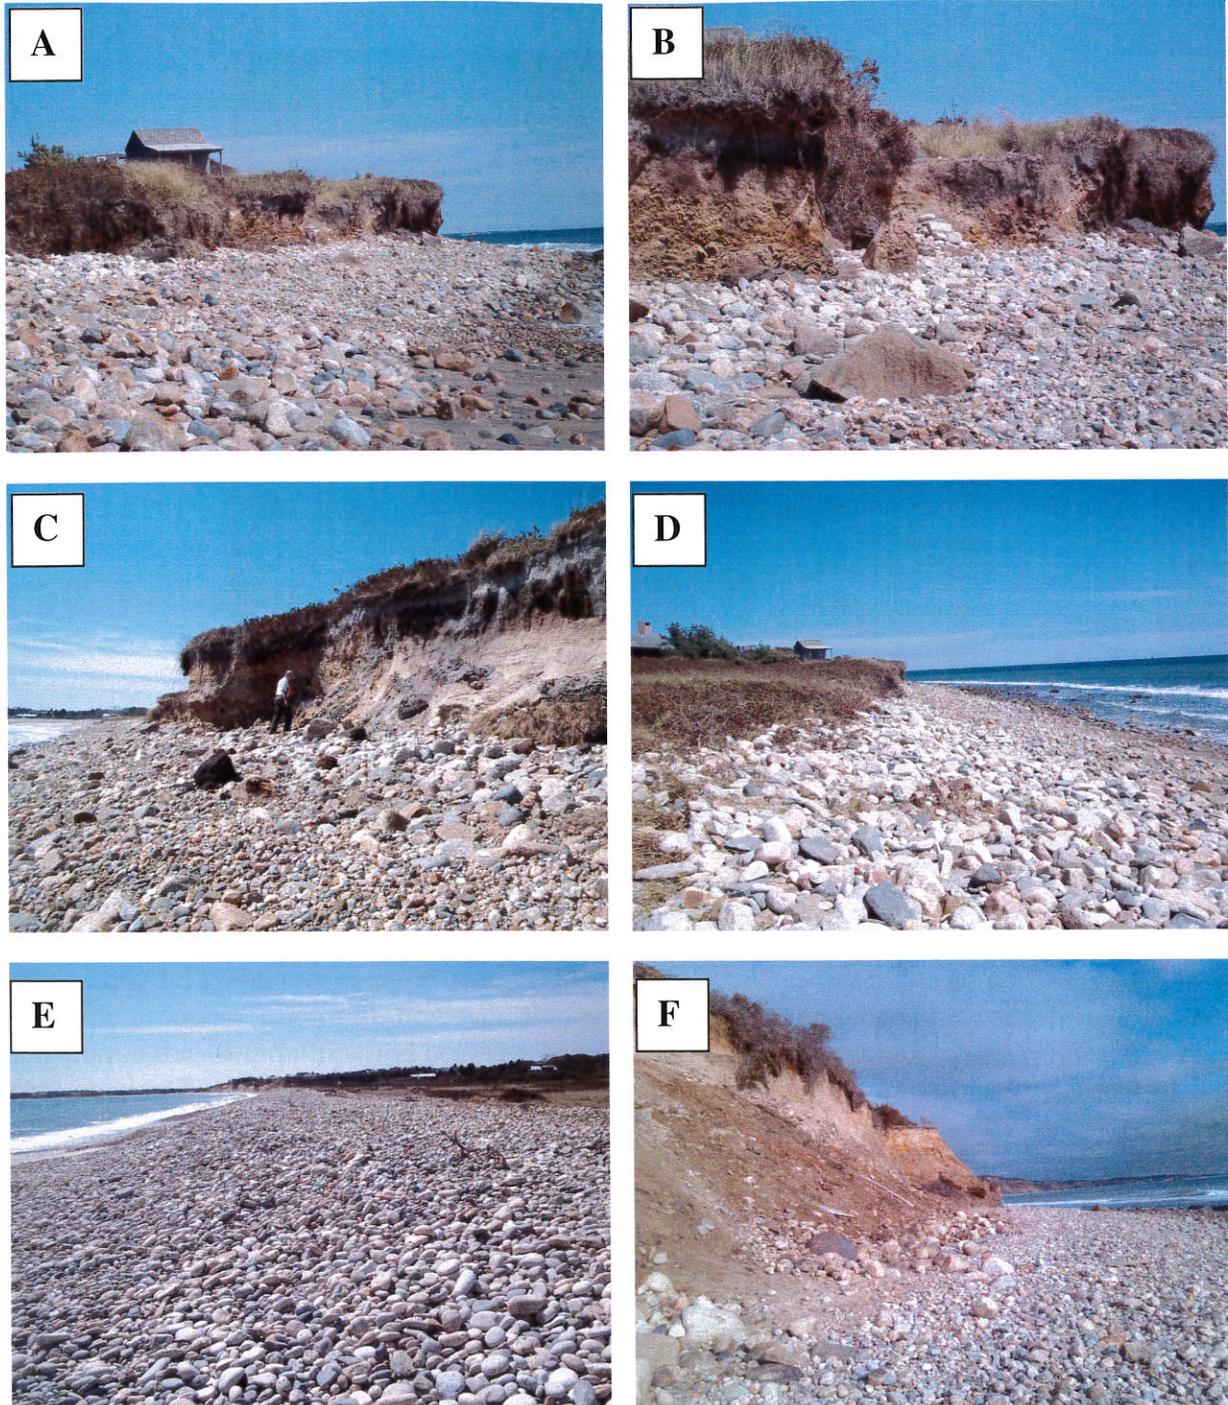
The coastal beach on the subject property is relatively steep and narrow. The beach is comprised of 3-12 inch cobble with a medium to coarse grain sandy substrate (Figure 3). The material on the beach is derived directly from the glacial bluffs landward of the beach and characteristic of the beaches along this entire stretch of shoreline. Adjacent to the subject property is the unique Stonewall Beach; a barrier beach that has natural, massive, cobble deposit overlying it. The cobble is several to tens of feet thick and provides protection to Stonewall Pond from elevated water levels and waves during storms as it acts as a natural wave break. The proposed beach nourishment/cobble berm has been designed to mimic the natural cobble berm on adjacent Stonewall Beach (Figure 3E).

The coastal bank on the Fool's High Tide LLC property exhibits a classic glacial morphology, having steep cohesive bluffs consisting of mixed strata ranging from clay to large glacial boulders (Figure 3). The coastal bank is highest along the eastern end of the property (elevation 20 feet NGVD) and tapers to the west where it ultimately intersects with the coastal dune at elevation ~12 feet NGVD. The coastal bank has been experiencing heightened erosion caused primarily from wave attack along the base of the bank during storms and periods of elevated water levels. During storms, waves scour away the seaward toe of the coastal bank, which leads to instability and slumping within the upper portions of the bank. This type of erosion is typical along many of the unprotected coastal banks on Cape Cod and the Islands. Due to the more cohesive nature of coastal bank sediments, erosion and slumping typically occurs as mass failure, where large quantities of bank material slump and fall from the coastal bank in a single event. Figure 4 shows an excellent example of such slumping on the northern flank of the glacial headland along Wequobsque Cliffs, just east of the subject property.

Figure 3. Various photographs of the coastal beach and coastal bank on the subject property. A, B, and C show the steep eroding coastal bank and cobble beach. D shows the low lying coastal dune and the cobble beach that abuts the dune. E is a view of the adjacent Stonewall Beach barrier beach to the west. F shows Wequobsque Cliffs and the cobble beach to the east.

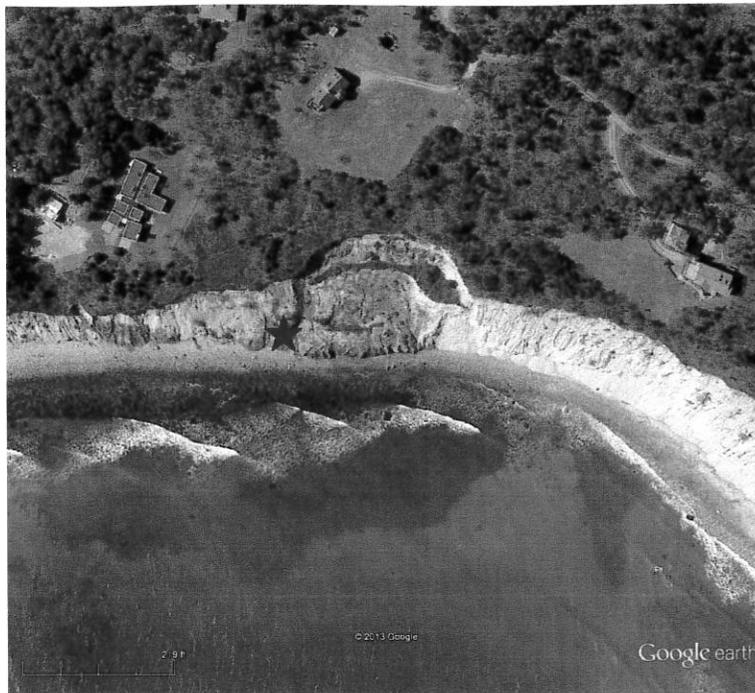
Figure 4. Massive slumping of the coastal bank at Wequobsque Cliffs, just east of the subject property.

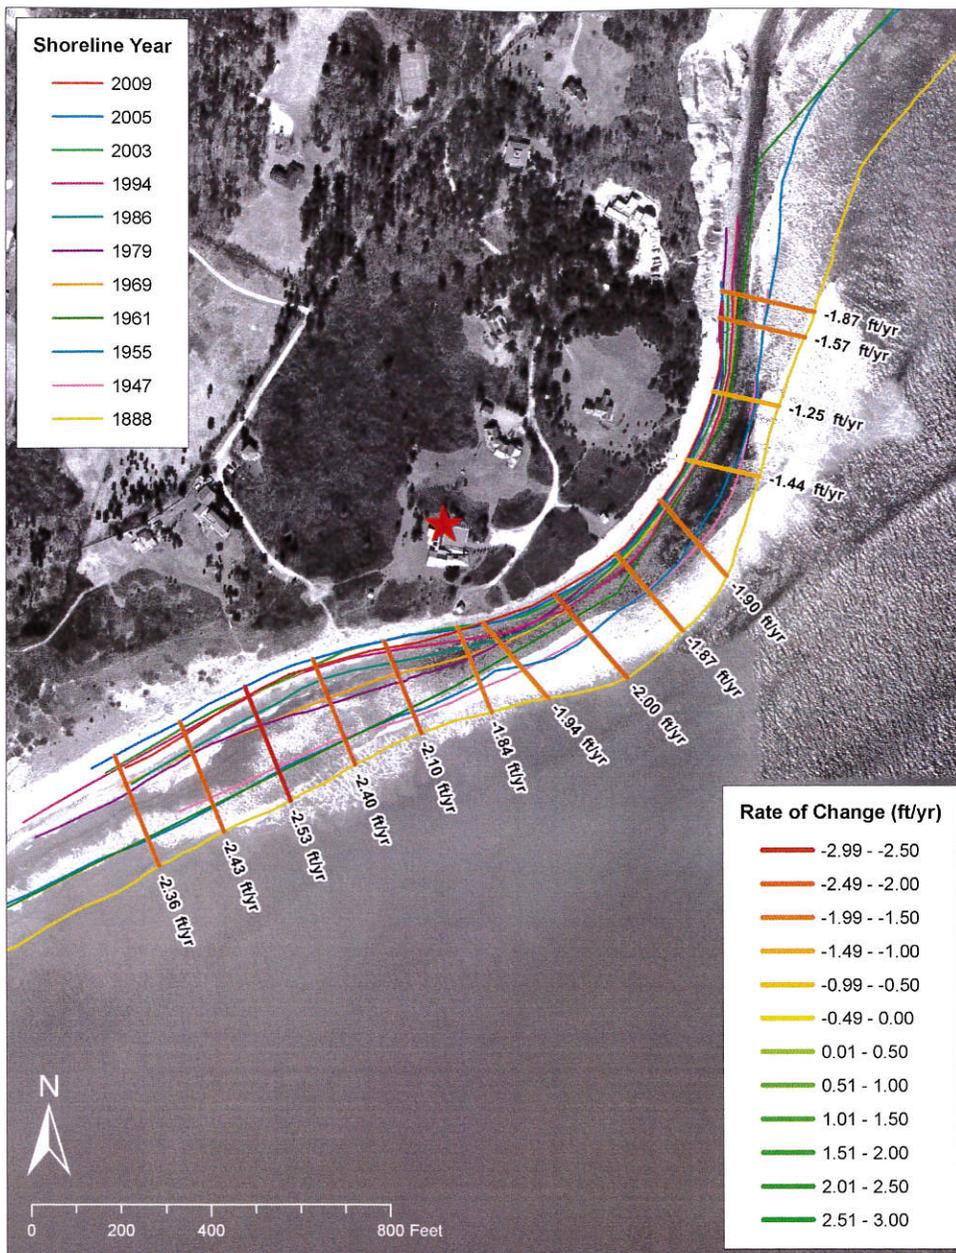
Our review of the Massachusetts Coastal Zone Management (CZM) shoreline change database indicates that the shoreline at the subject property has been gradually eroding over the past 106 years. Long-term rates of erosion from 1888 to 1994, have averaged approximately -1.5 to 3 ft/yr at the property (Figure 5), however, this particular site experienced between 17 and 33 feet of erosion in the 13 month period between November 2011 and December 2012 (Figure 6). This recent erosion has caused the coastal bank to cut back to within approximately 80 feet of the existing dwelling and resulting in a loss of over 6,500 square feet of property and removal of 2,400 cubic yards of native material from the coastal bank in just one year. This material is presumed to have spread along and off- shore and reworked by local coastal processes, with the heavier material landing on the coastal beach on the subject property and the finer material spreading to adjacent beaches and offshore.

Figure 5. MCZM shoreline positions from 1888-1994, supplemented with Woods Hole Group data from 2003, 2005 and 2009, showing long-term rates of change on the subject property. The subject property is delineated by the red star.

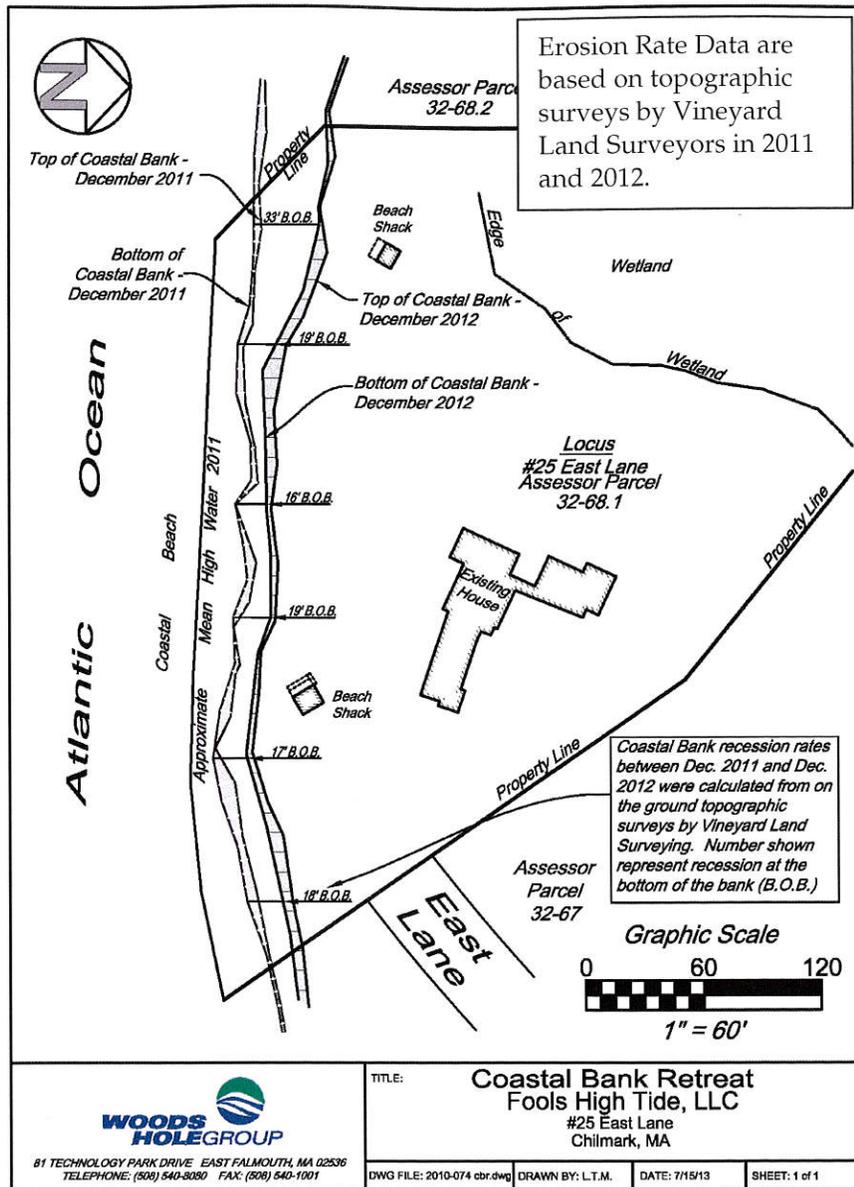
This dramatic erosion is quite alarming and has created an imminent threat to the existing infrastructure on the property. As the base of the bank continues to erode, the buffer zone between the top of bank and the dwelling will be further diminished, creating a substantial threat to the existing dwelling and other upland infrastructure. In an effort to minimize erosion of the coastal bank and prevent continued loss of upland property, the homeowners are proposing to install 6,000 yards of beach nourishment in the form of cobble reinforcement, as a natural buffer along the property, to protect against moderately sized storms in the future in compliance with the regulations.

Figure 6. Bank recession map created from on the ground topographic surveys done by Vineyard Land Surveyors in 2011 and 2012.
