Site Plan  
in  
Chilmark, Massachusetts  
Assessor Parcel 34-1.3  
prepared for  
**Santiago Realty Trust**  
Scale 1"=30' June 2, 2023  
Revision Date February 9, 2024

**DATE:** February 9, 2024  
**TO:** Chilmark Zoning Board of Appeals  
**FROM:** Mark Manganello (LEC)  
**RE:** Wetland Delineation at 9 Signal Hill Lane, Chilmark, MA  
**CC:** Sourati Engineering; Chilmark Conservation Agent

**Re: Wetland Delineation Report  
9 Signal Hill Lane  
Chilmark, Massachusetts**

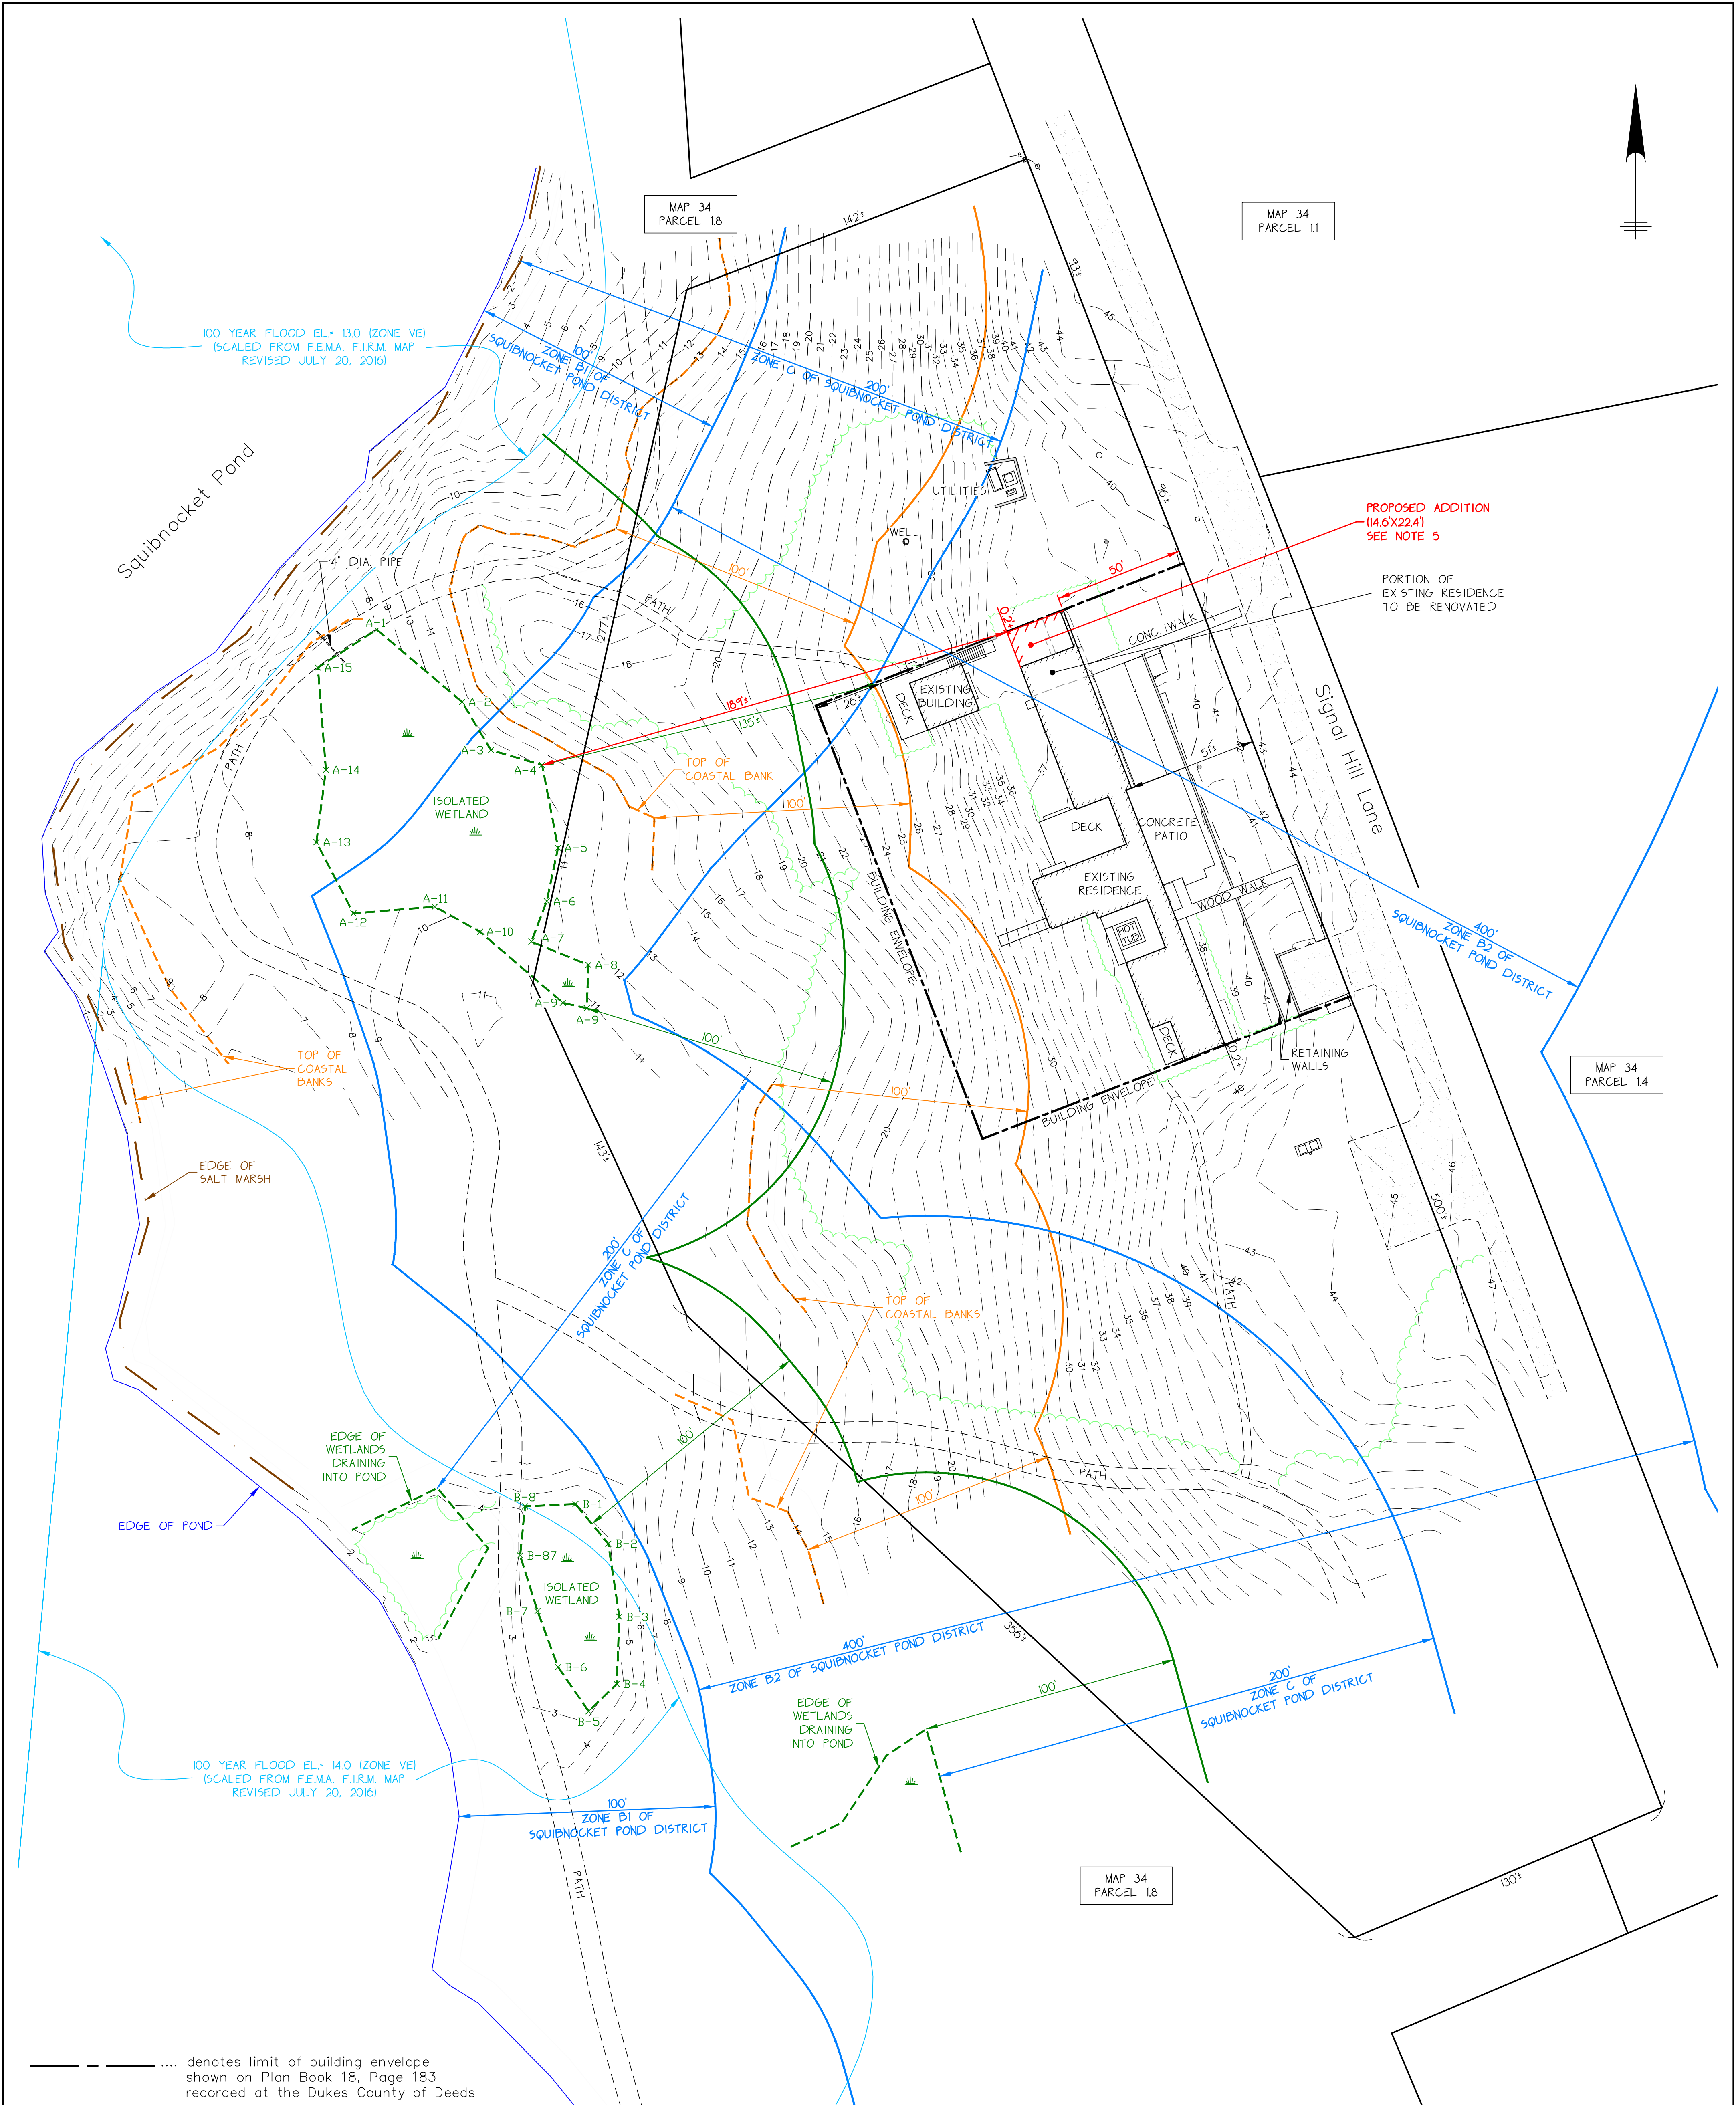
100 YEAR FLOOD EL. 13.0 (ZONE VE)  
[SCALED FROM F.E.M.A. F.I.R.M. MAP  
REVISED JULY 20, 2016]

PROPOSED ADDITION  
(14.6X22.4)  
SEE NOTE 5

PORTION OF  
EXISTING RESIDENCE  
TO BE RENOVATED

As shown on the *Site Plan*, the wetland located closest to the proposed project on *Locus* is identified as an Isolated Vegetated Wetland (IVW) and is delineated on the *Site Plan* with flags A1-A15 (the *A-Series IVW*). A second IVW, defined with flags B1-B8 on the *Site Plan* (the *B-Series IVW*) as well as a Bordering Vegetated Wetland (BVW), defined with wetland flags C1- C5 (the *C-Series BVW*), are located much further from the Project. In fact, only a small corner of the *A-Series Wetland* is on *Locus*. The remainder of that wetland, and the entirety of the *B-Series* and *C-Series Wetlands* are located on the abutting association property.

The proposed project involves construction of a small, 327 square foot addition to the existing single-family dwelling (the *Addition*). Based on the *Site Plan*, the proposed addition is 189 feet from the nearest corner of the *A-Series IVW* and well over 200 feet from the *B-Series* and *C-Series* wetlands, Squibnocket Pond, and most of the *A-series IVW* itself. Between the *A-series IVW* and the proposed *Addition*, the landscape is densely vegetated with shrubs and trees closer to the wetland and various grasses closer to the existing dwelling. The attached photographs (Attachment C) depict the conditions in the vicinity of the *Addition* and the vegetated area between the *Addition* and *A-series IVW*. The vegetated area between the *Addition* and the *A-series IVW* will not be disturbed by the project.

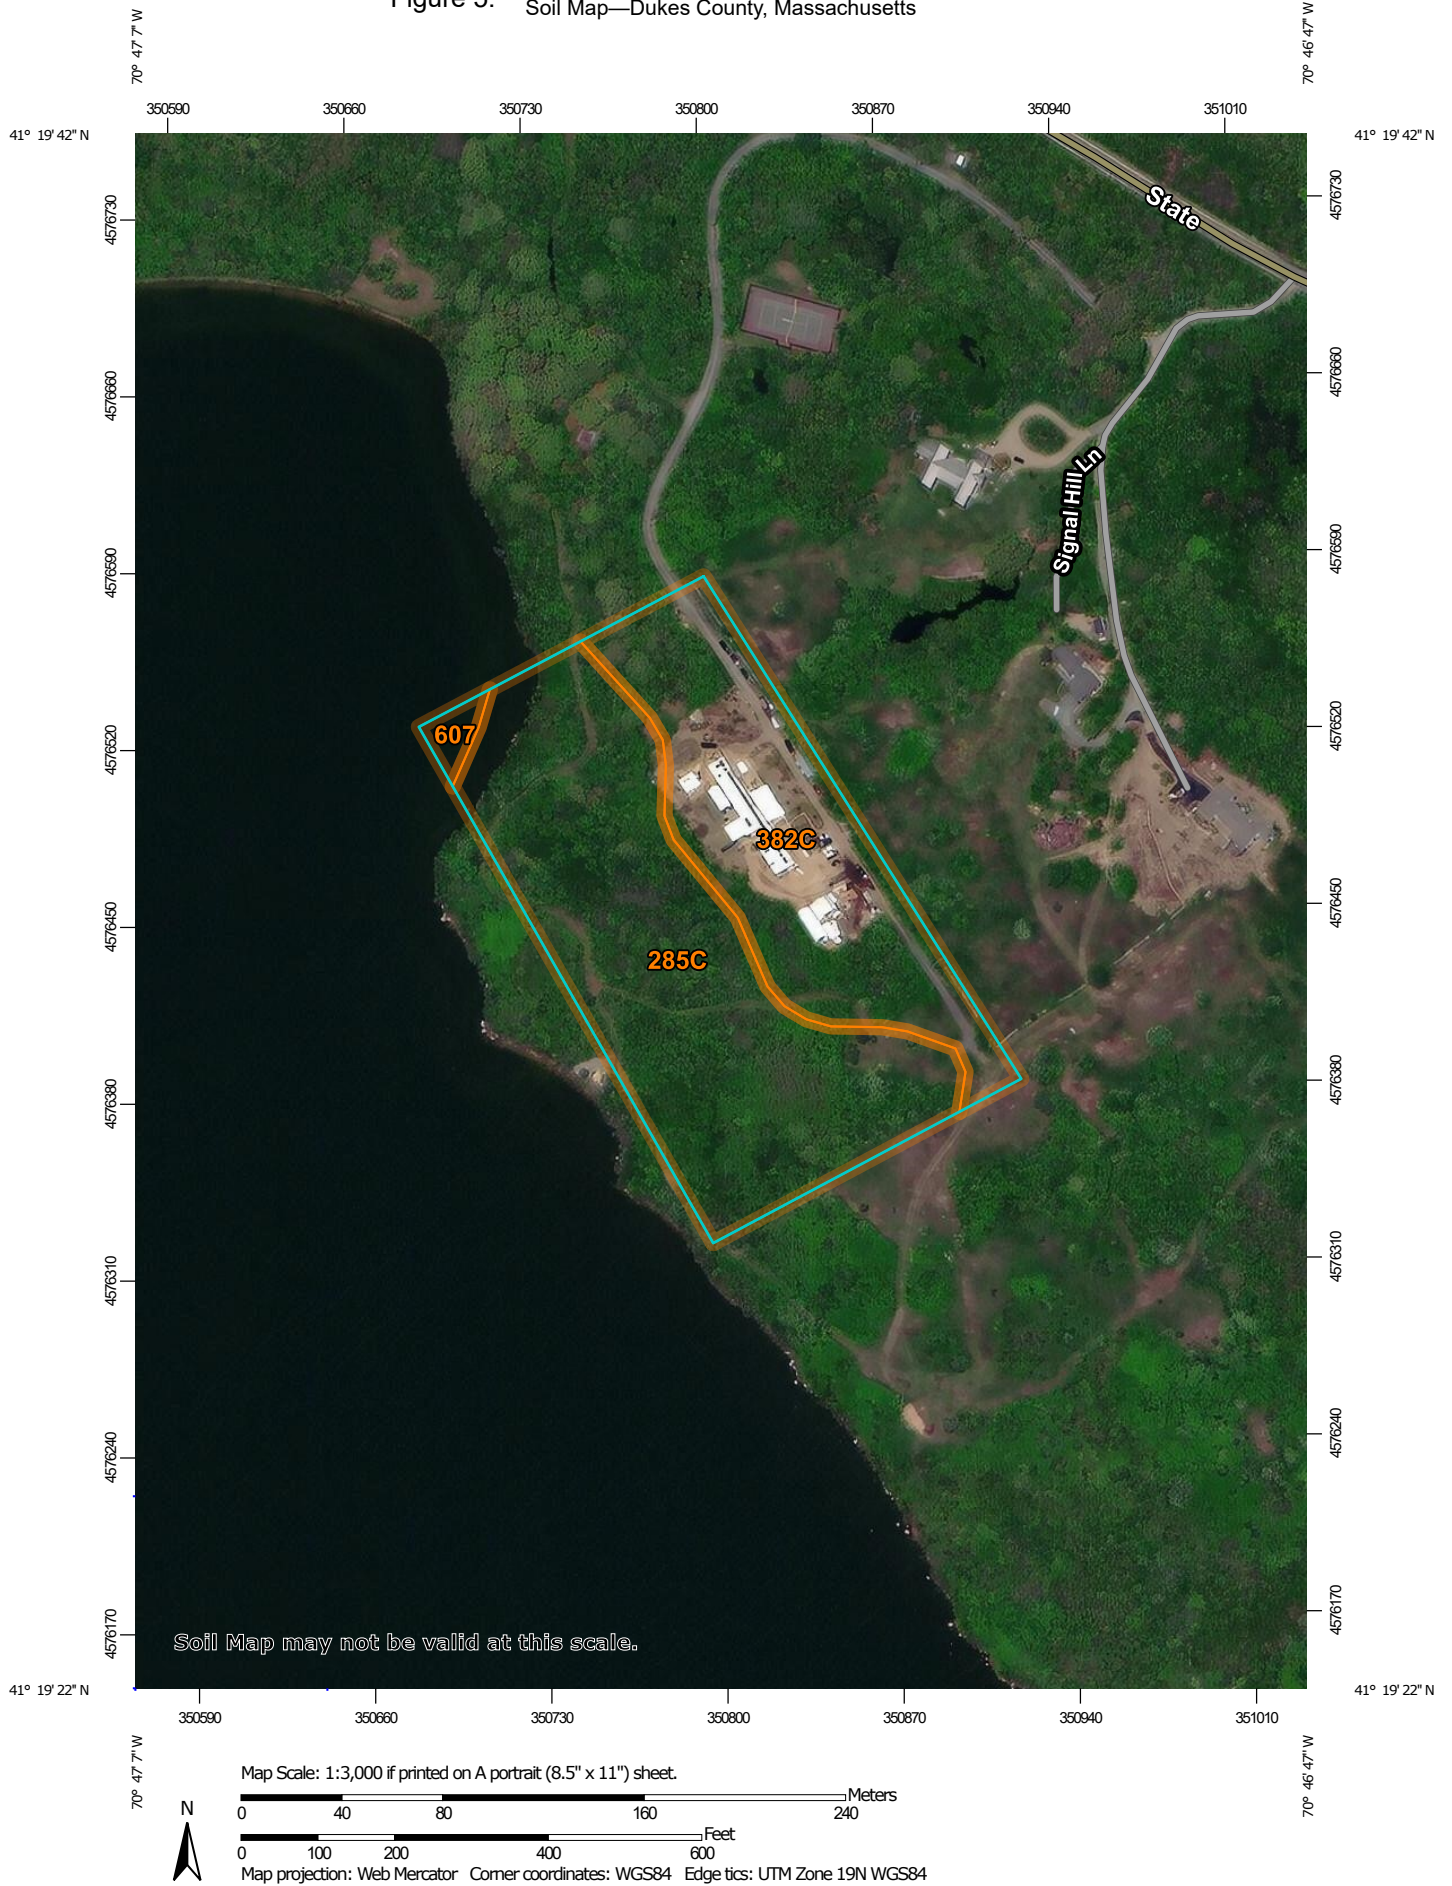
Figure 5: Soil Map—Dukes County, Massachusetts

Map Unit Symbol	Map Unit Name	Acres in AOI	Percent of AOI
285C	Eastchop loamy sand, 8 to 15 percent slopes, very stony	4.7	60.0%
382C	Nantucket sandy loam, 8 to 15 percent slopes, very stony	3.0	38.5%
607	Water, saline	0.1	1.5%
<b>Totals for Area of Interest</b>		<b>7.8</b>	<b>100.0%</b>

According to the NRCS Plymouth County Websoil Survey, the area surrounding the dwelling is mapped as Nantucket Loamy Sand, while the remainder of the site is mapped as Eastchop Loamy Sand (Attachment A, Figure 5). Eastchop soils are described as "very deep, gently sloping, excessively drained soil in broad areas on outwash plains and on low hills in areas of glacial lake deposits." Soils were evaluated throughout the densely vegetated upland areas using a hand-held soil auger. The typical non-

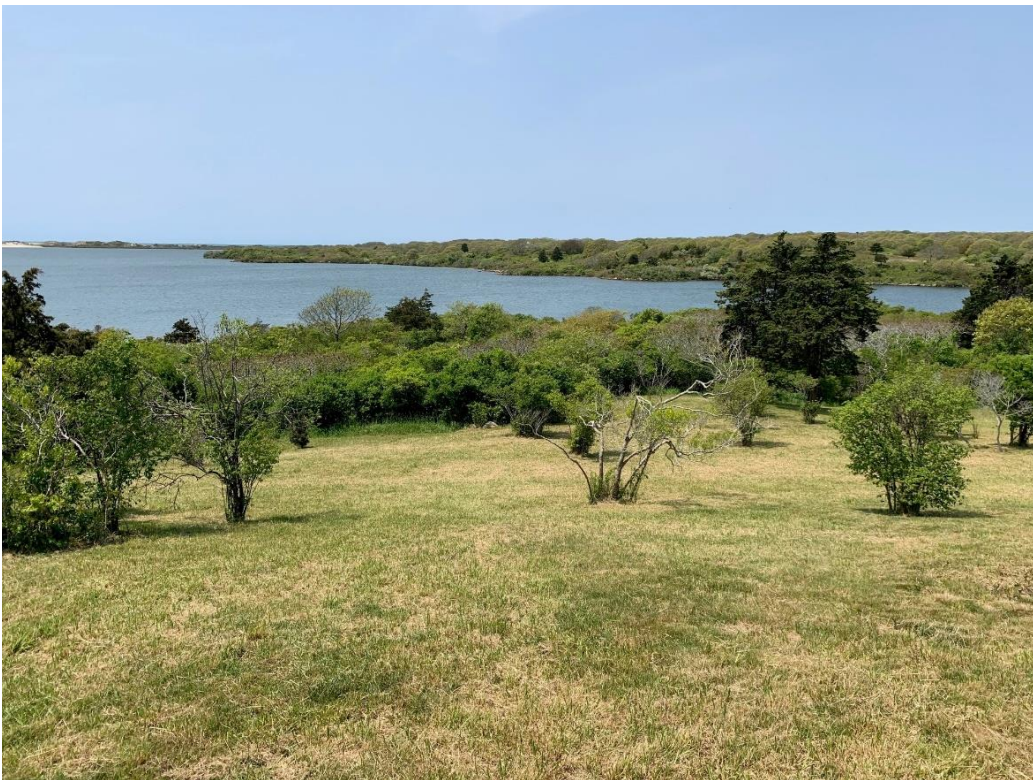
Photo 2: Lawn area looking west toward pond. IVWs located within thicket beyond edge of lawn.

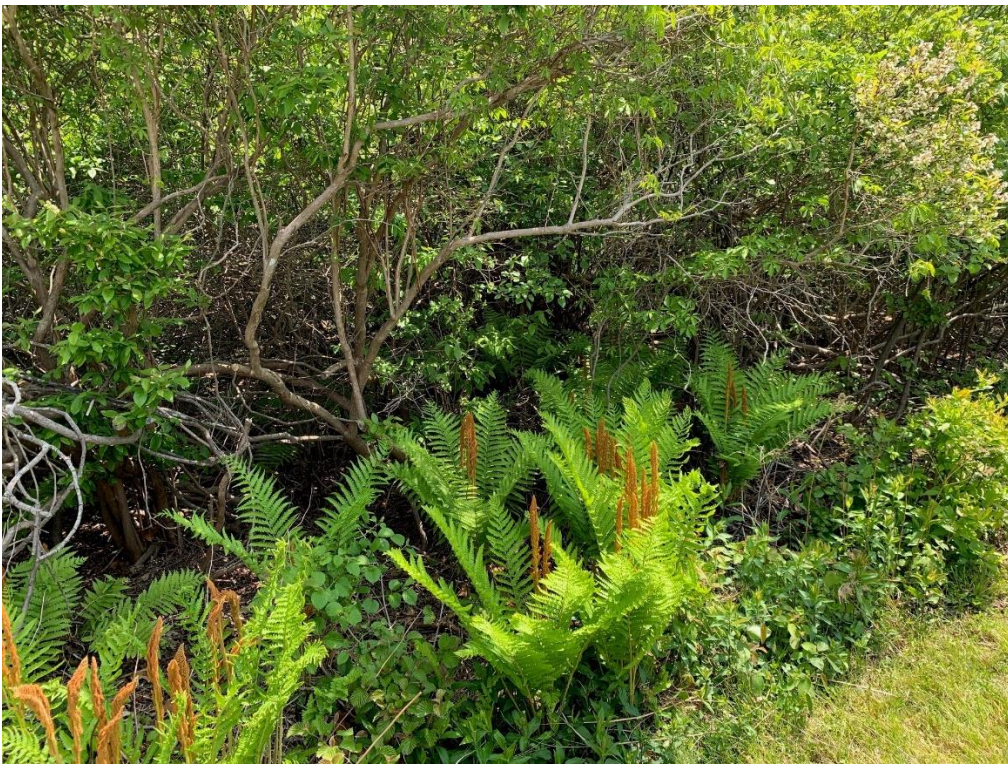
Photo 4: Vegetation in wetland near edge of grass path.

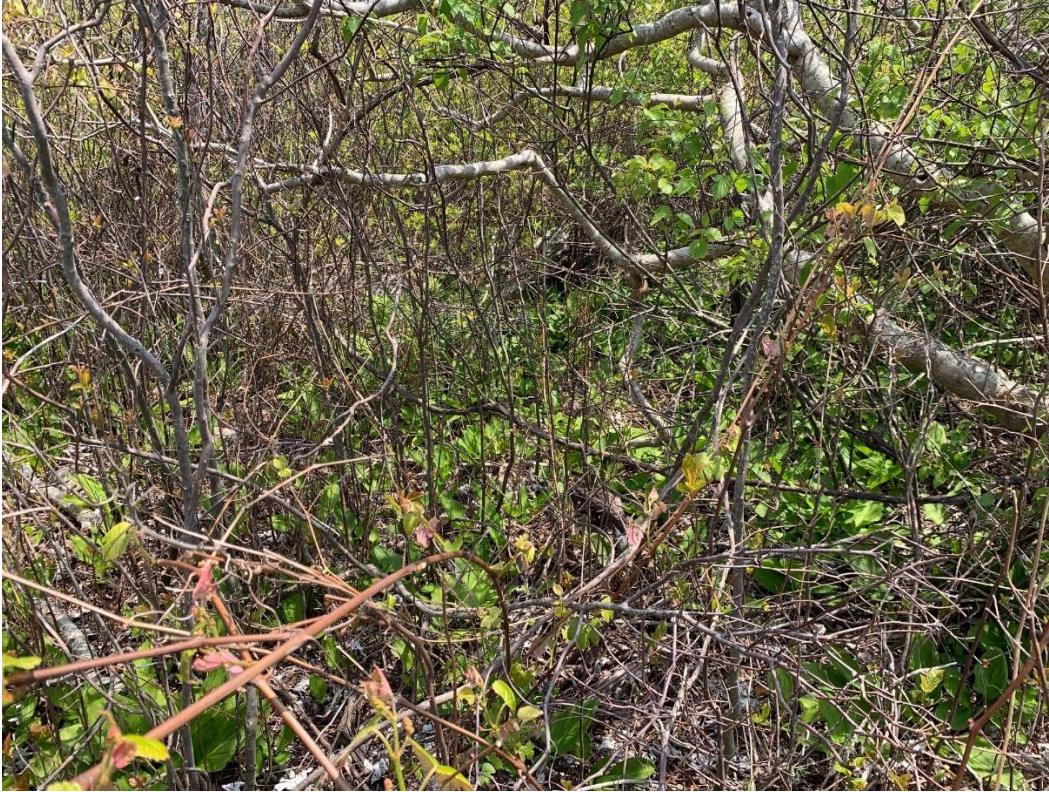
Photo 5: Dense layer of skunk cabbage within C-series wetland.

A BVW is located off-site to the south on association property. Only the portion of the BVW located closest to the site was delineated with flags C1-C5. LEC confirmed that the wetland extends west toward Squibnocket Pond and “Borders” on the Pond. However, no internal streams were observed and there is no evidence of a surface water connection to Squibnocket Pond. Vegetation within the BVW is similar to the species identified in the IVWs. One to four inches of surface water was present in portions of the BVW amidst dense colonies of skunk cabbage. As described above, the BVW does not contain streams and does not drain to the Pond; therefore, the applicable jurisdictional Buffer Zone for the Conservation Commission is 100 feet.

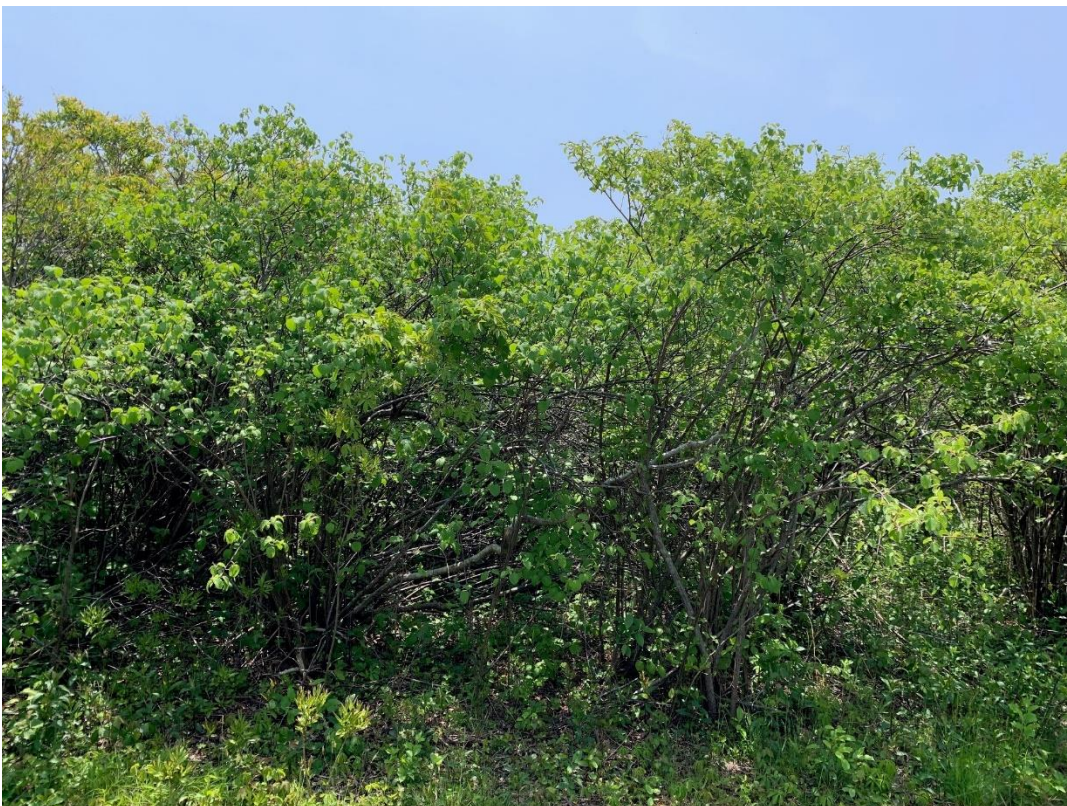
Photo 6: Typical upland thicket conditions.

A densely vegetated upland thicket occupies the northern, western and southern portions of the site beyond the meadow. Vegetation in the upland thicket is dominated by sweet pepperbush (*Clethra alnifolia*), arrowwood (*Viburnum dentatum*), staghorn sumac (*Rhus typhina*), highbush blueberry (*Vaccinium corymbosum*), multiflora rose (*Rosa multiflora*), and winterberry (*Ilex verticillata*) with scattered eastern red cedar (*Juniperus virginiana*), black cherry (*Prunus serotina*), and oak saplings (*Quercus* spp.). Groundcover includes various goldenrods (*Solidago* spp.). Numerous entanglements of Asiatic bittersweet (*Celastrus orbiculata*), grape (*Vitis* spp.), and poison ivy (*Toxicodendron radicans*) are also located within the upland thicket plant community.

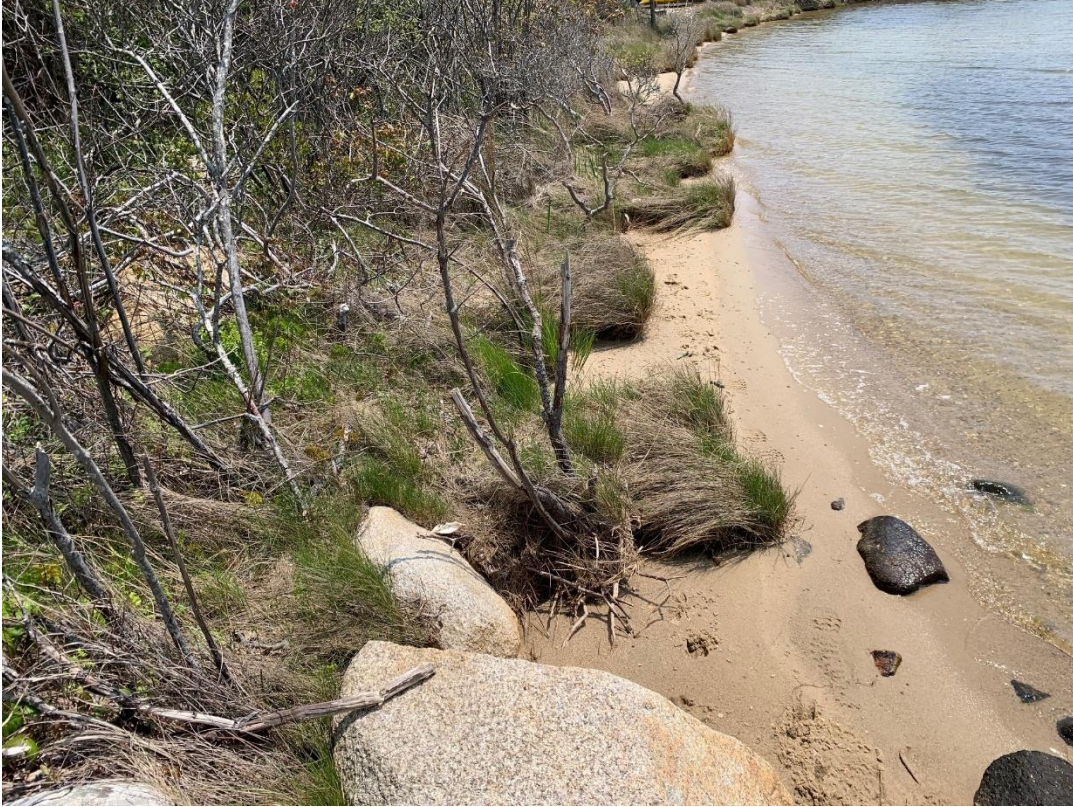
Photo 7: Salt Marsh and Beach along shoreline of Pond.

Salt Marsh extends along the shoreline of Squibnocket Pond off-site on the association property. The Salt Marsh is a narrow fringing band of vegetation, intermingled with sandy areas which abruptly transitions into upland thicket conditions described above. Salt marsh cordgrass (*Spartina alterniflora*) and salt meadow cordgrass (*Spartina patens*) are the dominant species in the marsh. Sandy areas in between the patches of Salt Marsh may also be protected as Coastal Beach.

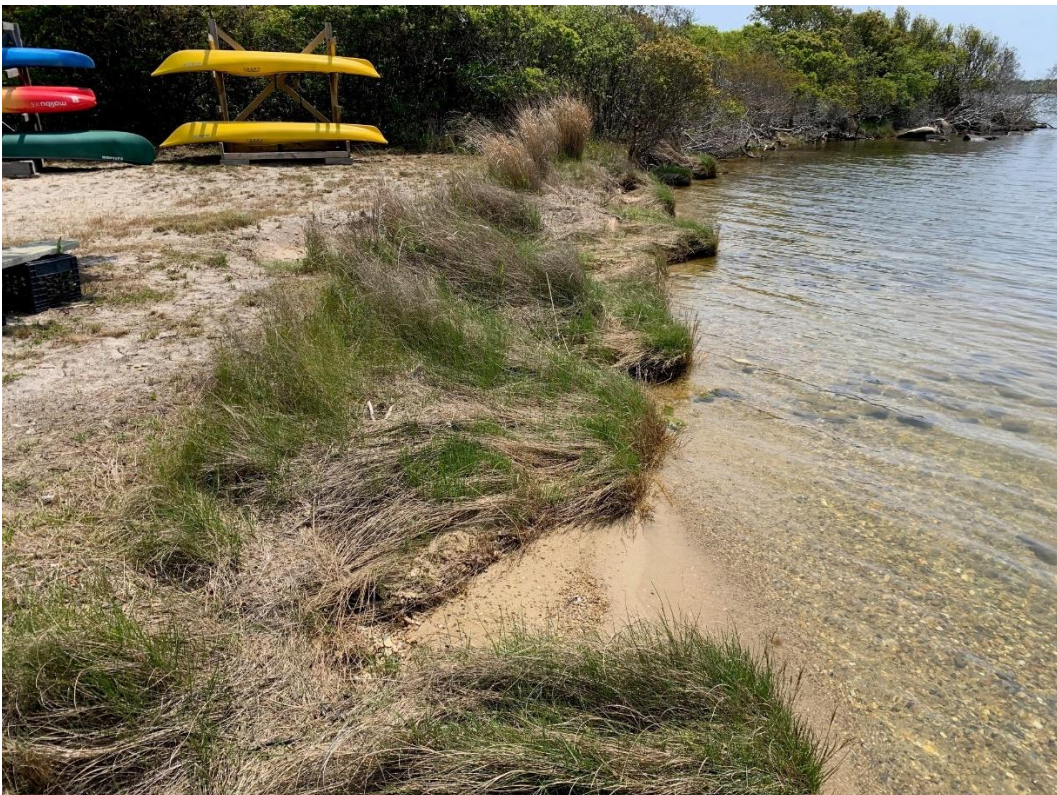
Photo 8: Salt Marsh and Dune area along shoreline of Pond.

A small Coastal Dune area is located on association property along the shoreline of Squibnocket Pond. The area is used for temporary storage of small watercrafts and for access to the Pond. Vegetation
