Re: Notice of Intent Application: Supplemental Information: 2020-2022 Monitoring Summary Report
Propose to Install and Maintain Cobble and Sand Renourishment
Fool's High Tide, LLC
25 East Lane
Chilmark, MA
Map 32 Parcel 68.1

Summary of 2020-2022 Monitoring Reports

Re: Post Construction Bi-Annual Monitoring Report: December 2020
Beach Nourishment/Cobble Berm
Fool's High Tide, LLC
25 East Lane
Chilmark, MA
Map 32 Parcel 68.1
DEP File No. SE 12-702 (SOOC)

Bi-Annual Monitoring Plan - Dec. 2020
Fools High Tide, LLC
#25 East Lane, Chilmark, MA

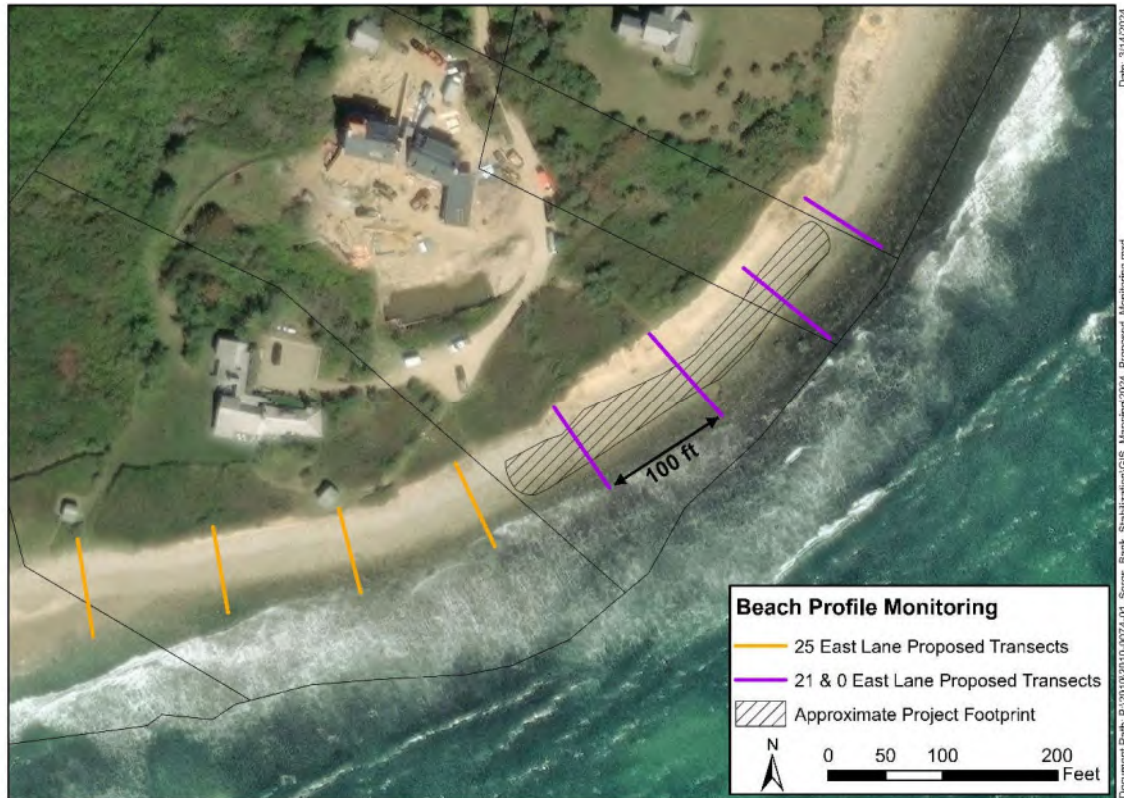
Figure 2. Plan showing location of proposed beach profile monitoring transects at 21 & 0 East Lane.

The current projects at 25 East Lane and 21 & 0 East Lane propose the same bi-annual post-construction monitoring as the previous 2020-2022 monitoring at 25 East Lane. Monitoring reports will include photographs and a synopsis of the beach profile surveys that will be collected twice per year, prior to April 1 and after September 1 of each year. Abutting properties will be visually inspected for seasonal changes within 100' of the cobble nourishment projects, and observations will be included in the monitoring reports. Topographic beach profiles will measure the elevation of the beach at distinct transects along the properties (Figure 1 & 2). The same transects will be measured during each survey so that a comparison of beach height can be made between surveys. Data will be used to monitor how the renourishment performs and to provide a gauge as to when additional renourishment will be required to maintain resiliency. The monitoring reports will be submitted to the Conservation Commission.

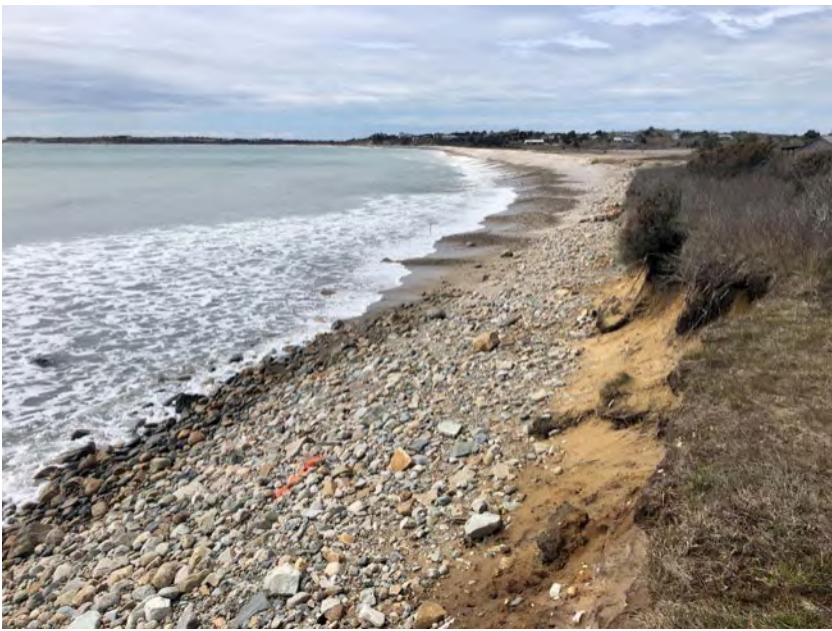
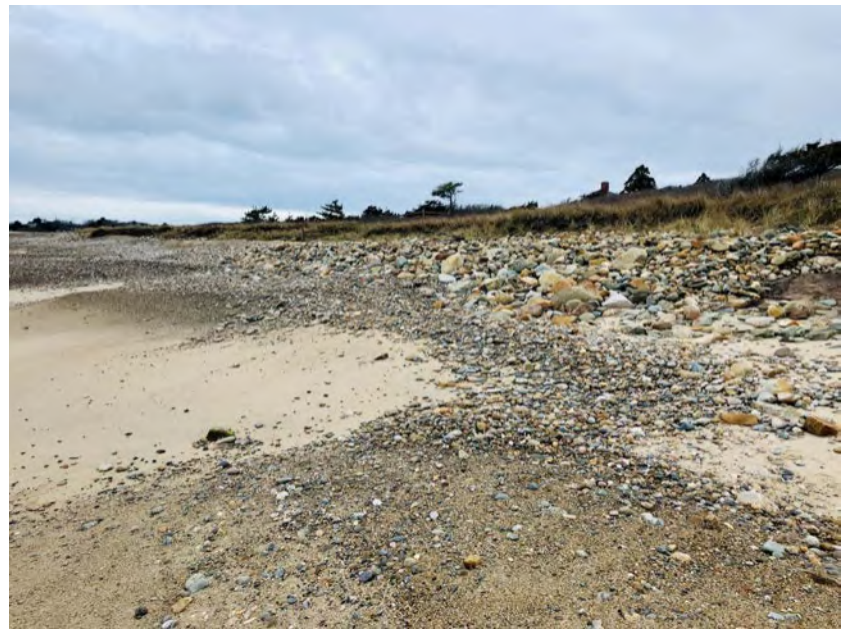
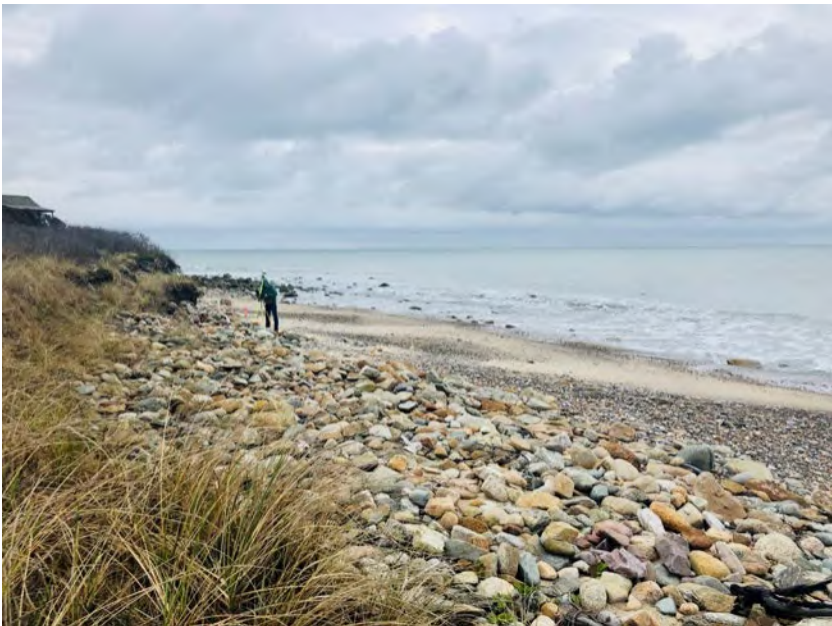
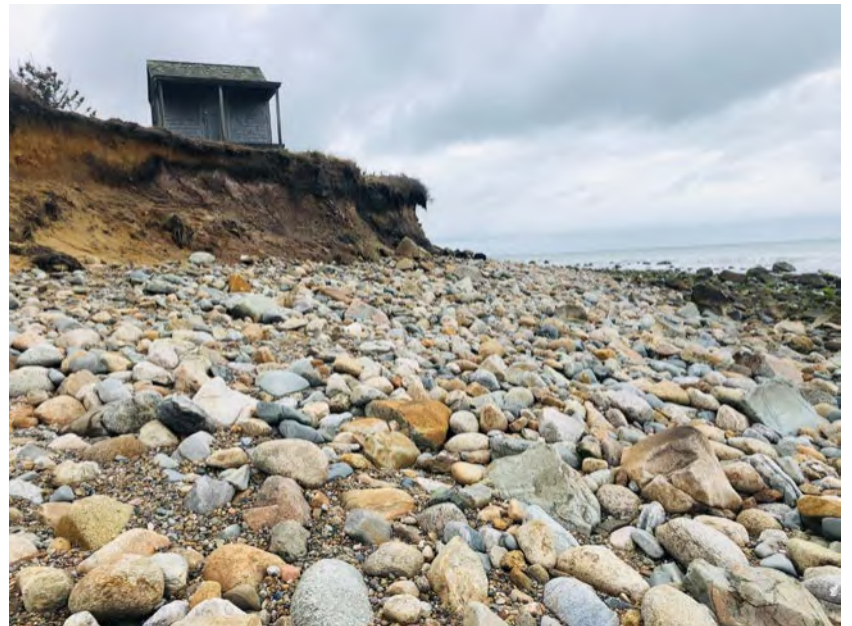
Pre-Construction - In April 2020, prior to construction, the beach was predominantly comprised of mixed cobble with a thin veneer of sand in spots. The bank was undercut and actively eroding. Figures 1 thru 4 were taken just prior to construction and show the existing conditions on the site and demonstrate the need for the permitted cobble and sand nourishment project. At this time, the cobble stretched continuously from the project site through Stonewall Beach to the west and the thin veneer of sand that comes and goes seasonally, can be seen in Figures 1-3.

Figure 1. Fool's High Tide beach looking west, April 2020

Figure 2. Fool's High Tide beach looking west, April 2020

Figure 3. Fool's High Tide beach looking east, April 2020

Figure 4. Figure 3. Fool's High Tide beach looking east, April 2020

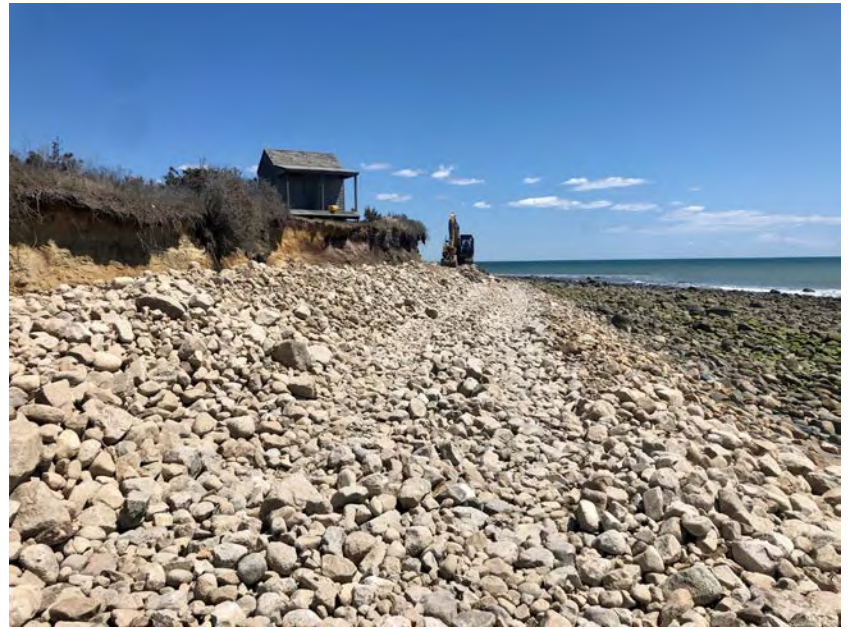
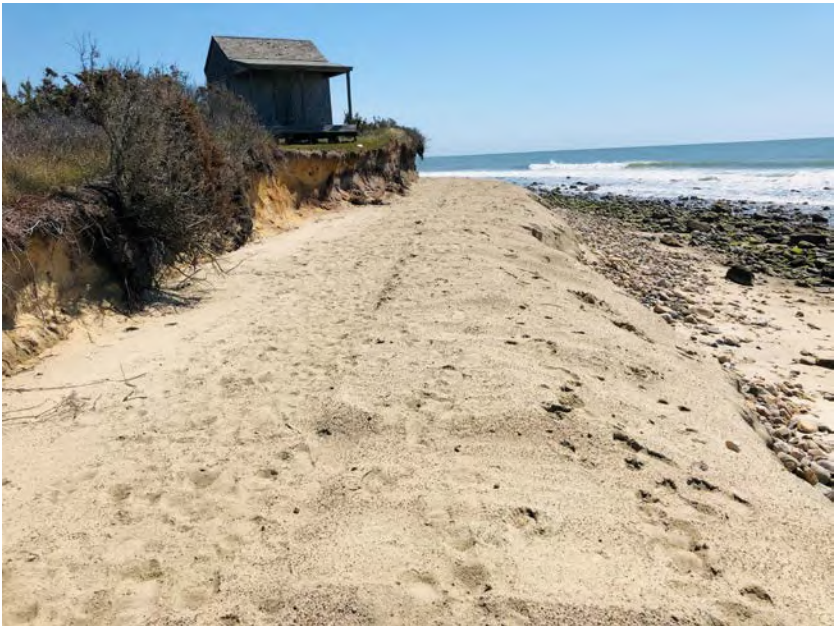
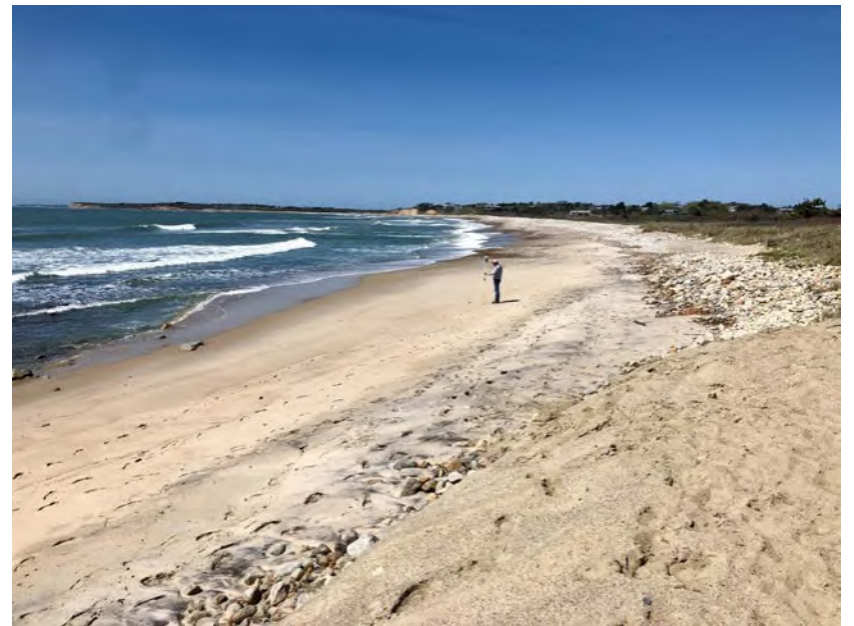
During Construction- The cobble berm was constructed in May of 2020 by John Keene Excavation and supervised by Woods Hole Group. The homeowner was given permission by the Conservation Department and the Natural Heritage Endangered Species Program to work inside of the time-of-year restriction for state listed shorebirds to get the project completed before the summer. Per the Bylaw Only OOC, a total of 575 cubic yards of mixed cobble was placed along the toe of the coastal bank to build the cobble berm, and 650 cubic yards of compatible sand nourishment was placed over the top of the cobble berm as a sand veneer and as an apron on the east and west sides of the berm. Figures 5 and 6 were taken during construction in early May. Figure 5, taken from Stonewall Beach and looking east, shows the eastern extend of the construction limit of work (red line) with Stonewall Beach in the foreground. Figure 6, taken on the property, shows new placed cobble in the permitted footprint. Figures 7 and 8 were taken upon completion of the work and show the newly constructed berm covered with a two-foot sand veneer.

Figure 6. Fool's High Tide cobble berm construction, May 2020

Figure 7. Fool's High Tide cobble berm construction complete, May 2020

Figure 8. Fool's High Tide cobble berm construction complete, May 2020

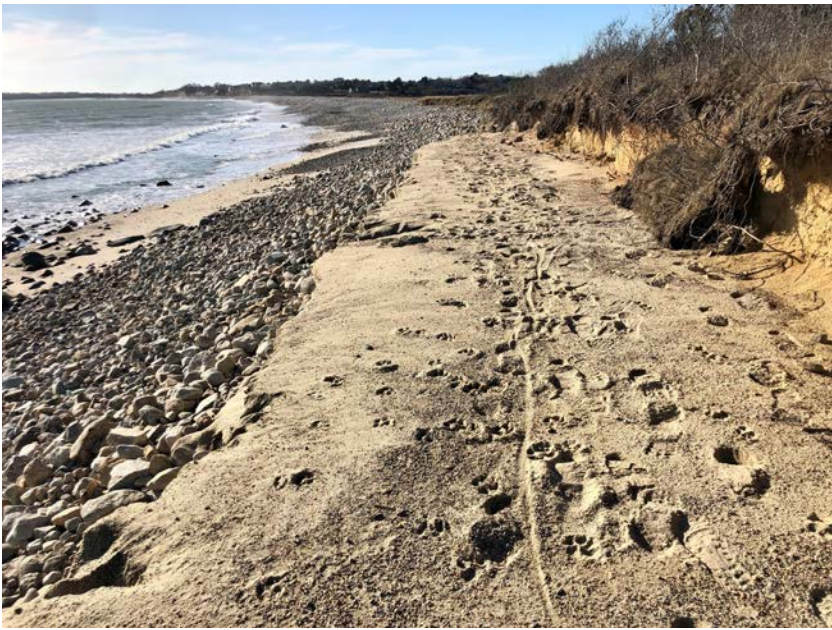
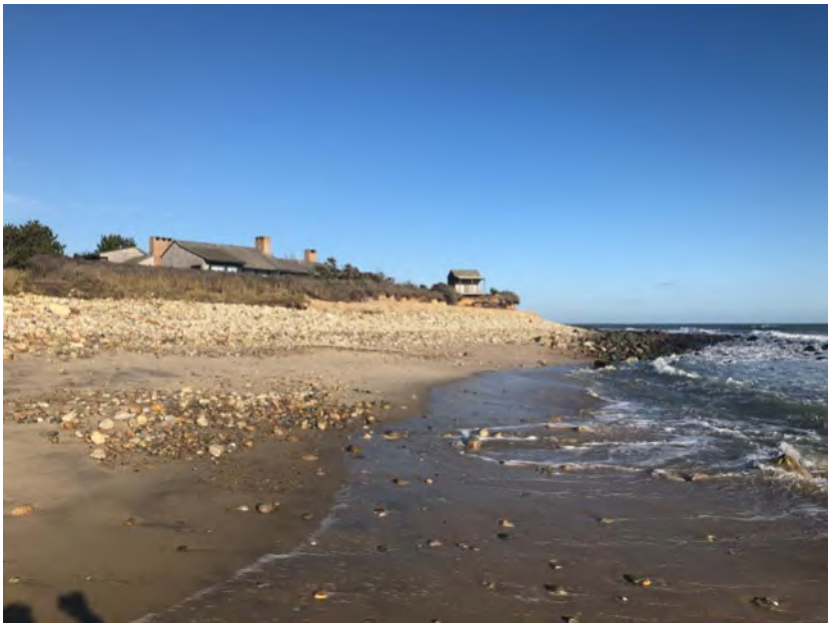
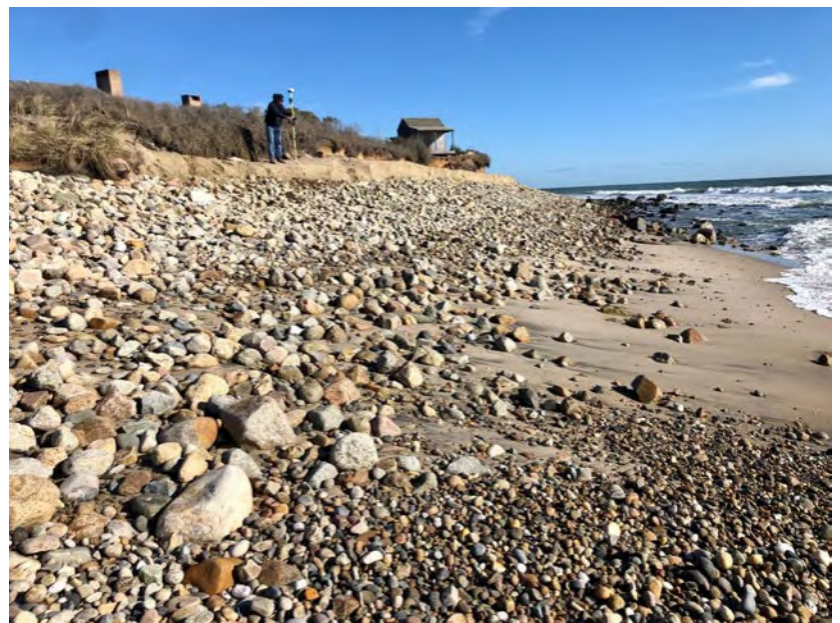
Post-Construction Monitoring, fall 2020 - Between the time of construction and the first bi-annual survey on December 3, 2020, the native coastal bank was well protected by the cobble and sand nourishment and exhibited no new erosion. The seaward edge of the newly constructed berm cut back approximately five (5) feet and there was a slight rise in elevation of the fronting beach where the eroded material likely deposited. There was a slight lowering of the profile farther seaward

Figure 9. Fool's High Tide beach looking west, December 2020

Figure 11. Fool's High Tide beach looking east, December 2020

Figure 12. Fool's High Tide beach looking east, December 2020

Woods Hole Group will continue to monitor the site to determine if additional cobble is necessary after the winter season. The next survey will be performed in 6 months and the data will be presented to the agencies.

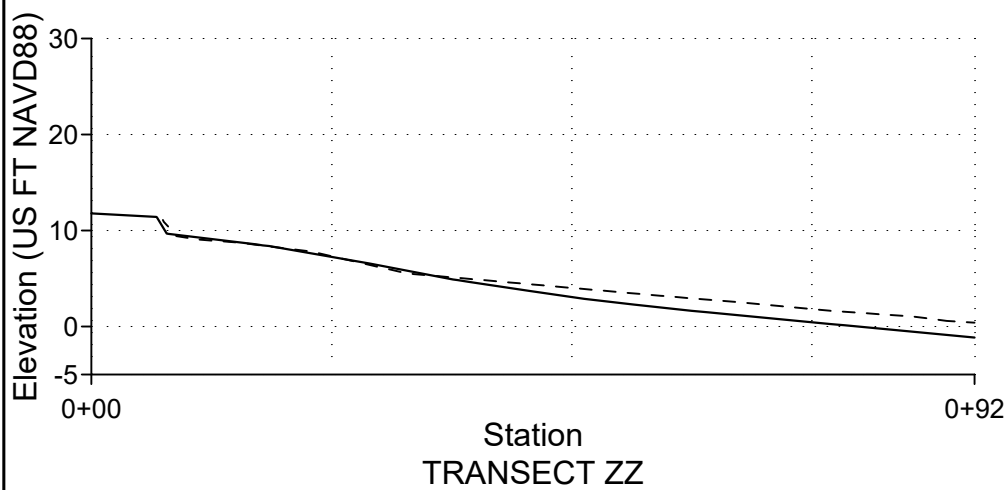
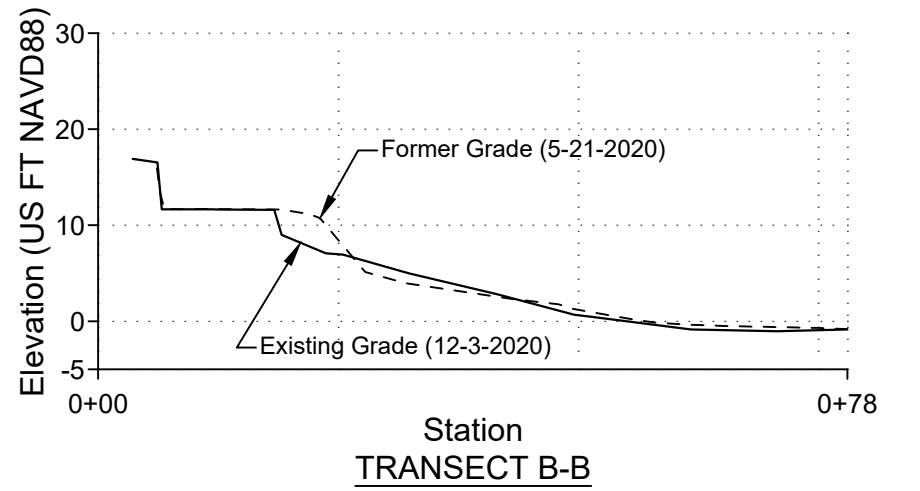
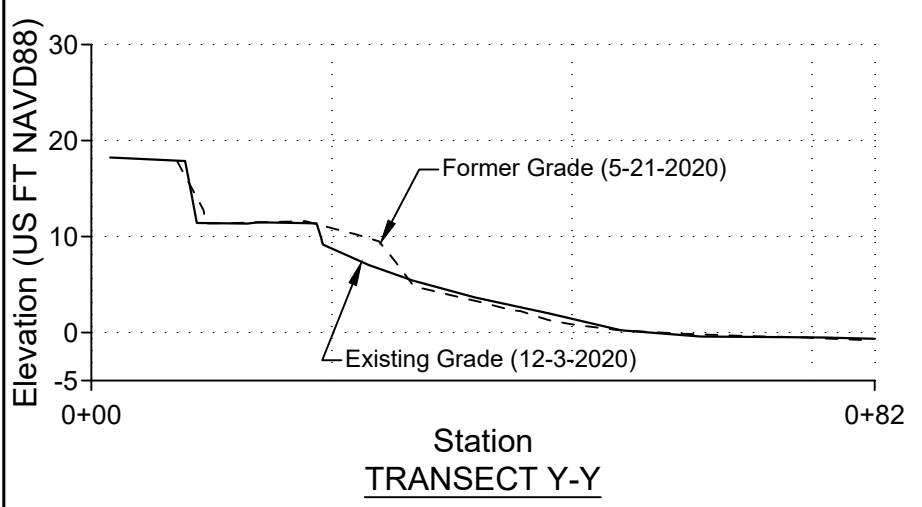
but this is typical for winter beaches in high energy environments. The surveyed cross-sections are shown on the attached plan, "Bi-Annual Monitoring Plan – December 2020 for Fools High Tide, LLC".

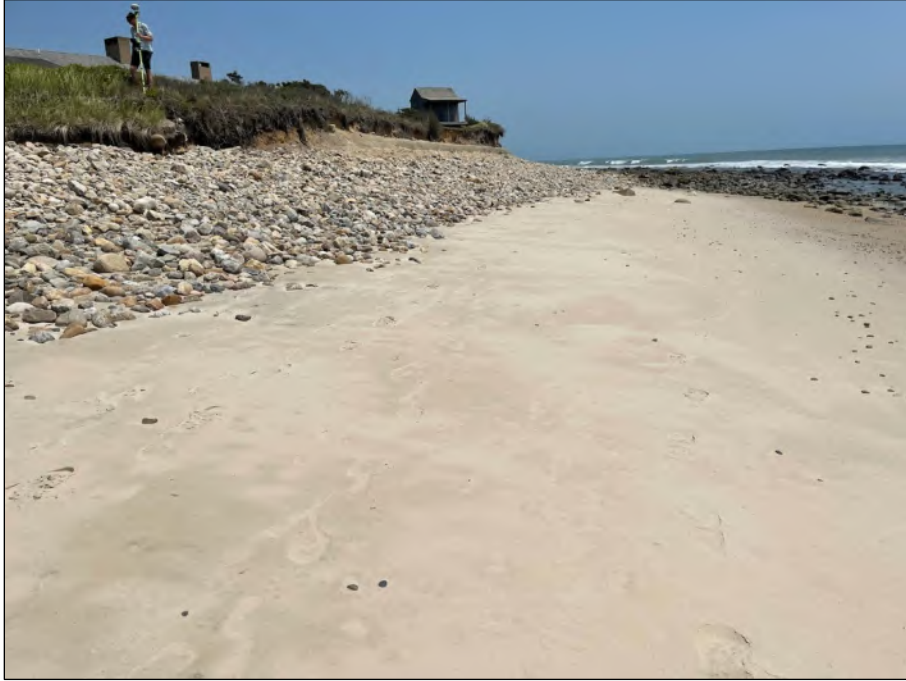
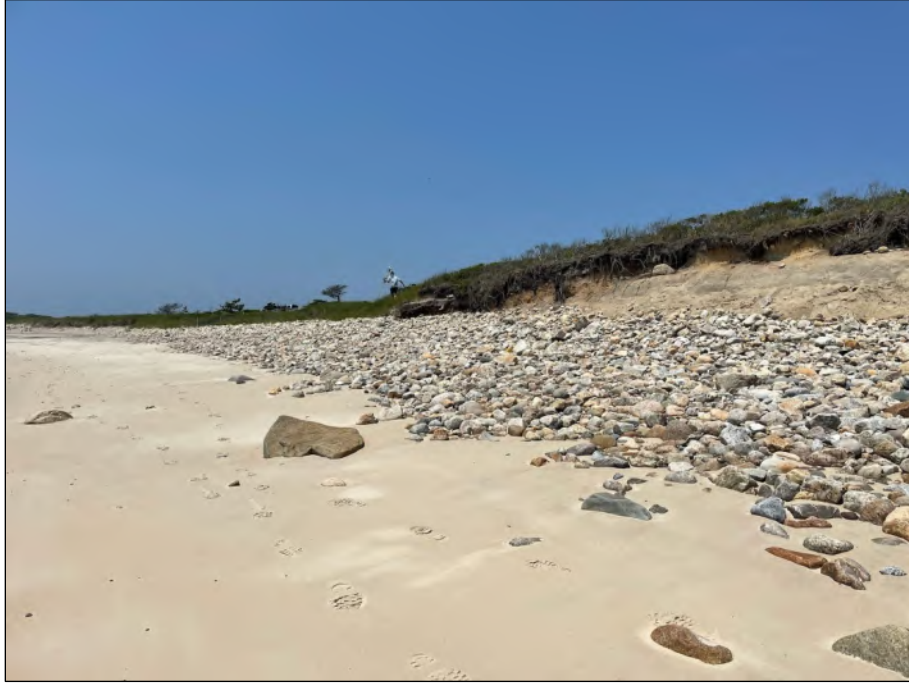
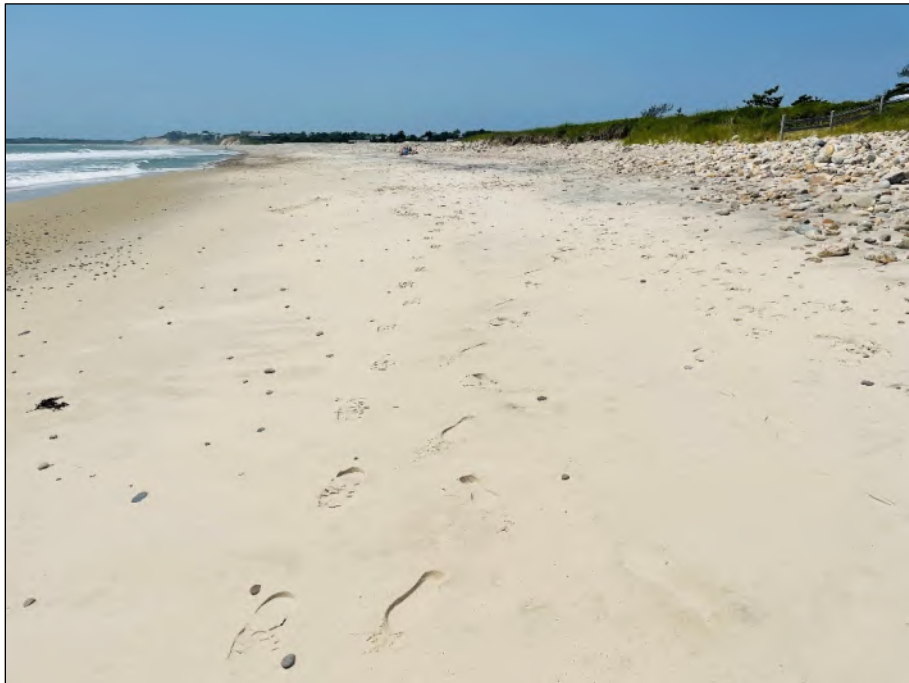
Figures 1, 3 and 4 show the dramatic sand cover that had accreted across the coastal beach from the western end of the project site across Stonewall Beach to the west. This is typical for this site during the summer months when prevailing winds carry sand back onto the beach. Figure 5 shows the rocky intertidal area, which looks unaffected by the cobble berm and sand nourishment project. The profile data confirm that changes to the intertidal beach and rocky intertidal area have been insignificant.

Figure 1. Cobble beach, July 7, 20021 (looking east).

Figure 3. Cobble beach, July 7, 2021 (looking west).

Figure 4. Stonewall Association beach, July 7, 2021 (looking west).

Whereas the berm continues to decrease in volume, the protection it affords will be diminished overtime. If the berm cuts back to the point of no longer be able to protect the native coastal bank and upland property, it will be the recommendation of the Woods Hole Group to renourish the berm with additional sand and cobble. The property owner is aware that they will need additional permission from the regulatory agencies prior to installing any new material on the beach.

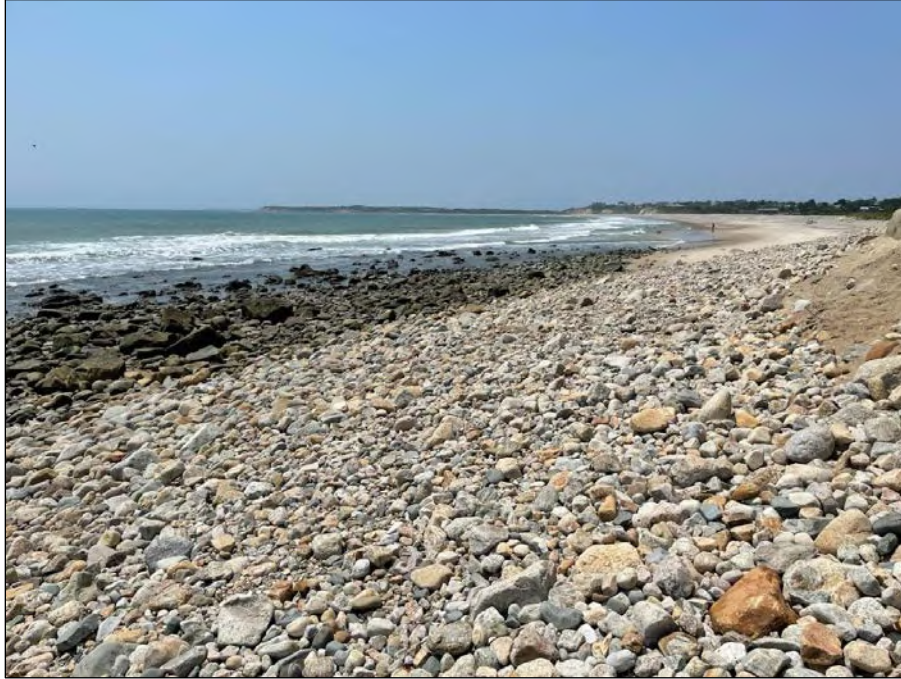
Figure 5. Cobble beach, July 7, 2021 (looking west).

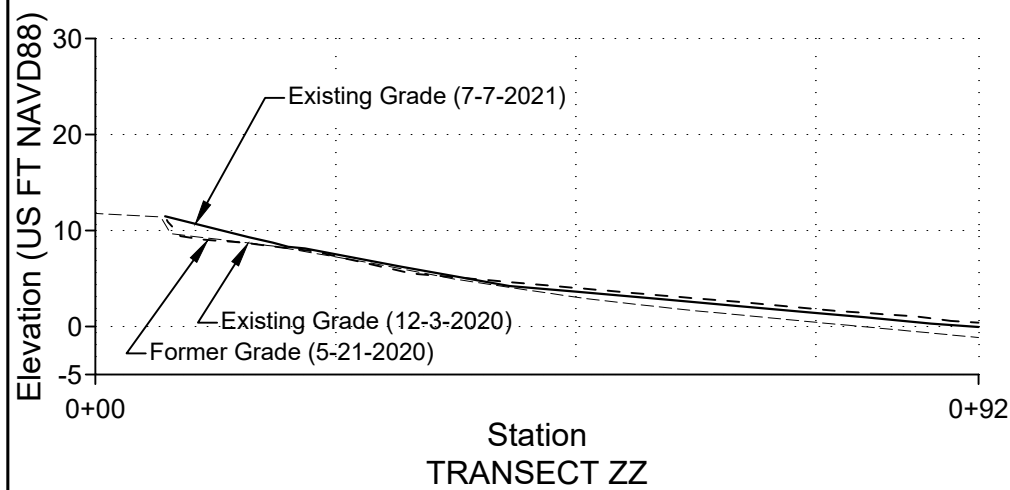
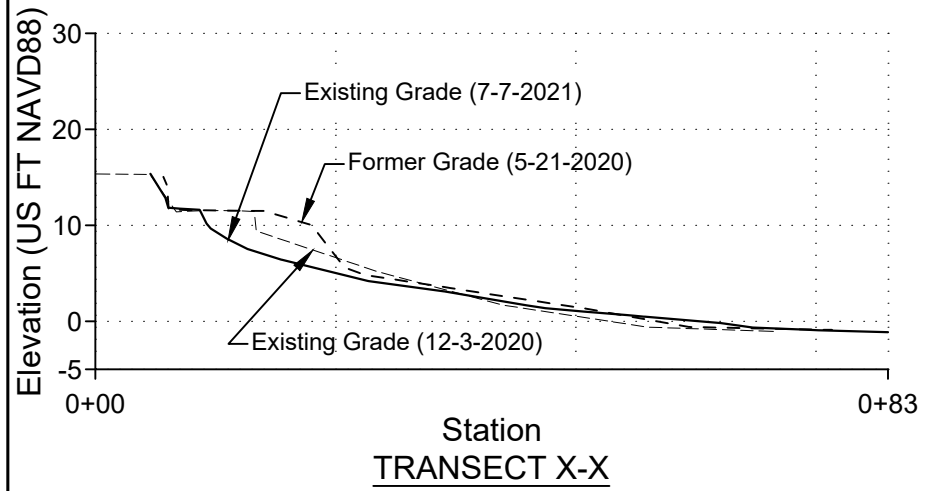
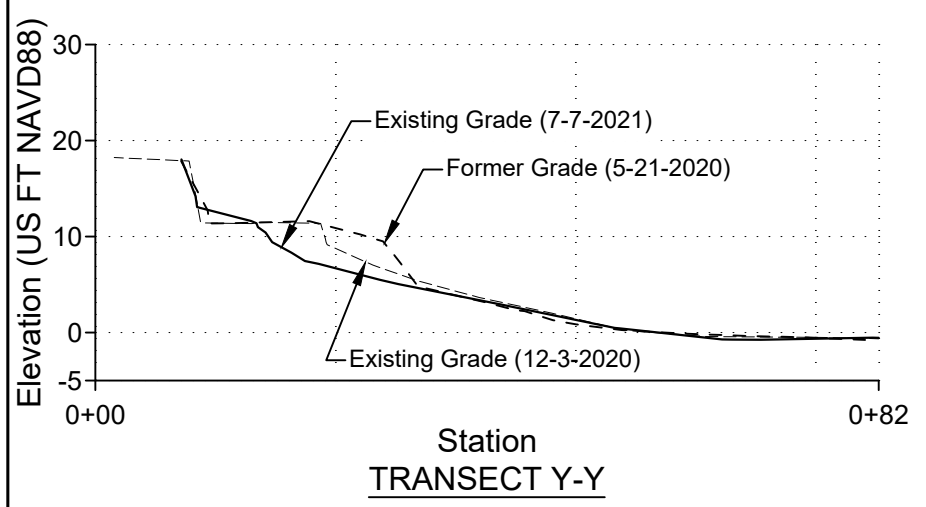
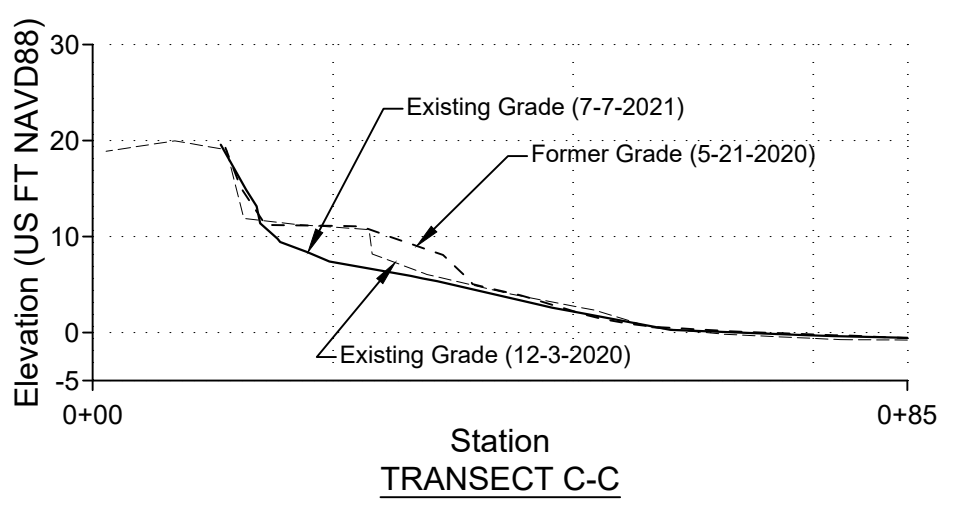
Bi-Annual Monitoring Plan - July 2021
Fools High Tide, LLC
#25 East Lane, Chilmark, MA

Between the time of the previous bi-annual survey on December 3, 2020 and the next survey on July 7, 2021, the native coastal bank was still afforded adequate protected by the constructed cobble berm and sand nourishment and exhibited no new undercutting or erosion. Even though there was approximately five (5) feet of additional berm erosion, the remaining berm continued to protect the toe of the native coastal bank as shown in Figures 1 and 2. The profile data indicate an insignificant change across the remaining profile of the beach. The ephemeral sand cover that comes and goes seasonally had returned and extended from the Fools High Tide Beach across Stonewall Beach to the west.

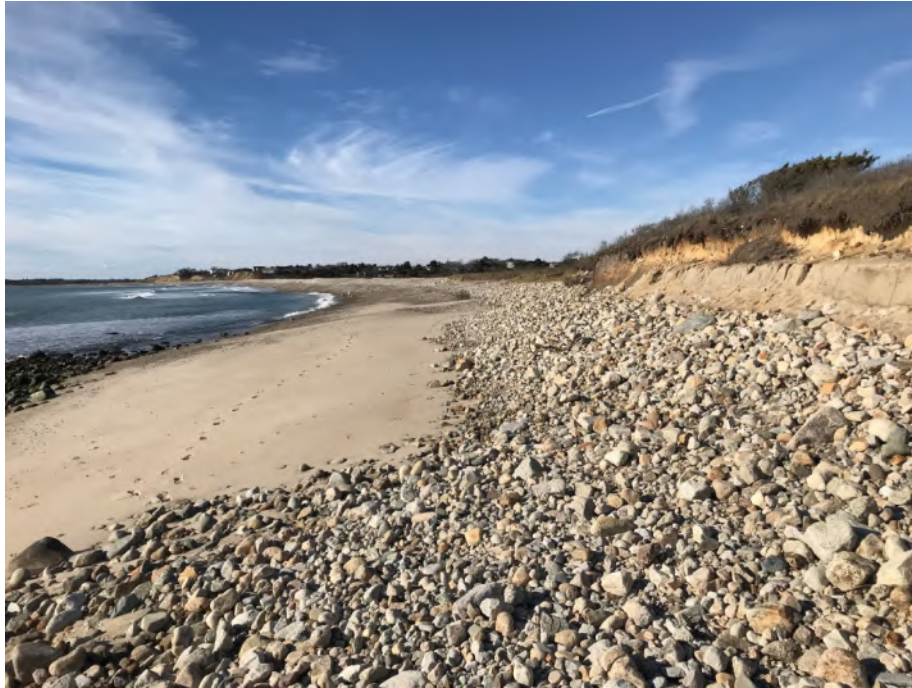
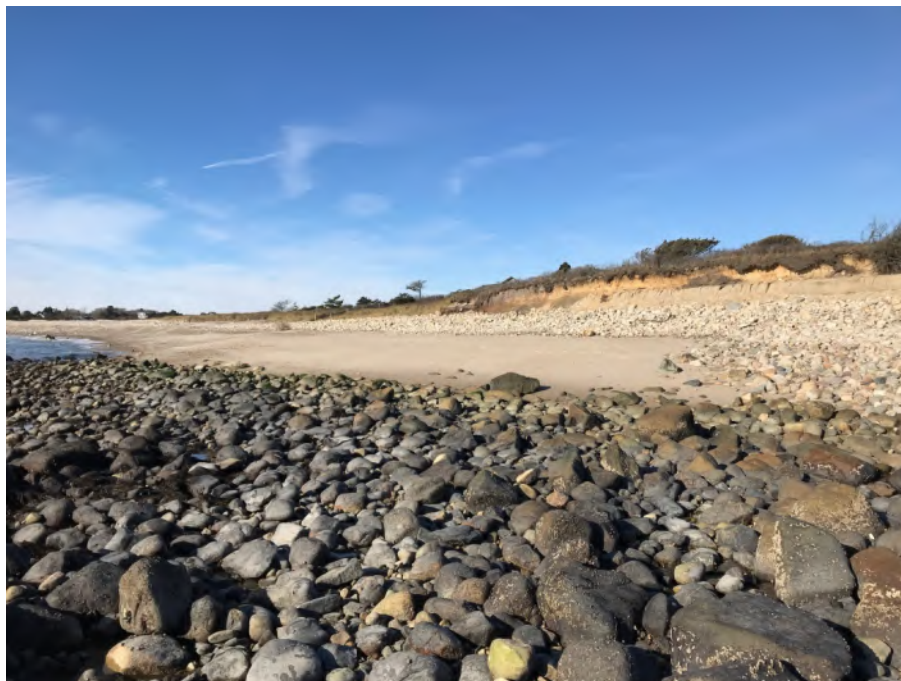
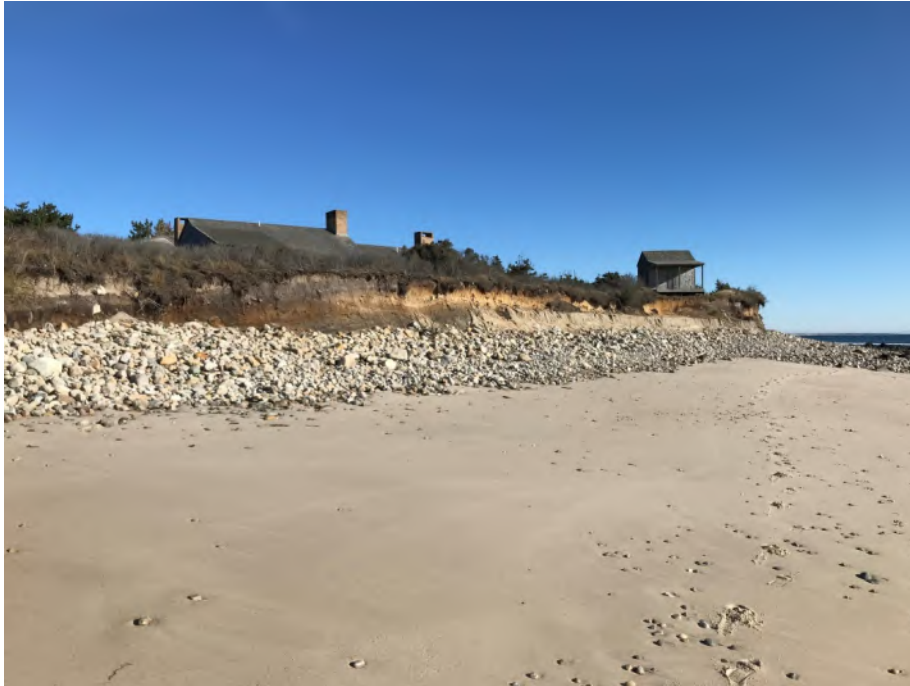
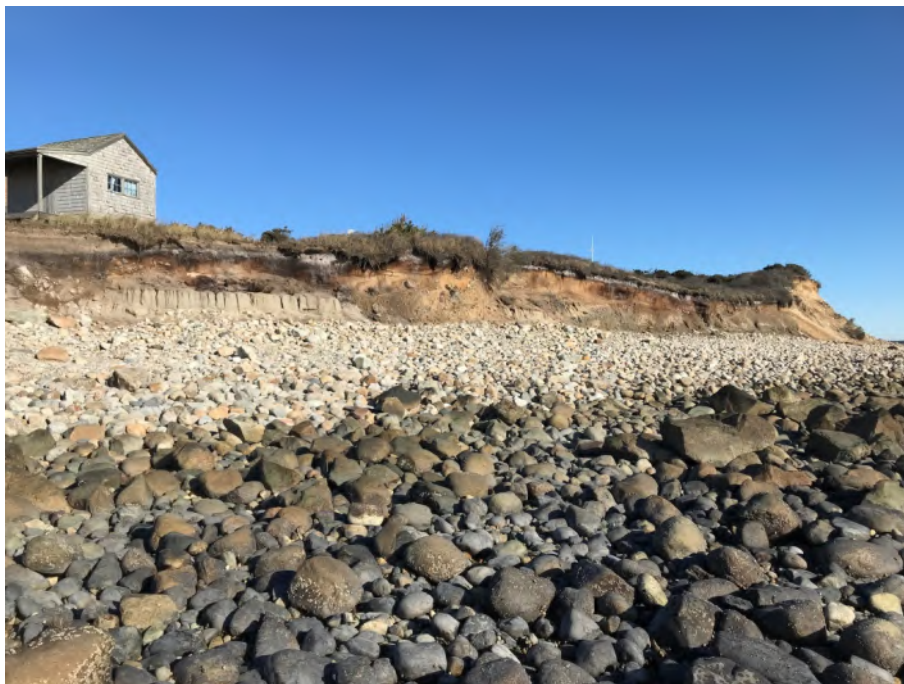
Between the time of the previous bi-annual survey on July 7, 2021 and this survey on December 7, 2021, the majority of the material in the cobble berm had eroded away, and therefore, the berm no longer provided adequate protection to the coastal bank, see Figures 1-4.

Figure 1. Cobble and sandy beach, December 2021 (looking east).

Figure 2. Cobble and sandy beach, December 2021 (looking east).

Figure 3. Cobble and sandy beach, December 2021 (looking west).

Figure 4. Cobble beach, December 2021 (looking west).

Since the berm continued to decrease in volume, Woods Hole Group recommended it be renourished with additional sand and cobble. The process to obtain additional permission from the regulatory agencies began and subsequent permits were issued. The renourishment project was scheduled for March, 2022.

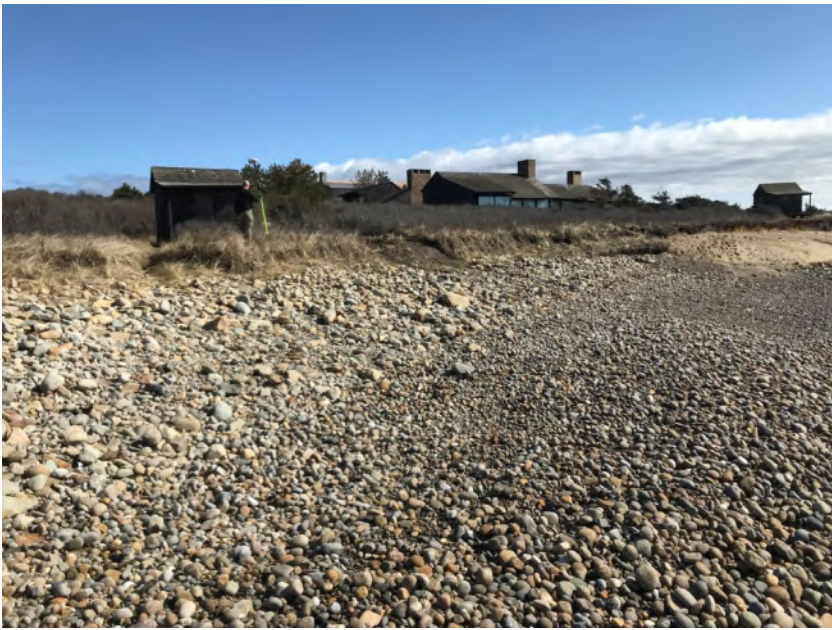
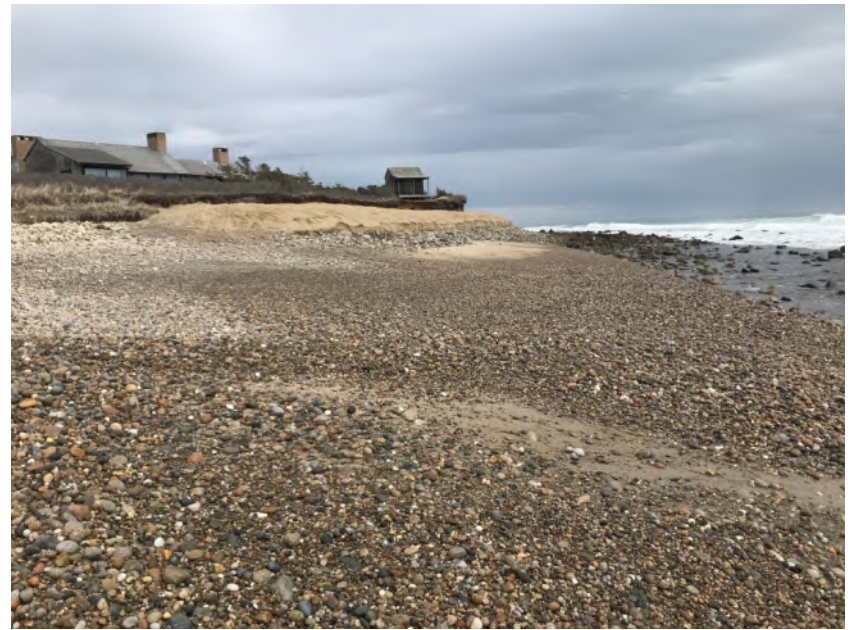
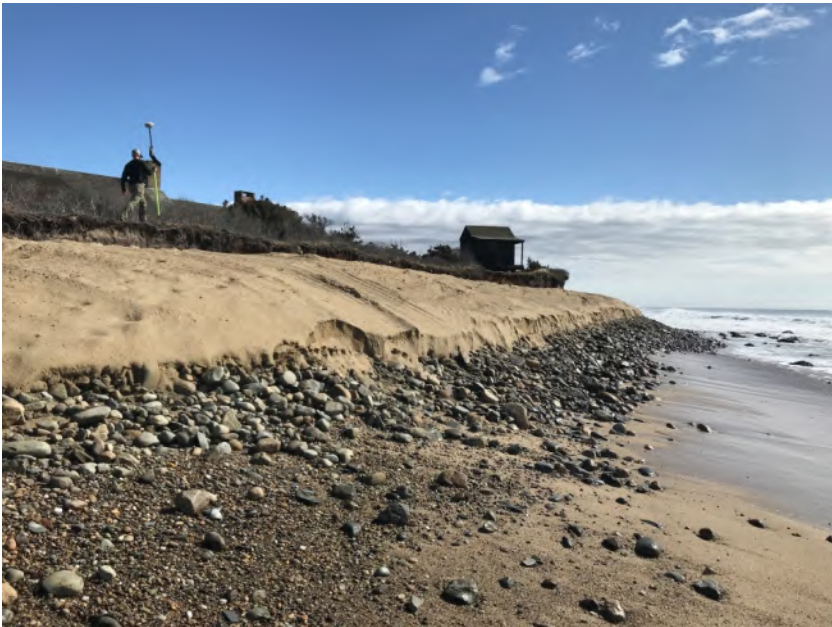
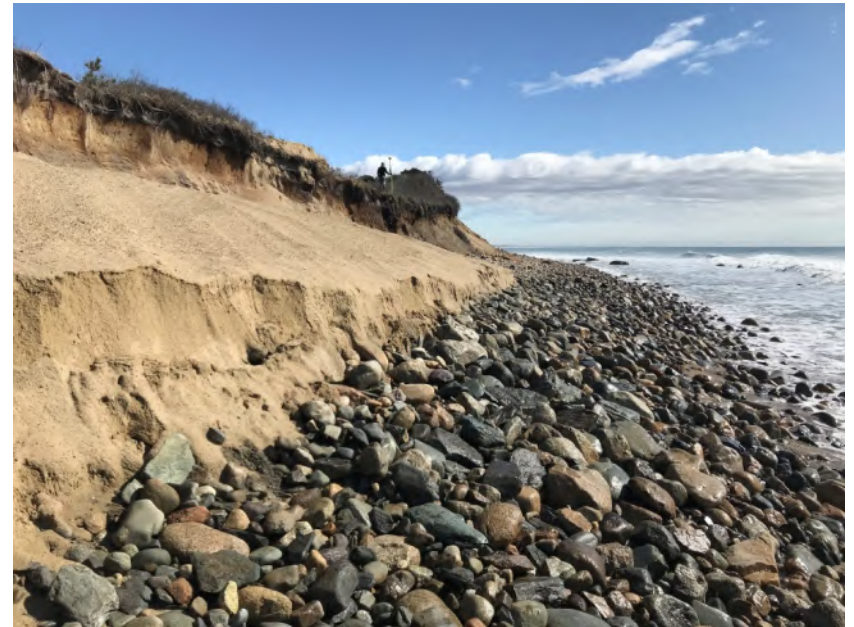
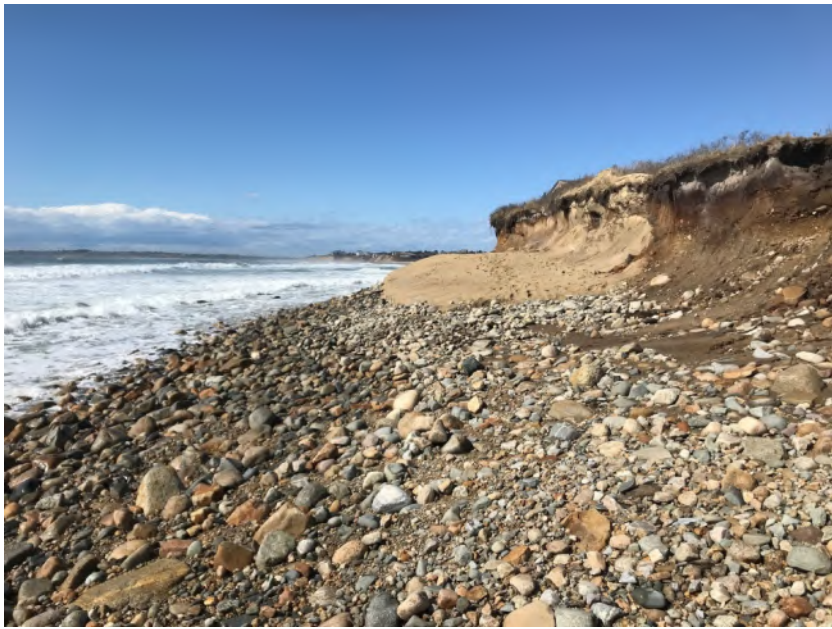
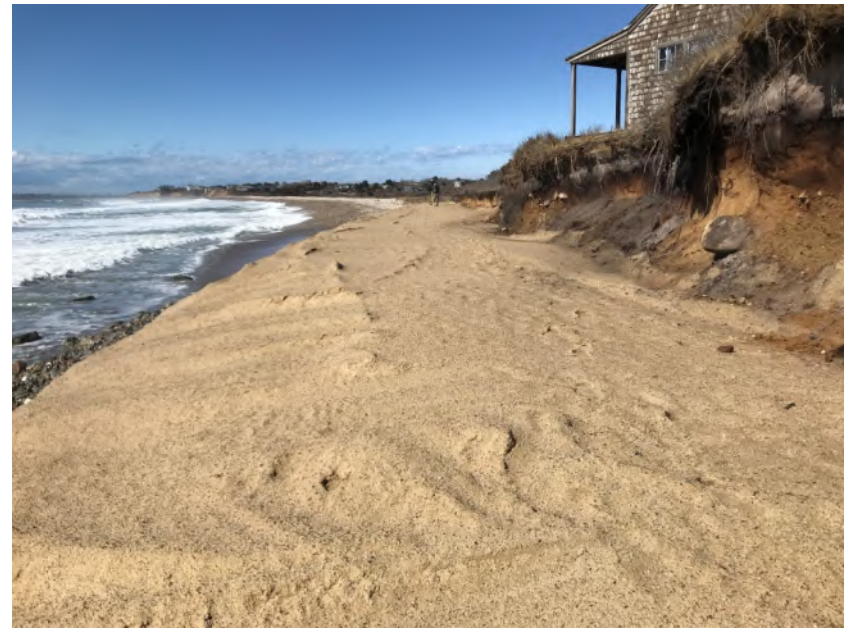
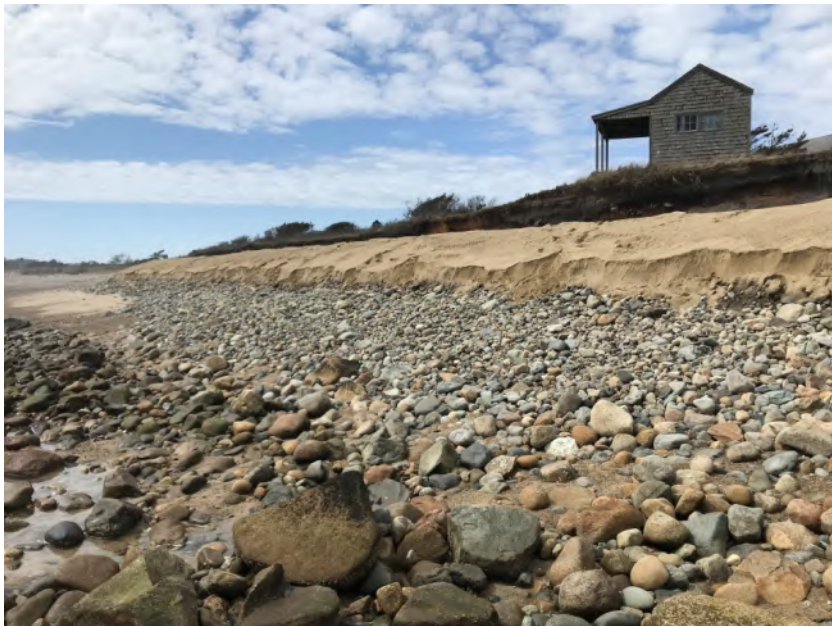
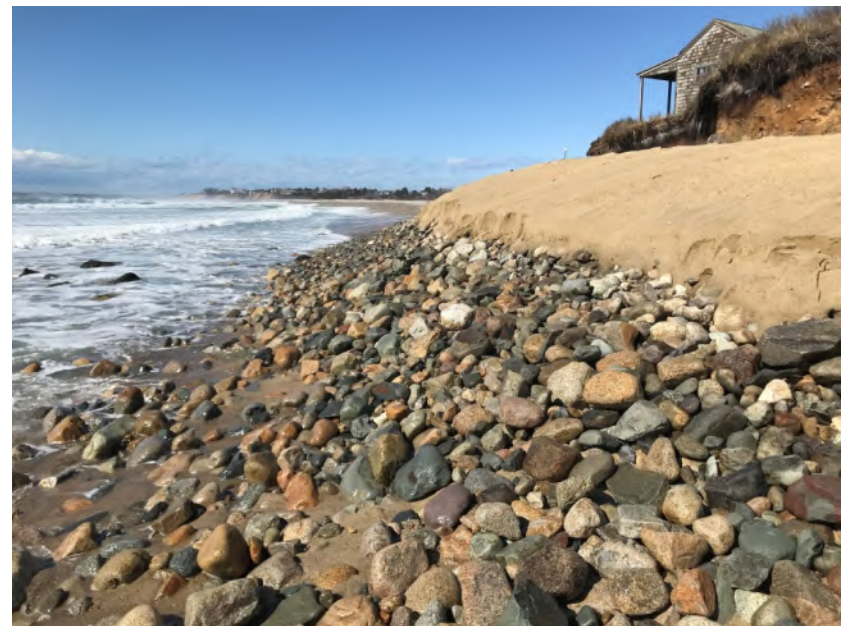
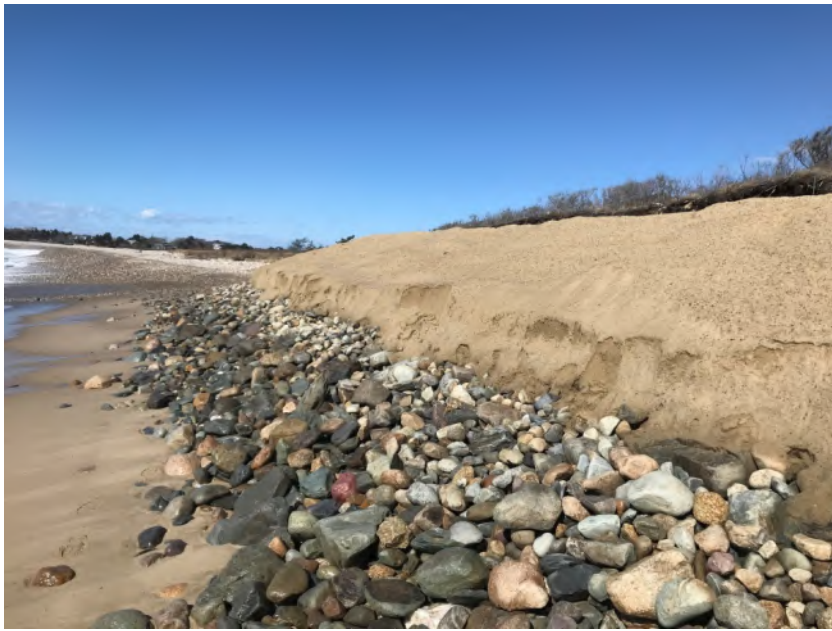
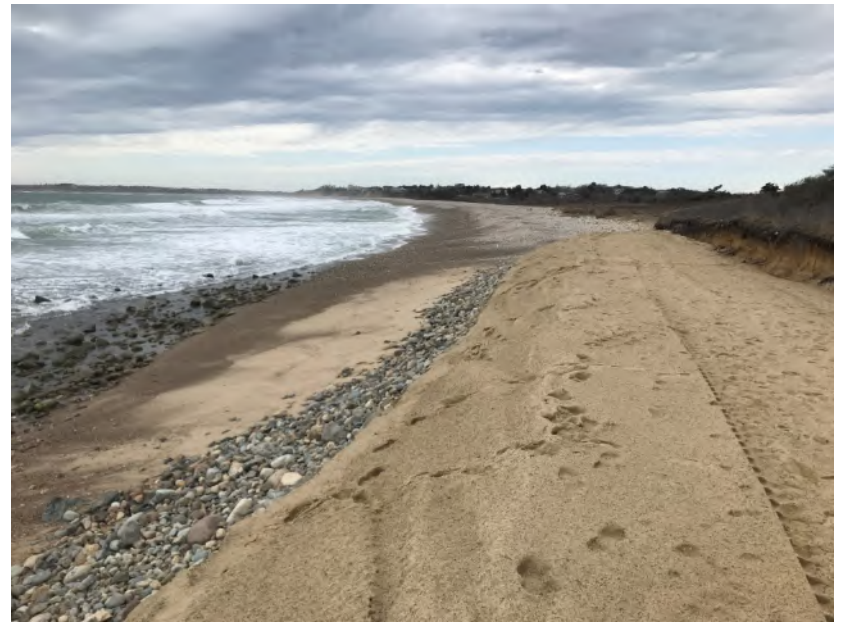
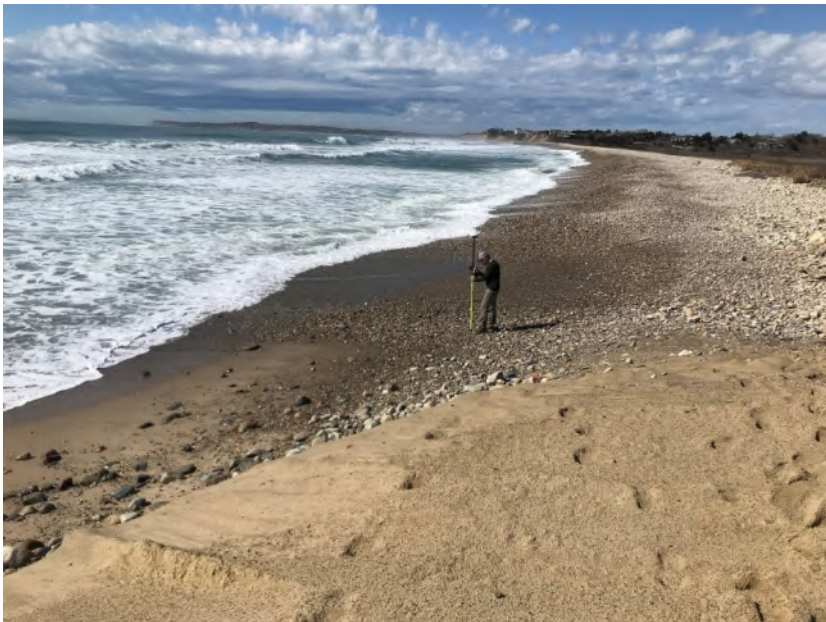
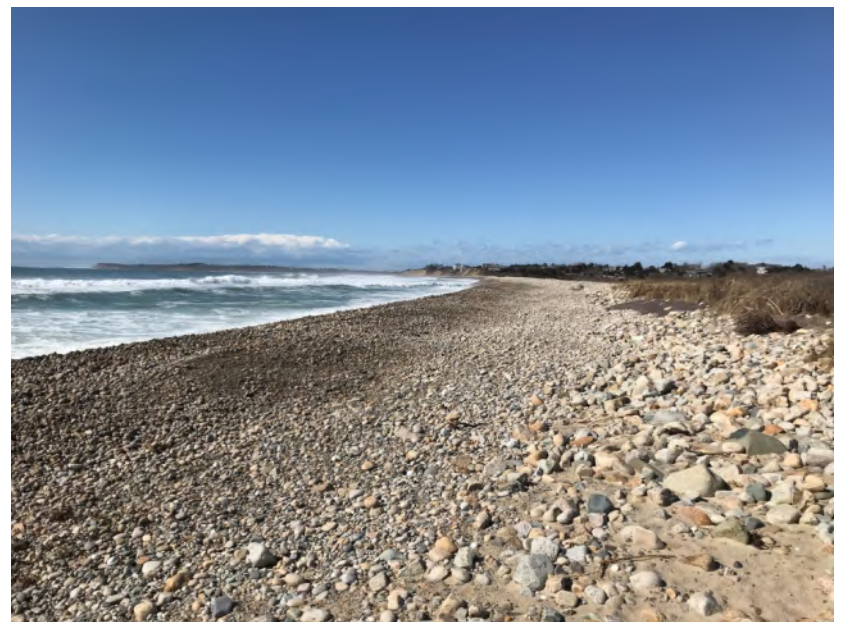
During Reconstruction- The cobble berm was reconstructed in March of 2022 by John Keene Excavation and supervised by Woods Hole Group. Per the Amended Bylaw Only OOC, a total of 575 cubic yards of mixed cobble was placed along the toe of the coastal bank to rebuild the cobble berm, and 650 cubic yards of compatible sand nourishment was placed over the top of the cobble berm as a sand veneer and as an apron on the east and west sides of the berm.

Post-Reconstruction/Bi-Annual Monitoring, April 2022 – During the post-reconstruction/bi-annual survey on April 1, 2022, the native coastal bank is once again well protected by the cobble and sand renourishment. Figures 1-12 were taken upon completion of the work and show the newly reconstructed berm covered with a two-foot sand veneer.
