Re: Notice of Intent Application: Supplemental Information: 2020-2022 Monitoring Summary Report
Propose to Install and Maintain Cobble and Sand Renourishment
Fool's High Tide, LLC
25 East Lane
Chilmark, MA
Map 32 Parcel 68.1

Summary of 2020-2022 Monitoring Reports

Re: Post Construction Bi-Annual Monitoring Report: December 2020
Beach Nourishment/Cobble Berm
Fool's High Tide, LLC
25 East Lane
Chilmark, MA
Map 32 Parcel 68.1
DEP File No. SE 12-702 (SOOC)

Bi-Annual Monitoring Plan - Dec. 2020
Fools High Tide, LLC
#25 East Lane, Chilmark, MA

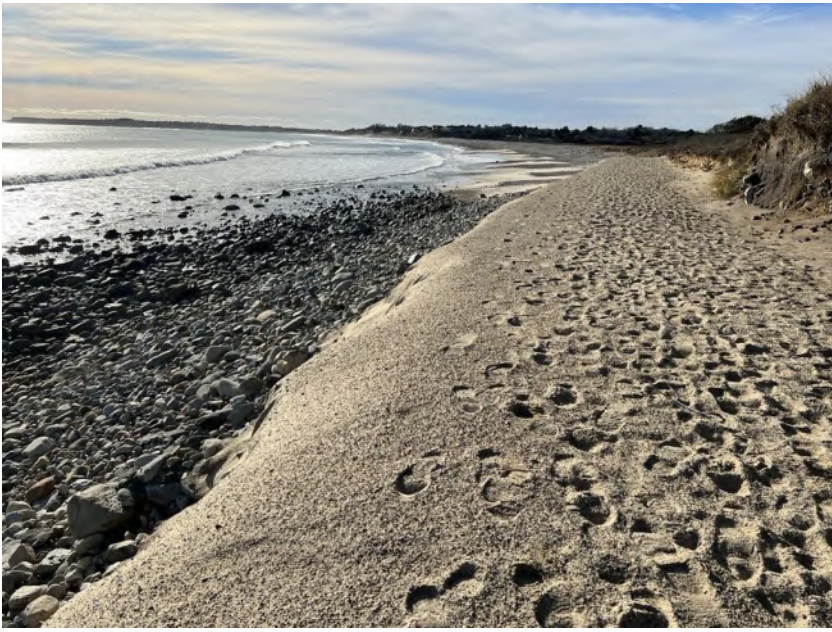
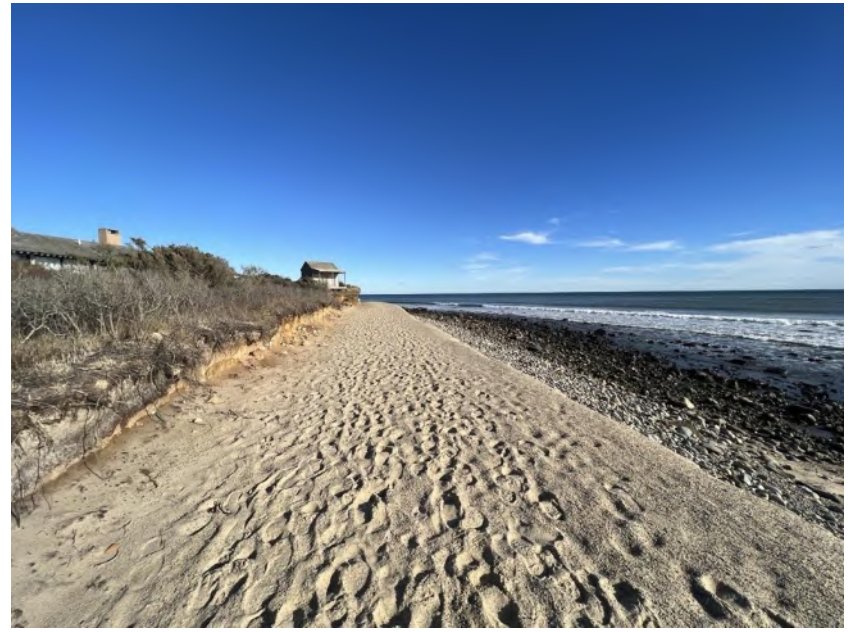
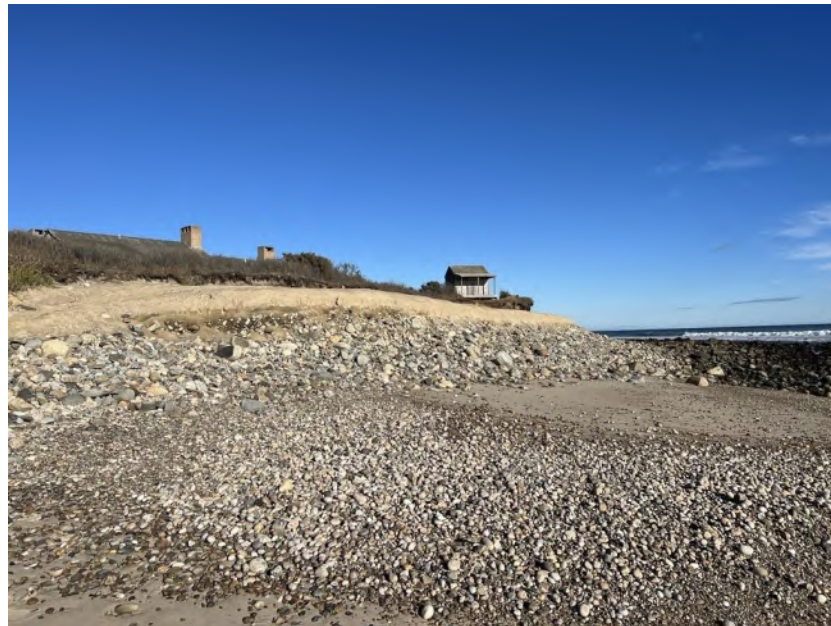
Between the time of the previous bi-annual survey on April 1, 2022 and this survey on December 8, 2022, minor erosion of the cobble berm occurred.

Figure 1. Fool's High Tide (FHT) cobble berm looking west, Dec. 8, 2022

Figure 2. FHT cobble berm looking east, Dec. 8, 2022

Figure 3. FHT beach and cobble berm looking east, Dec. 8, 2022

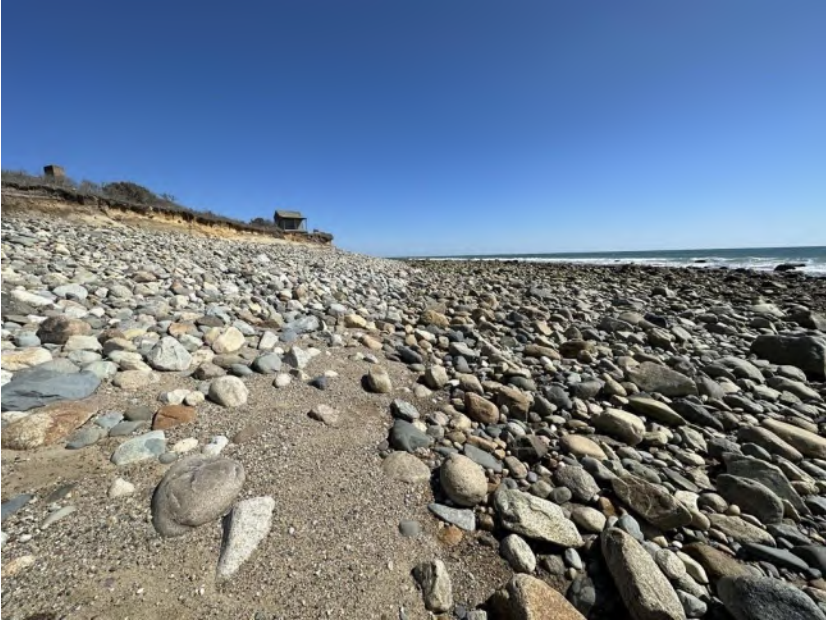
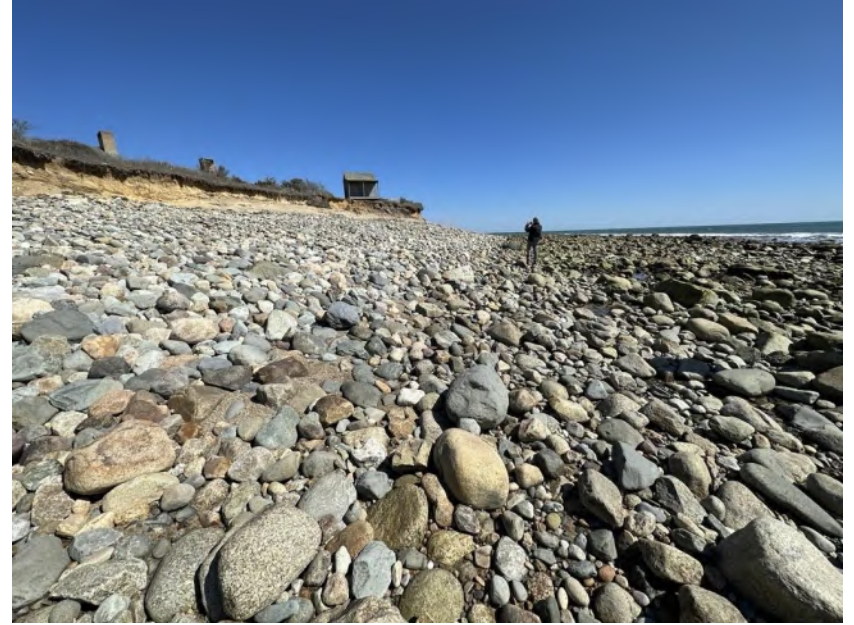
Despite minimal erosion between the April and December surveys, the cobble berm experienced significant erosion due to a storm event that took place on December 23, 2022 (see figures 4 & 6). Although the cobble berm has been successful at protecting the coastal bank, the volume of nourishment is inadequate to protect the bank for more than 1-2 years. Due to the loss of the berm and the Commission's decision to require a new Notice of Intent (NOI) to place additional nourishment, the Owner will be submitting requests for Certificates of Compliance to the Commission and MassDEP for the AOOC and SOOC. A new NOI will also be submitted for additional nourishment.

Figure 4. FHT beach and cobble berm looking east, March 20, 2023

Figure 5. FHT beach and exposed coastal bank, March 20, 2023
