**Re: Concept Plan Review
Chilmark Firehouse
401 Middle Road
Chilmark, Massachusetts**

In response to your request, LEC Environmental Consultants, Inc. (LEC) has prepared the following review of concept site plans for the new Chilmark Firehouse and associated improvements to the site located at 401 Middle Road in Chilmark. This report includes an assessment of the adjacent Wetland Resource Areas and guidance on measures to ensure the long-term protection of these Resources in the context of the proposed project, the *Massachusetts Wetlands Protection Act* (M.G.L. c. 31, s. 40, the *Act*) and its implementing Regulations at 310 CMR 10.00, and the *Town of Chilmark Wetlands Protection Bylaw* and its implementing *Regulations* (the *Bylaw Regulations*).

This review is based on a site evaluation conducted by LEC on May 22, 2019 and conceptual site plans prepared for the project, including the *Site Plan*, prepared by Vineyard Land Surveying & Engineering, Inc. (VLS), dated April 9, 2018, and the *Fire Station Conceptual Site Plan With Existing Underlay*, prepared by Pacheco Ross Architects, P.C. This review includes a General Site Description, Wetland Resource Area Description, Proje

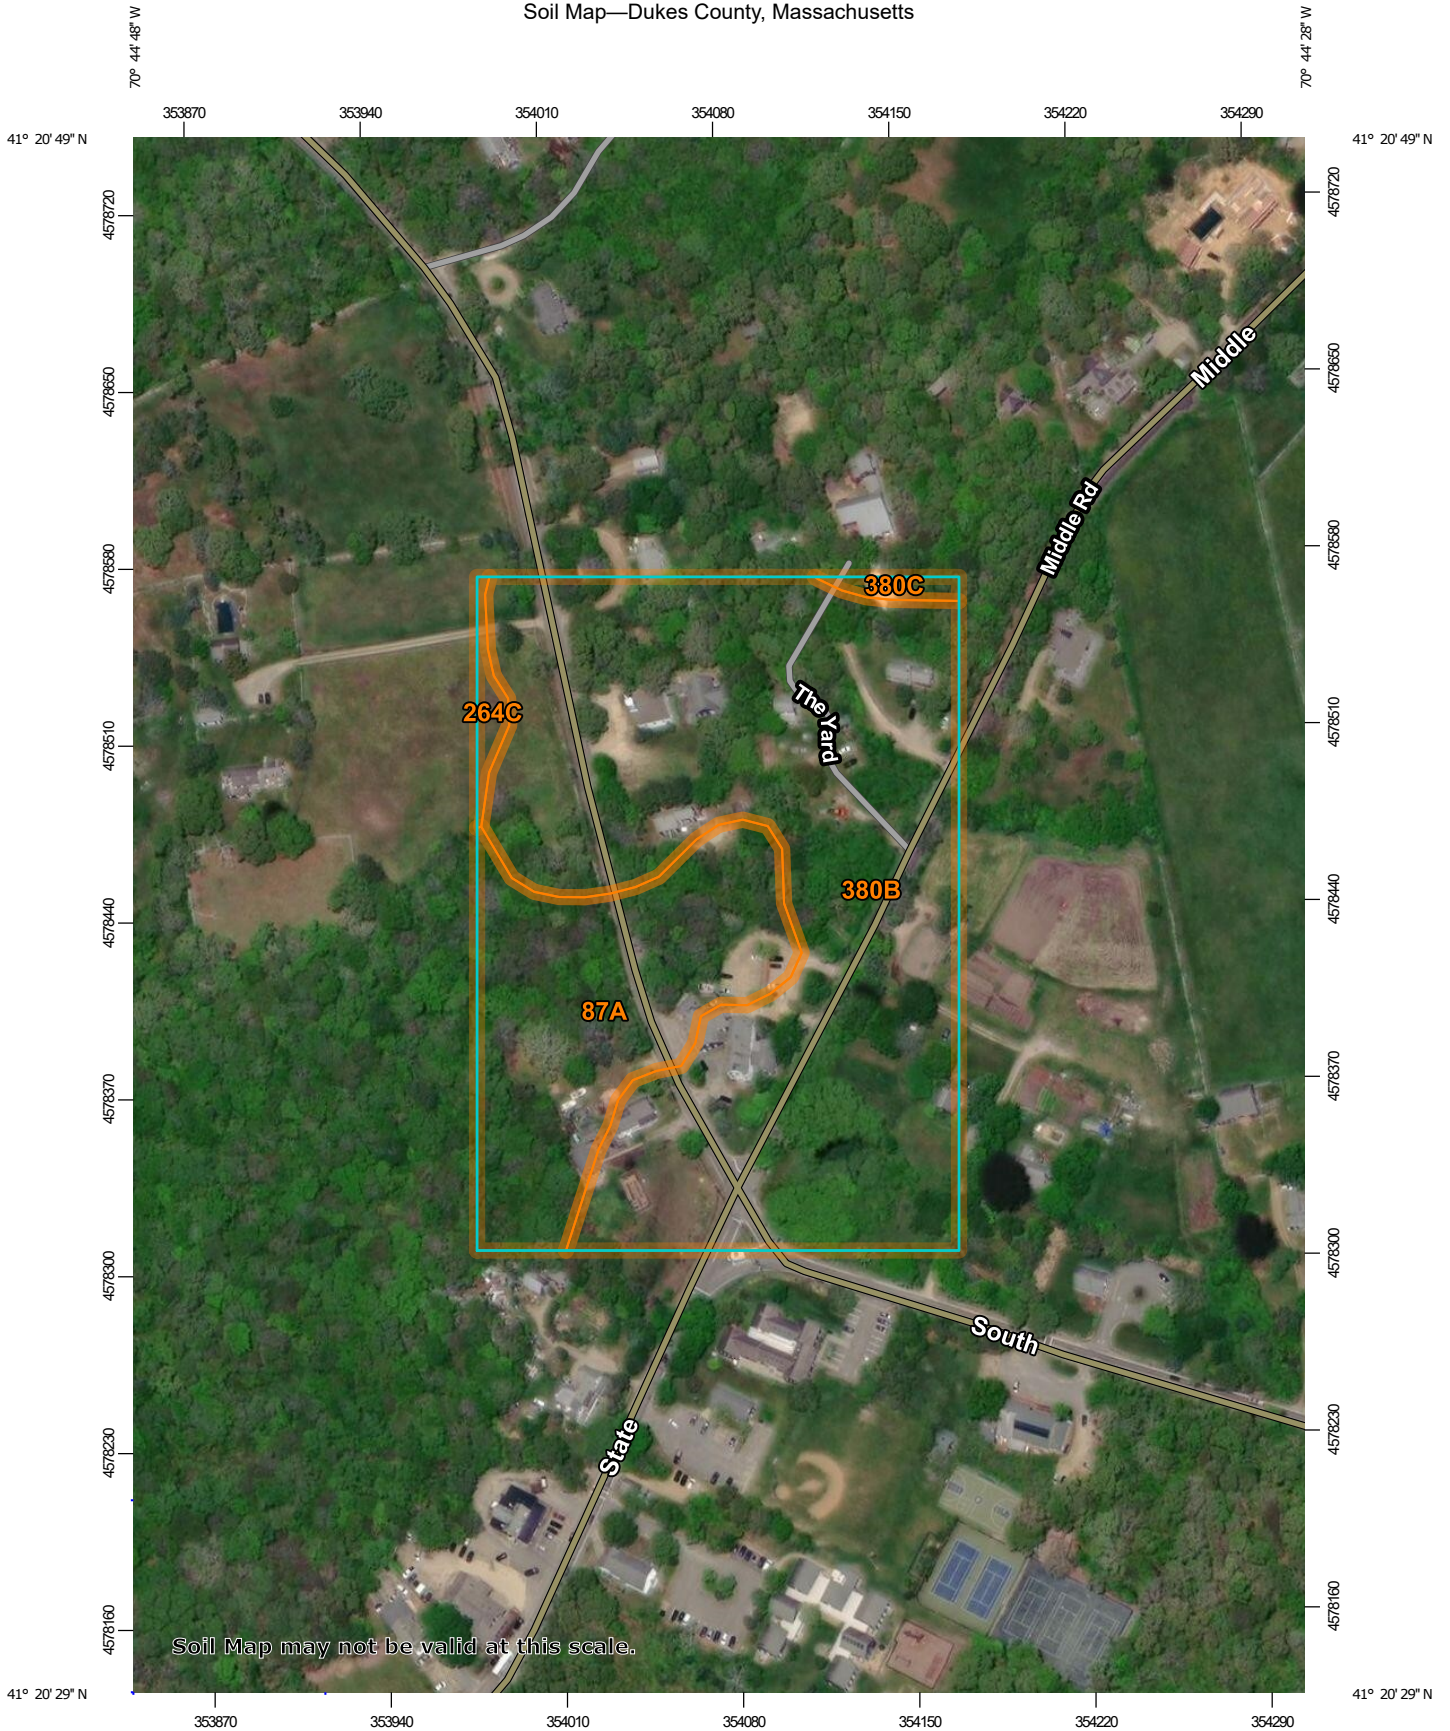
Soil Map

According to the Dukes County Soil Survey, the western portion of the site, including about half of the existing development and the existing wetland system, contains Ridgebury Variant Fine Sandy Loam soil. The eastern portion of the property contains Nantucket Sandy Loam soil (Attachment D). Ridgebury Fine Sandy Loam soils are described as *nearly level, poorly drained soil is in depressions and drainageways of glacial upland hills and drumlins*. Nantucket Soils are *very deep, well drained soils formed in dense glacial till. They are moderately deep to dense till. They are gently sloping to strongly sloping soils on or near terminal moraines*. As described below, soil evaluations conducted on-site confirmed the presence of poorly drained, fine sandy loam soils within the wetland system.

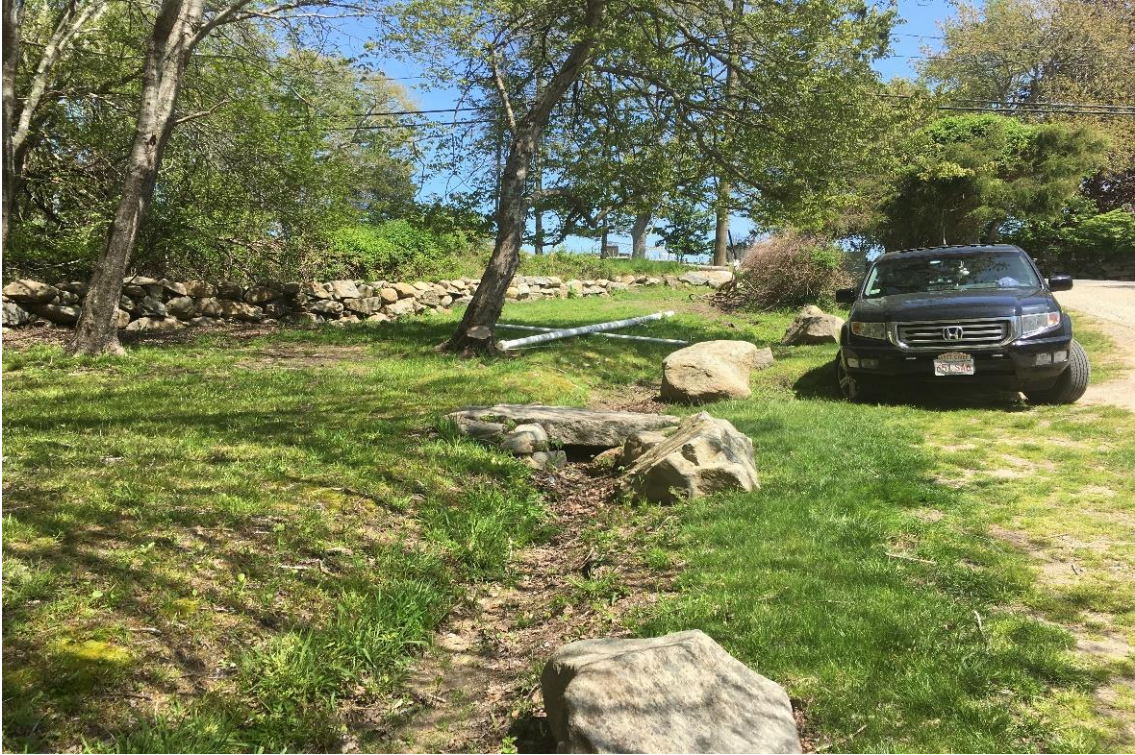
Photo 1: Ditch extending from Middle Road; mowed wet meadow to the left.

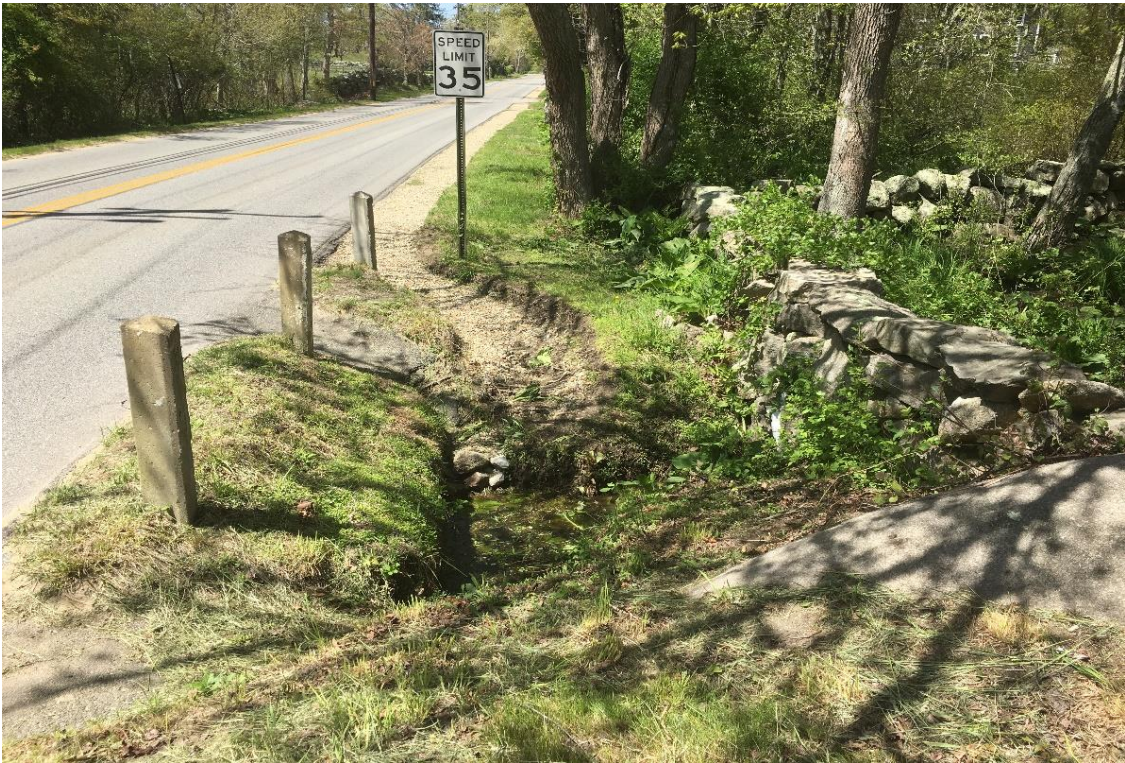
Bank is associated with the ditch within the mowed wetland meadow and the intermittent stream extending from the BVW beneath Menemsha Crossroad. The Banks near the culvert are approximately 1± foot tall and nearly vertical. The Banks associated with the ditch are smaller, typically less than 6± inches and gently sloping.

Photo 2: Intermittent stream at mouth of culvert beneath Menemsha Crossroad.

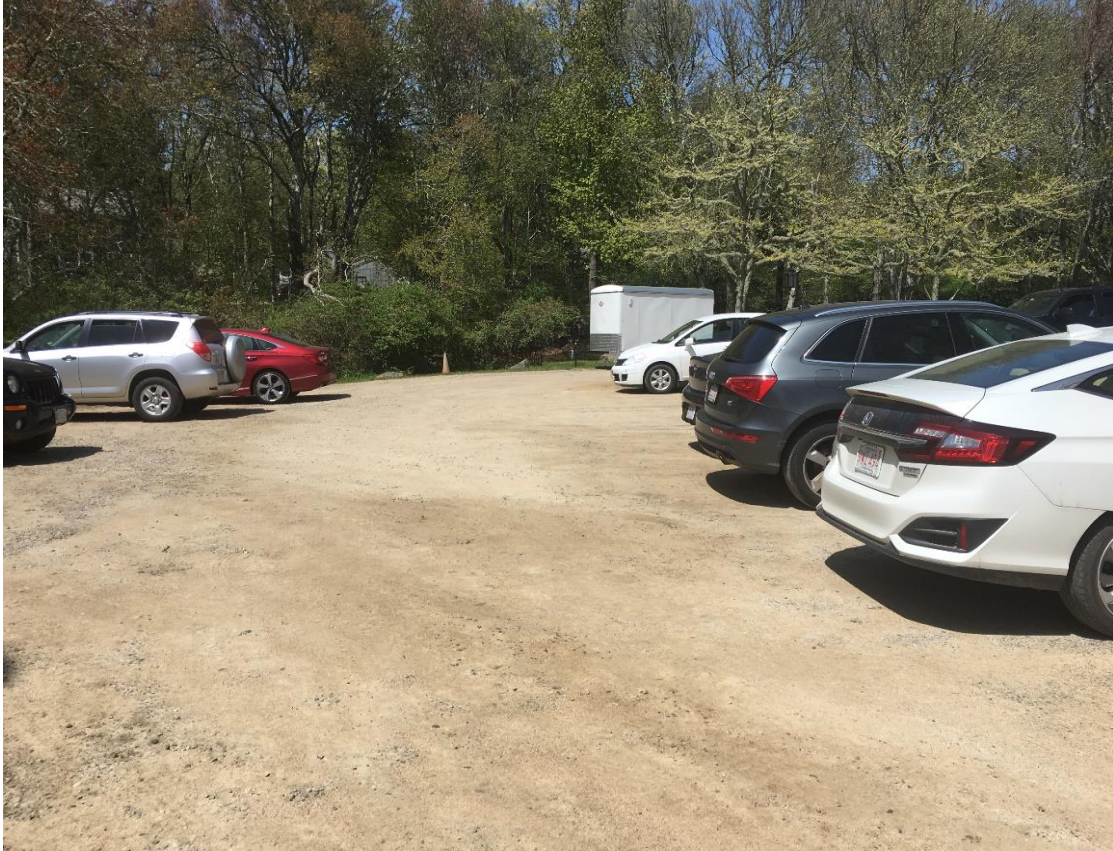
Upland vegetation fringing the edge of the wetland system is limited due to the lack of a significant buffer between the development and wetland system. The limits of development adjacent to the wetland system, including the existing gravel parking lot (Photograph 3), storage container (Photograph 4), and EMS building (Photograph 5), are less than 10± feet from the edge of the wetland, and at the closest points actually extend into the wetland (see above-referenced *Plans*). Under existing conditions, the property does not contain any substantive stormwater controls. It appears that untreated stormwater from the gravel parking lot and buildings sheet flows northwesterly toward the wetland system.

Photo 3: Gravel parking lot.

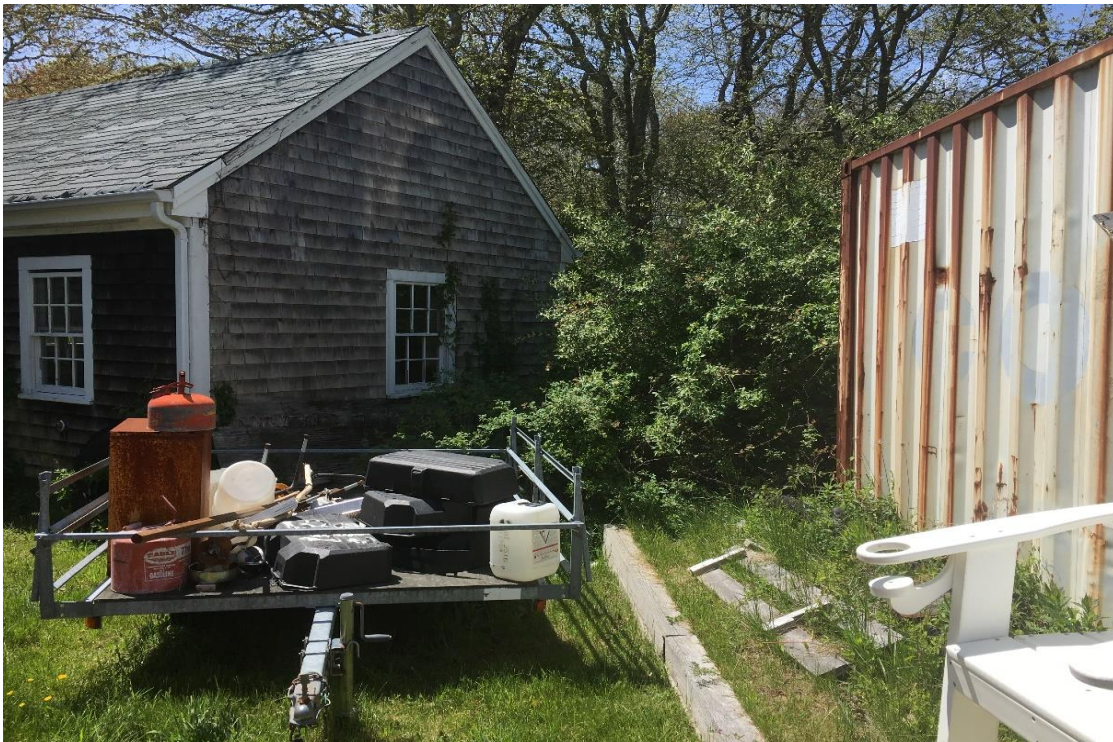
Photo 4: Storage container and rear of EMS building adjacent to wetlands.

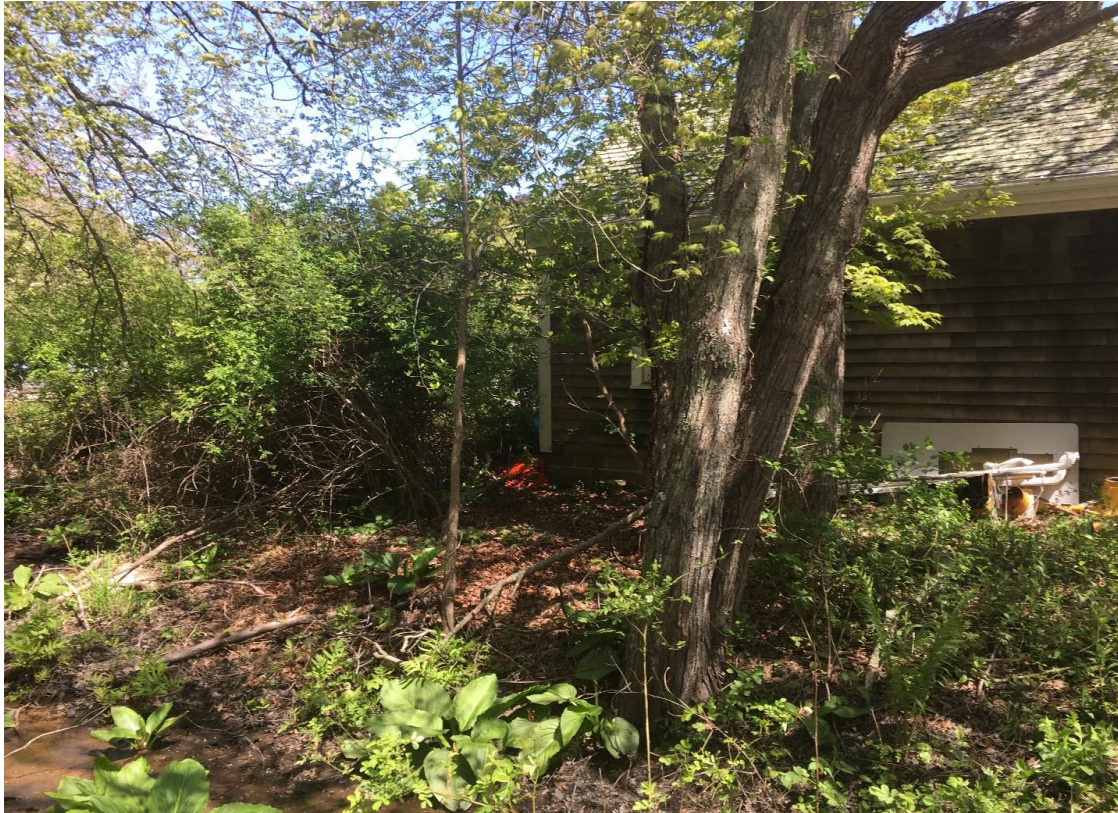
Photo 5: EMS building located adjacent to wetlands.

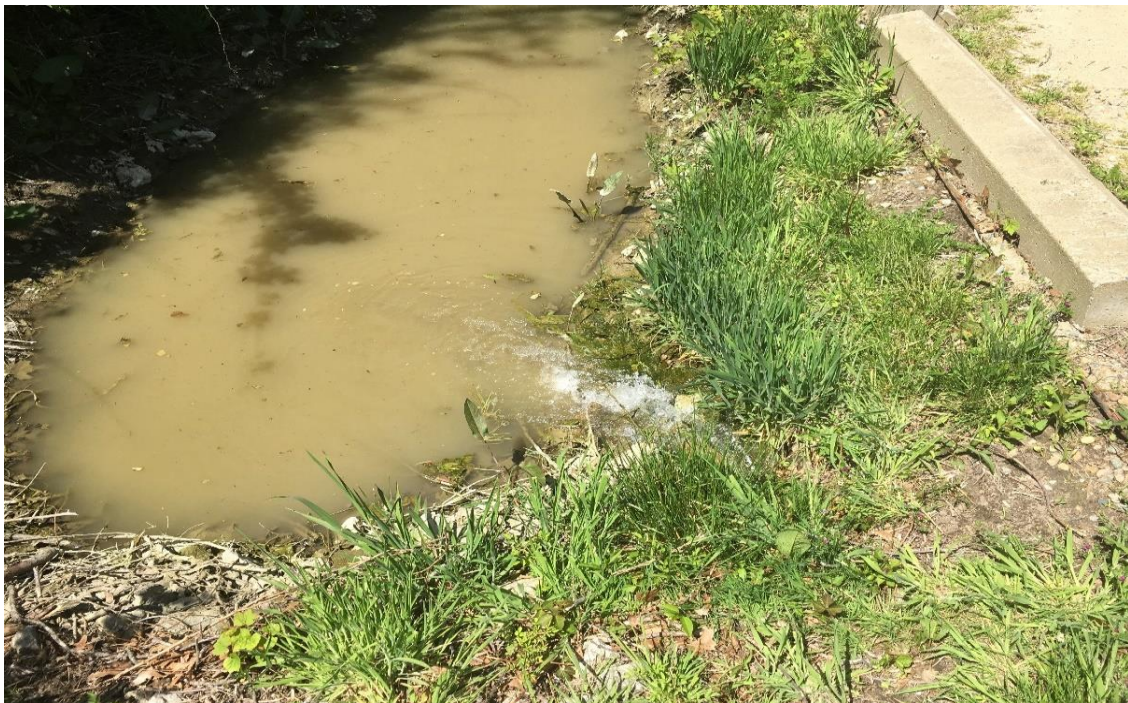
A small man-made depression, containing standing water, is located between the edge of the parking lot and wetland system. This depression contained up to 12± inches of water during our site evaluation. The primary water source appears to be from a building sump pump which we observed actively discharging through a small plastic pipe (Photograph 6).

Photo 6: Small stormwater basin with sump pump discharging adjacent to parking lot.

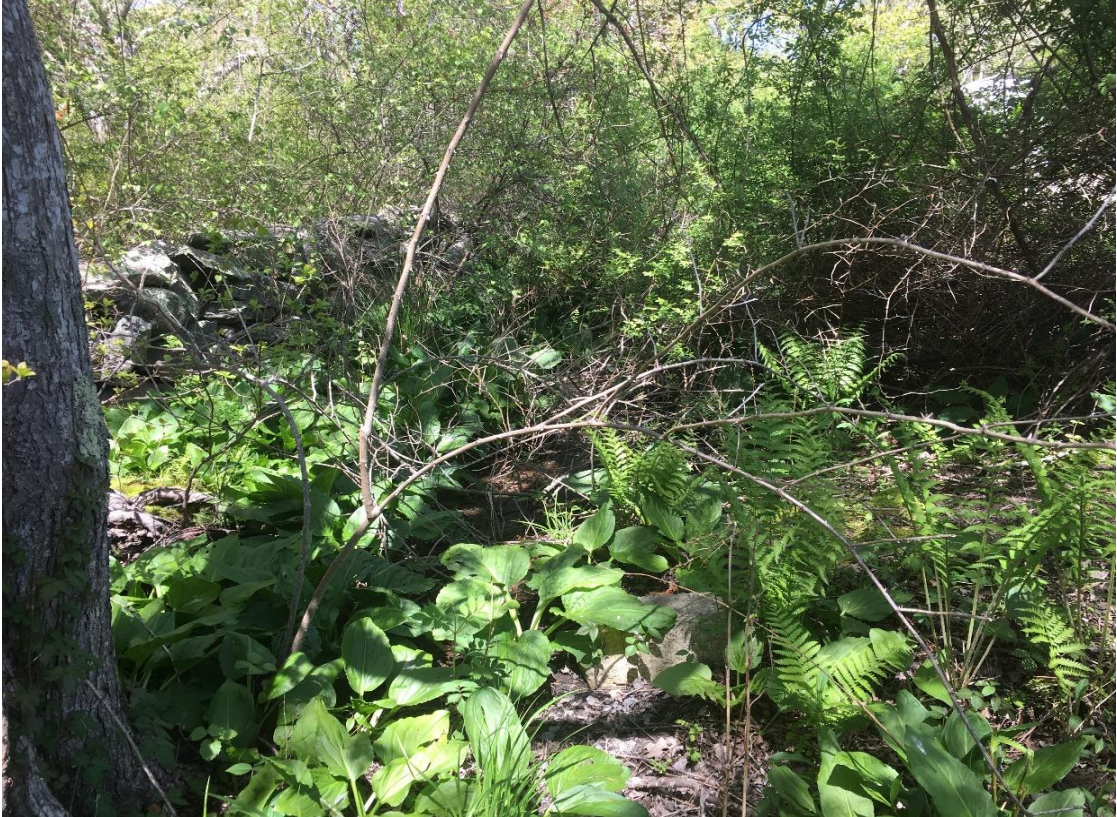
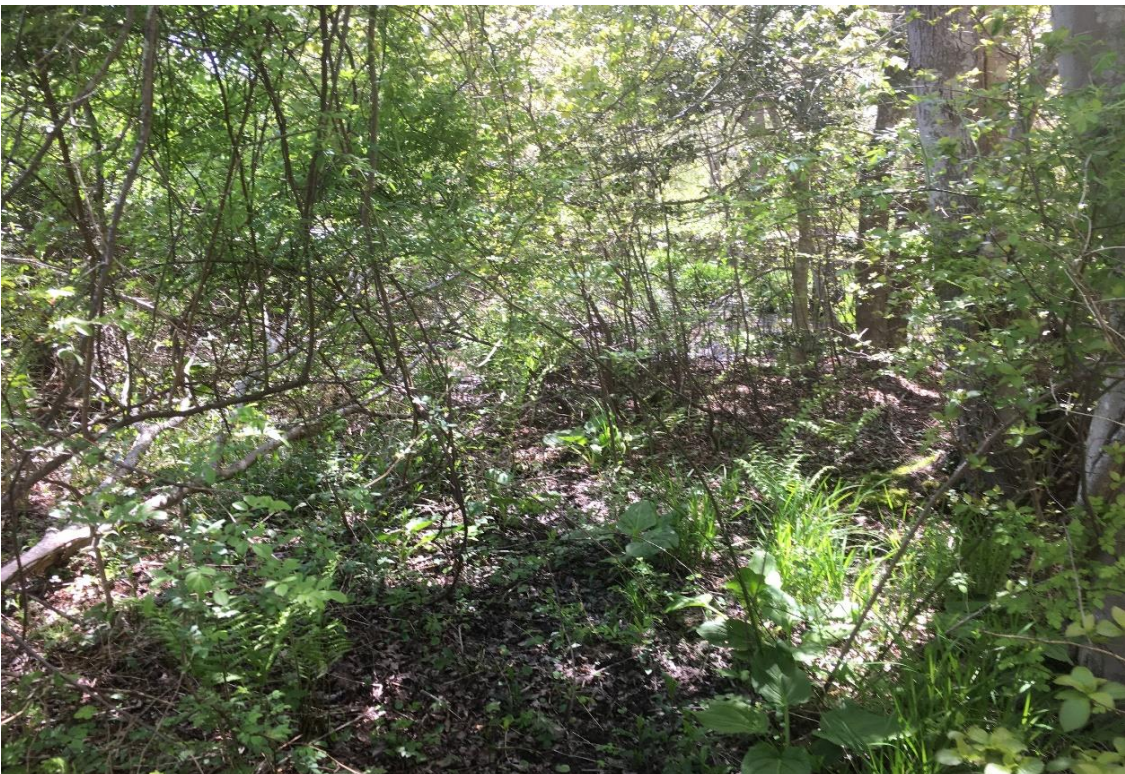
Groundcover in the wetland consists of skunk cabbage (*Symplocarpus foetidus*), sensitive fern (*Onoclea sensibilis*), and cinnamon fern (*Osmunda cinnamomea*) (Photographs 7 and 8). The mowed wetland is characterized as wet meadow with various rushes (*Juncus* spp.), Canada mayflower (*Maianthemum canadense*), sensitive fern, and other grasses observed (Photographs 9 and 10).

Photo 7: Wetland interior to the west of the parking lot.

Photo 8: Wetland interior to the west of the parking lot.

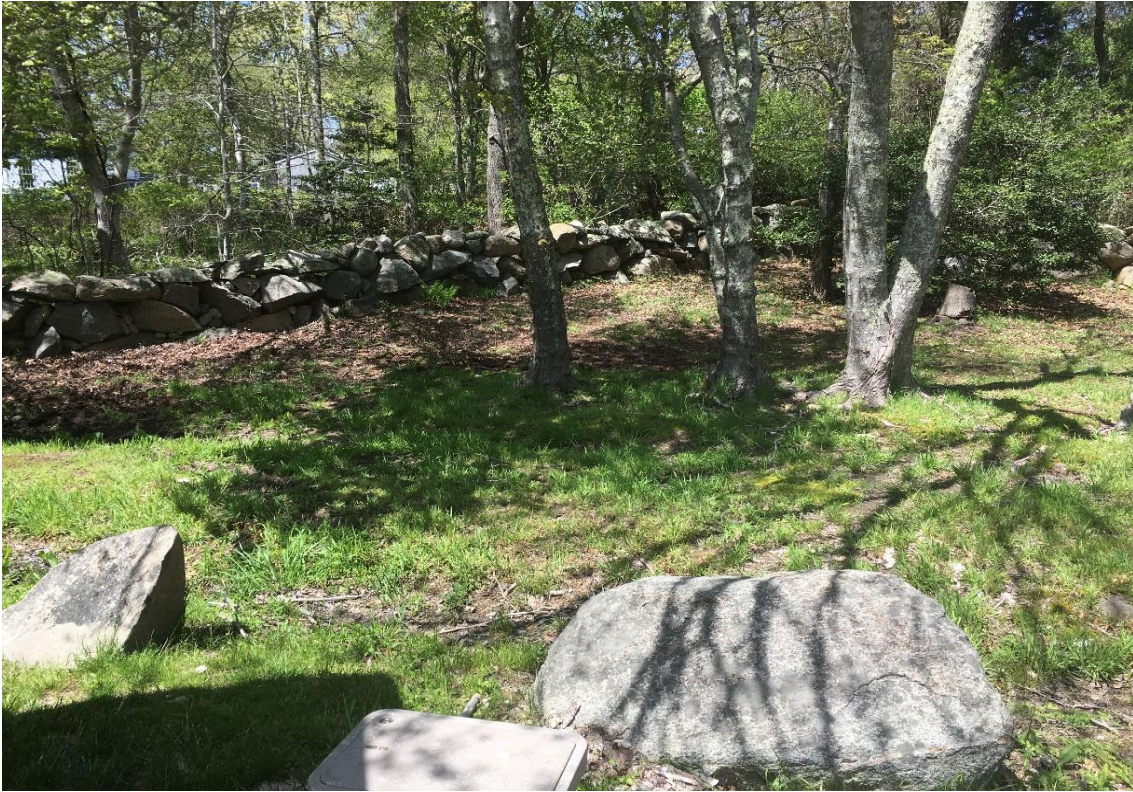
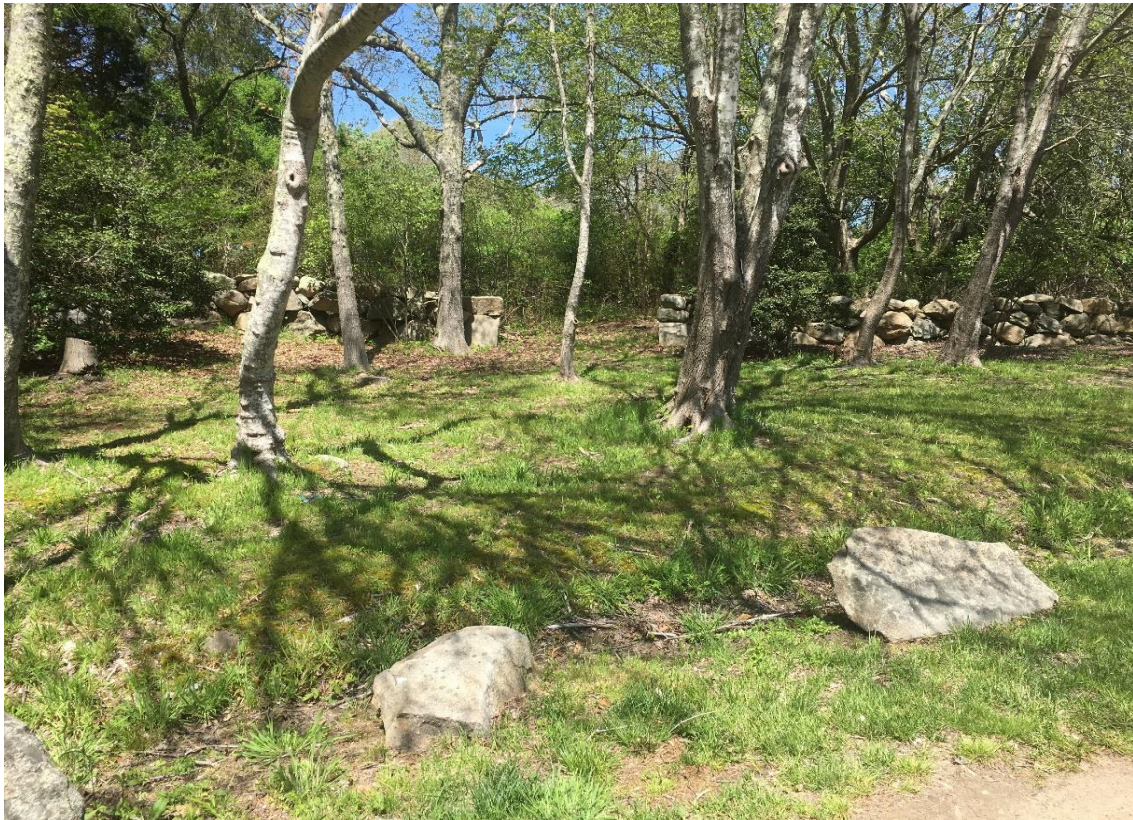
Photo 9: Wet meadow area to the northwest of gravel parking lot.

Photo 10: Intermittent stream and wet meadow northwest of parking lot.

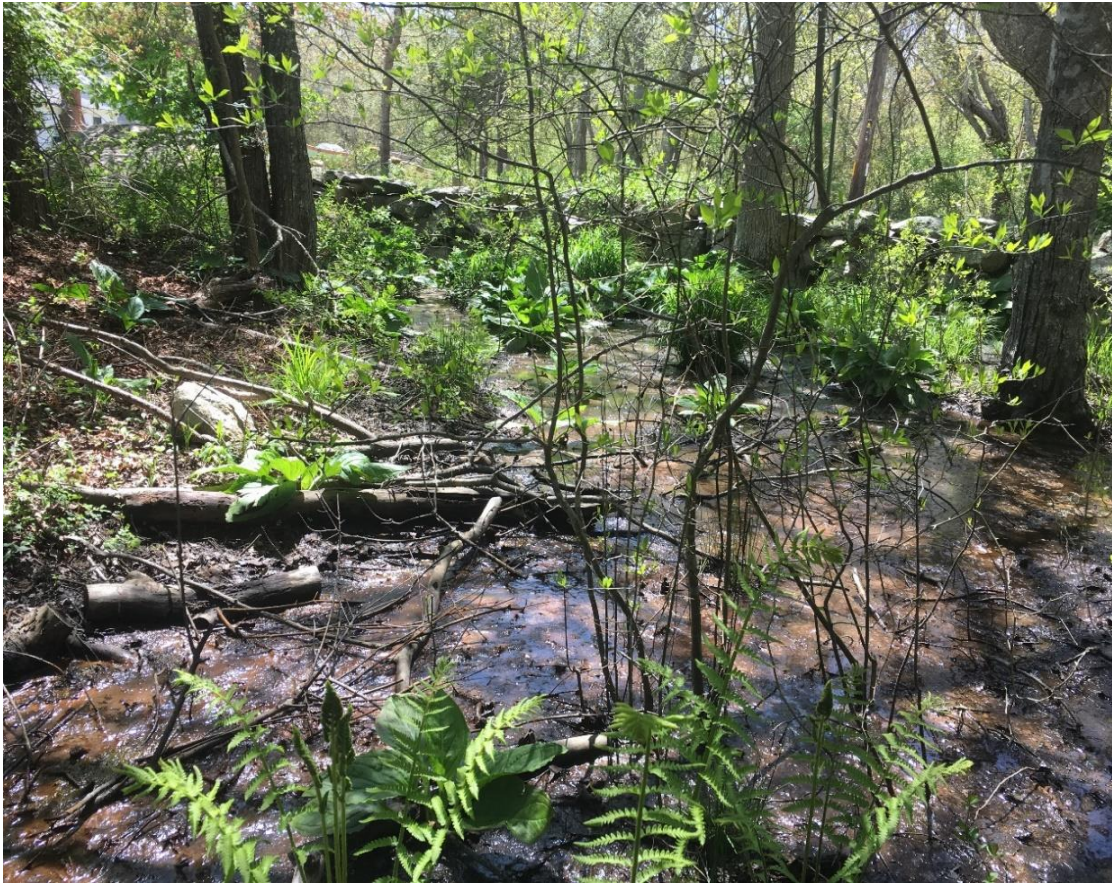
Soils in the forested wetland were saturated to the surface with small, scattered pockets of standing water (Photograph 11). While saturation prevented a thorough documentation of the soil horizons, soil texture was confirmed to be a poorly drained, fine sandy loam. Hydrology in the wetland is driven primarily by shallow groundwater. Secondary contributions to wetland hydrology appear to include stormwater from the subject property and Middle Road via the above-referenced ditch, along with stormwater from upgradient off-site areas.

Photo 11: Surface water within the wetland near Menemsha Crossroad.
