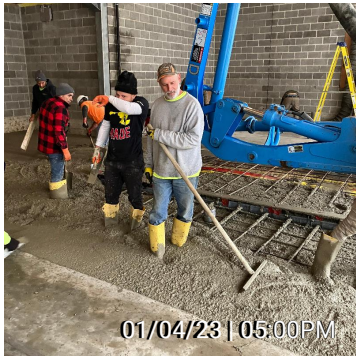
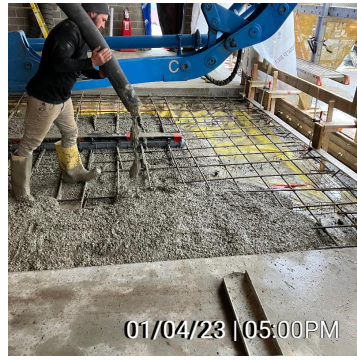
1. Another big day with Trades on site Mike Leon ,and Jim Watt were on site for Dellbrook along with Tom Shevory and Brandon Kee For Team meeting .

There were 9 Men for Simmons pouring the last slabs at the FH, another Milestone .

There were 6 Carpenters working on Trim and Shingling at the FH

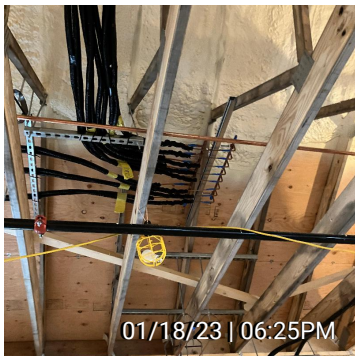
1. Today was the Team meeting with all present .
There was discussion regarding Shoring and when steel will be starting and when will the short delay start affecting the master schedule.
The sprinklers were also discussed and the heads under the porches and were they going to be Frost proof .
Mike Leon also asked for clarification regarding the plywood at the bottom of the truss cords . John K. said he would have answer by 11:00am today .
the well contractor was going to show up today at some point but I did not stay to see.
There were 4 Carpenters working on Siding at the EMS .
There were 3 Electricians working at both sites and in the Trenches.
There were 4 insulators spraying and cleaning up at the EMS .
Two plumbers were working at the FH starting piping in the apparatus bay for the compressed air piping .
The Steel worker foreman came by to talk to Mike Leon regarding schedule .
This is a picture of the line sets and other piping in the meeting room ceiling of the EMS building

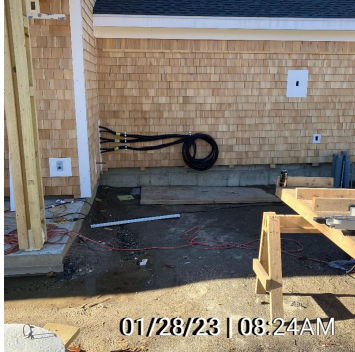
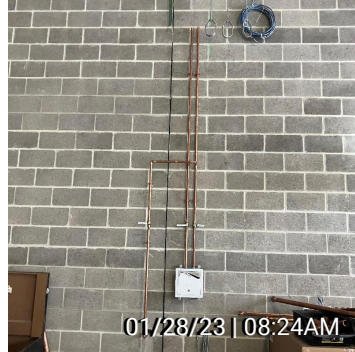
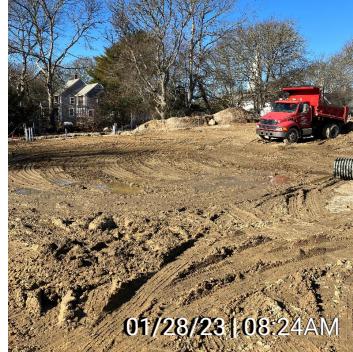
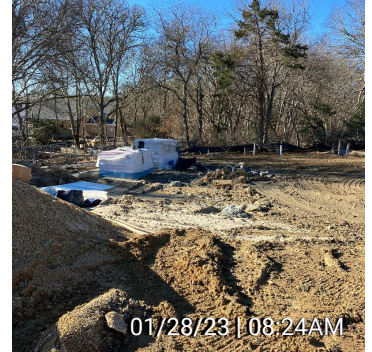
1. Slow day on site as only 5Carpenters working on Garage door jambs at FH .
Jim Watt was in for Dellbrook doing some clean up around site .
2 plumbers were working at FH setting Hangers for pipe in Apparatus bay.
There were 2 Pipe fitters working on Sprinklers runs at EMS .
Jim said that Farland will be laying out parking area at EMS next week .
