COASTAL PROCESSES SPECIALIST  
WOODS HOLE SEA GRANT | CAPE COD COOPERATIVE EXTENSION  
[gberman@whoi.edu](mailto:gberman@whoi.edu) | [gberman@barnstablecounty.org](mailto:gberman@barnstablecounty.org)  
508-289-3046 | 193 Oyster Pond Road, MS #2, Woods Hole, MA 02543-1525

February 26, 2014

RE: Town of Chilmark Squibnocket Beach and Parking Area Project

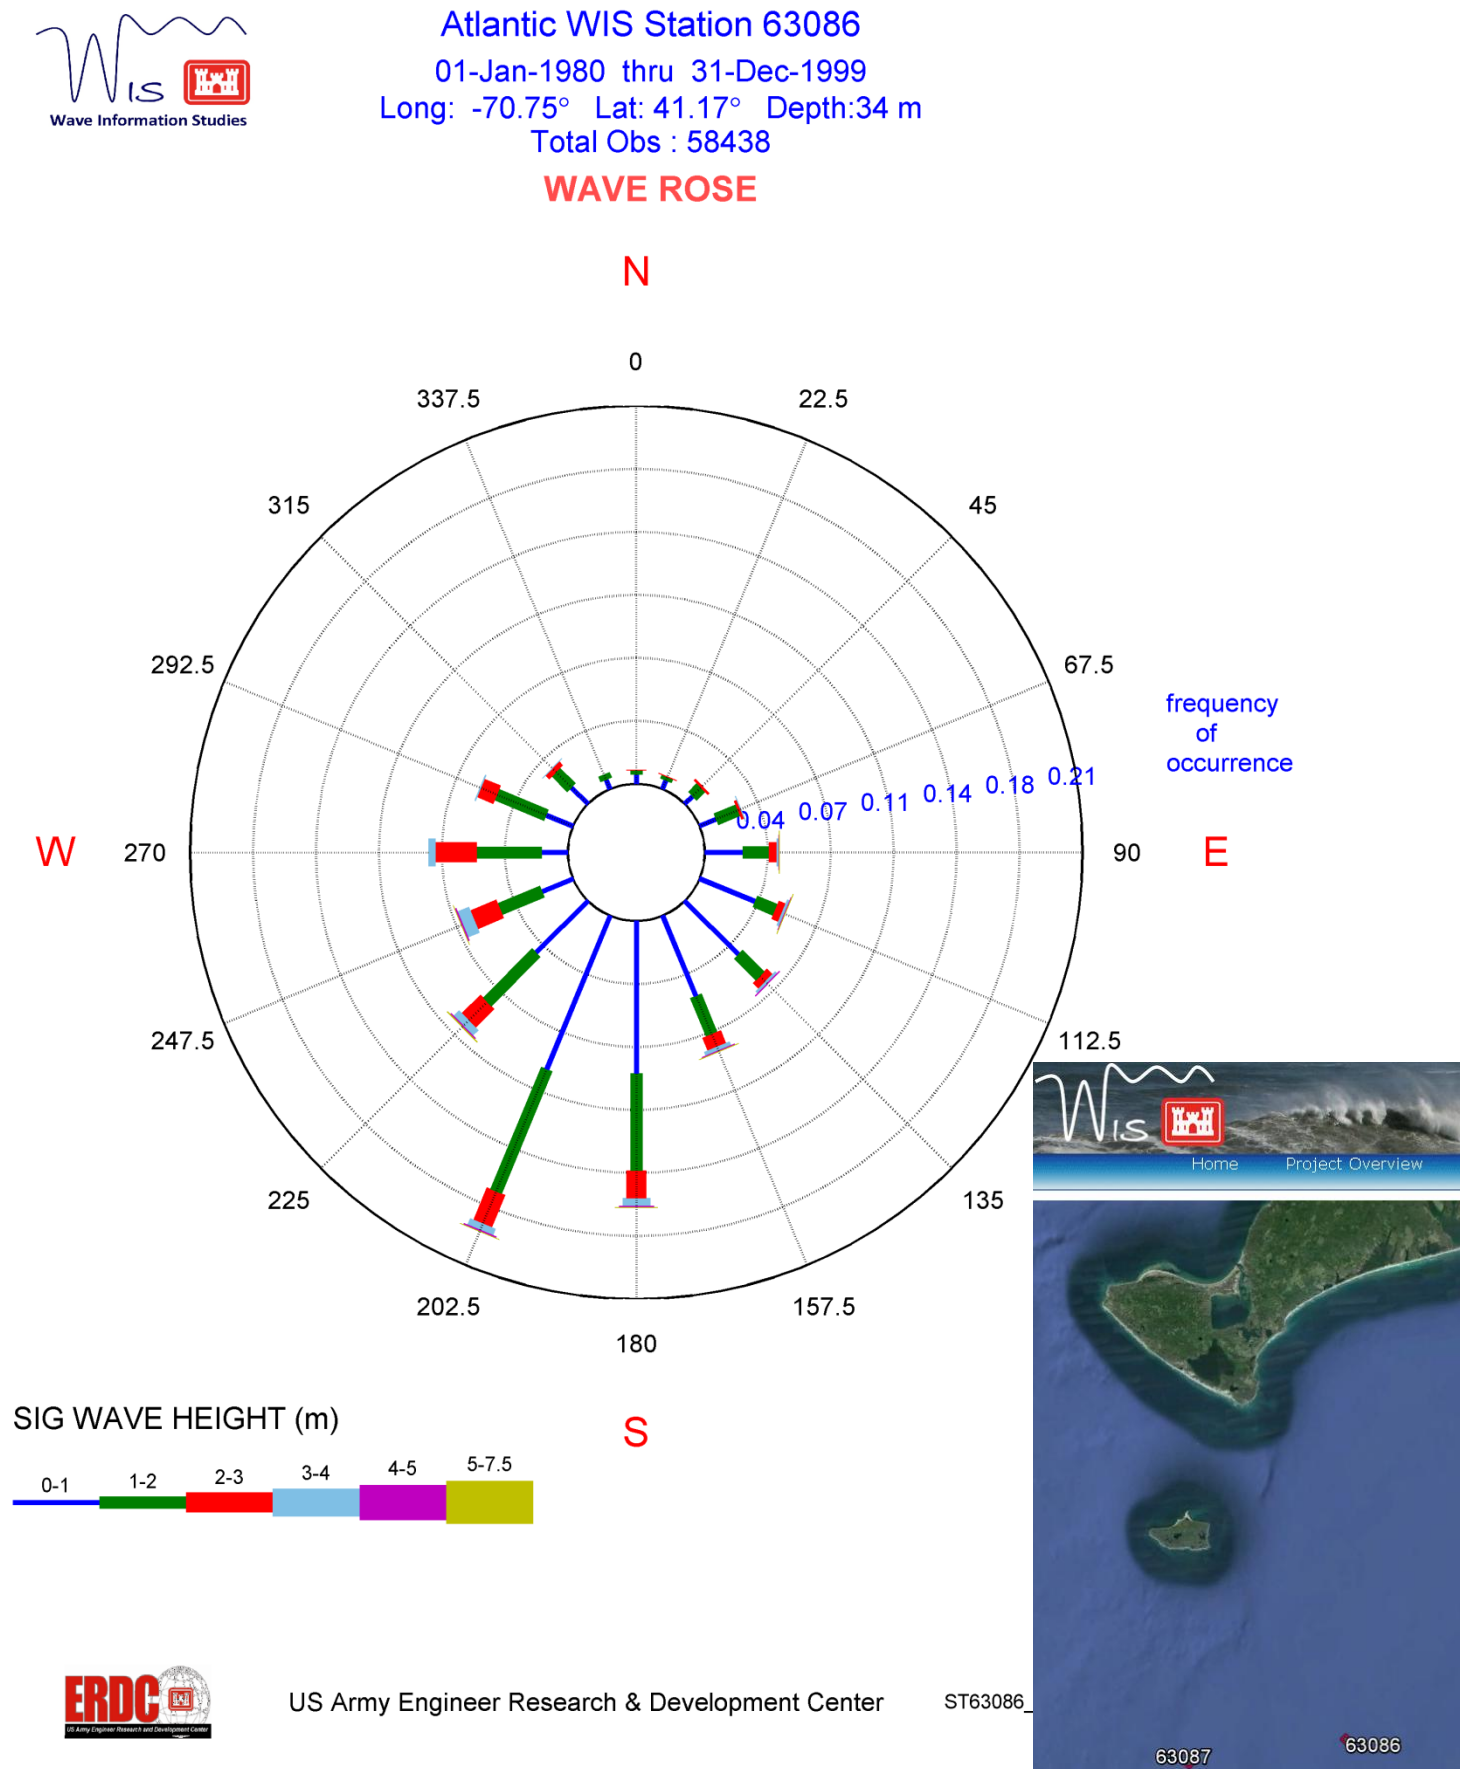
The wave rose of the offshore WIS wave hindcast station shows relatively weak and infrequent waves from the north (Figure 3). The station shows the trend of a higher quantity of waves from the SSW, likely due to the protection of the island of Martha's Vineyard to the north. Therefore a hurricane, with a landfall just west of the Vineyard, would be able to more directly impact Squibnocket Beach than comparable strength nor'easter. The most frequent wave energy direction is narrowly distributed from the south to the south-southwest, however the largest significant wave heights (>15') come from the east. This may indicate that, although the most frequent waves at Squibnocket Beach occur from the south, it may be that the swell from the east (generated during nor'easters) results in the most significant erosion.

Figure 3. Map showing a wave rose of the nearest WIS (Wave Information Studies) station #63086 to the site. The USACE produces wave climate information for U.S. coastal waters. WIS information is generated by numerical simulation of past wind and wave conditions, a process called hindcasting. (images adapted from <http://wis.usace.army.mil/>)

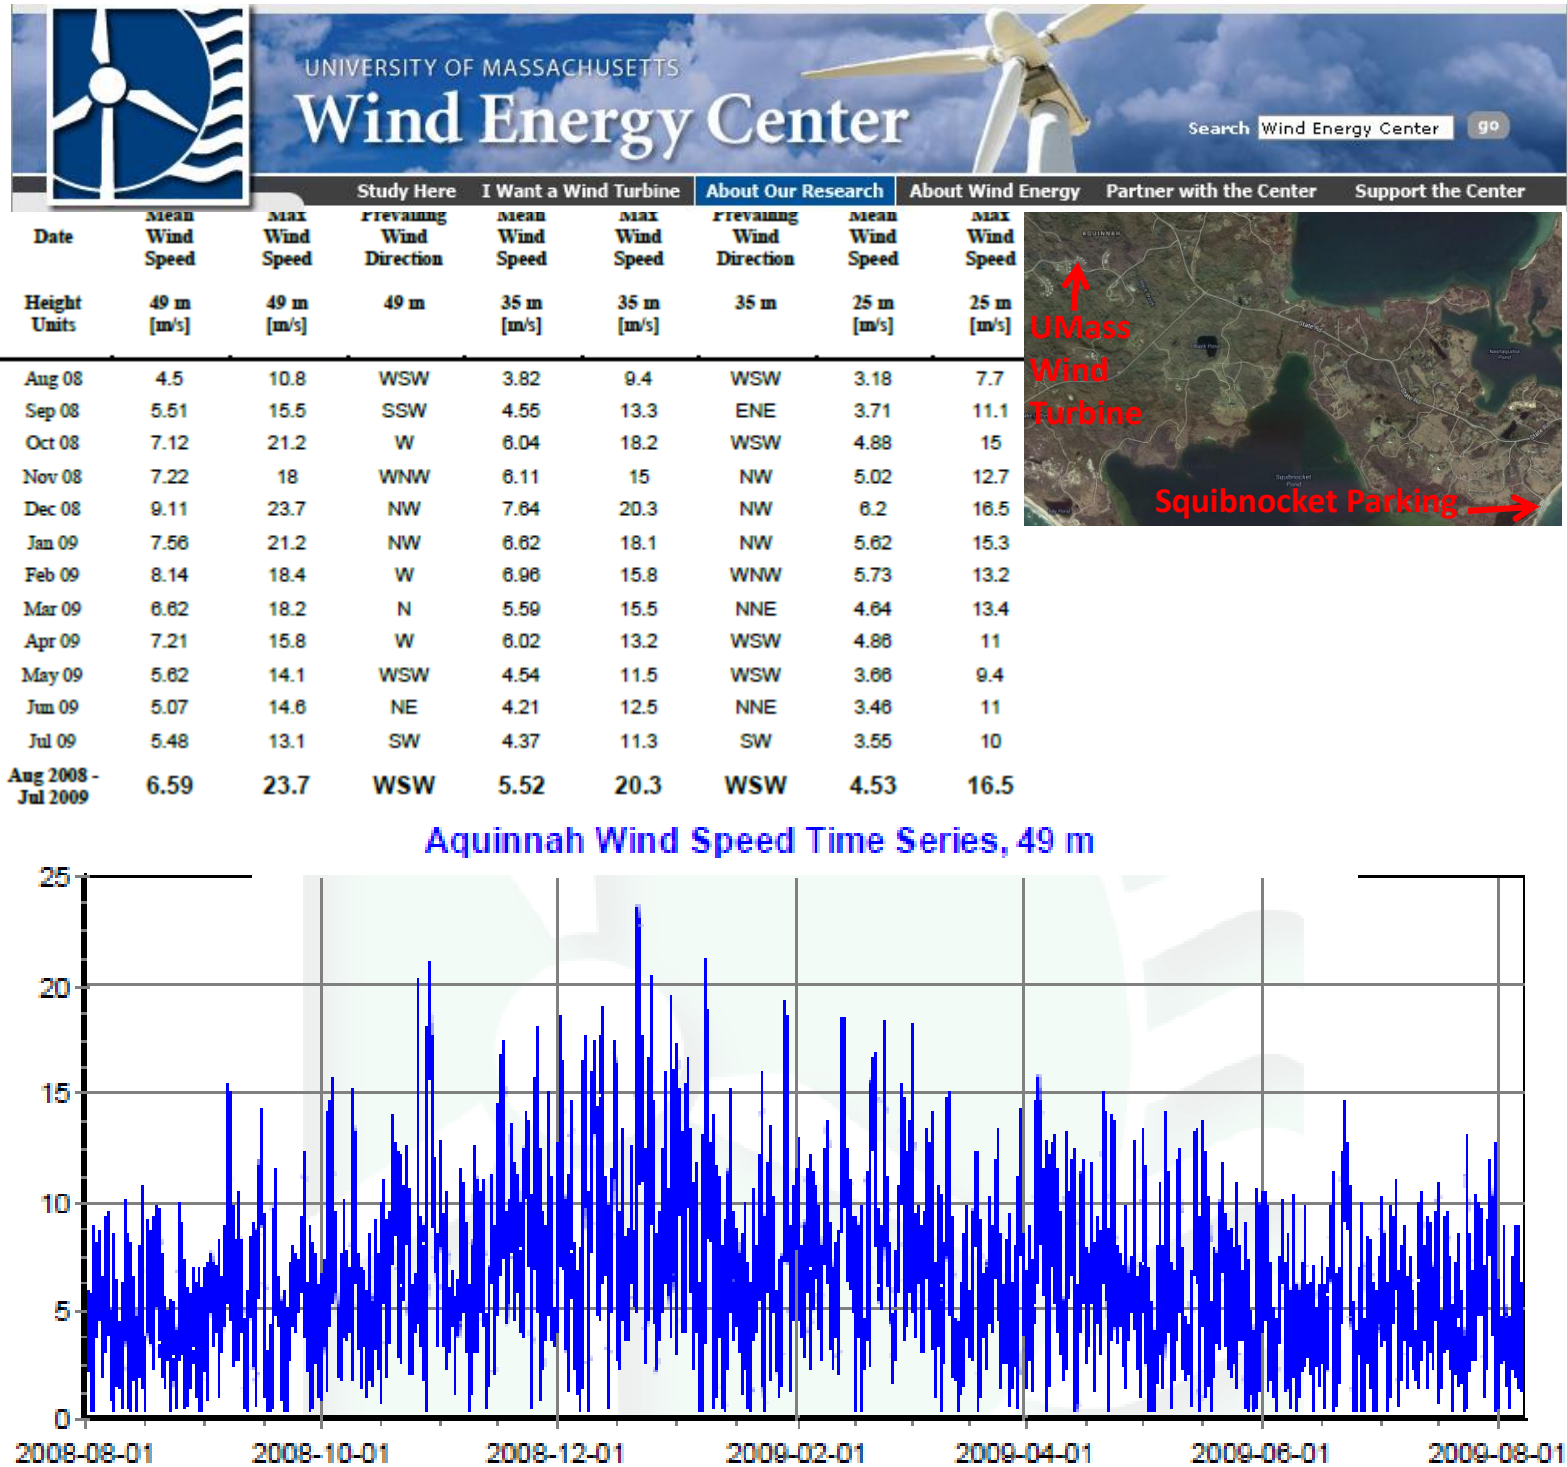
Local wind data was collected from a nearby site in Aquinnah by the UMASS-Renewable Energy Research Laboratory from 07/11/2008 to 08/13/2009 (Figure 4). The annual average wind speed, at 160' off the ground, was 15 mph and the prevailing wind direction was West-Southwest, however seasonal trends are apparent in the data. The summer is characterized by lower wind speed and a more southerly wind direction. Winter is characterized by prevailing north and west winds as well as higher wind speeds. It should be noted that the peak winds recorded (53 mph) occurred during December from a northwest direction, October and January had similar peak speeds and direction.

Figure 4. Wind data collected from a site in Aquinnah by the Renewable Energy Research Laboratory, UMASS. The table and graph below are adapted from their Wind Data Report (07/11/2008 – 08/13/2009).

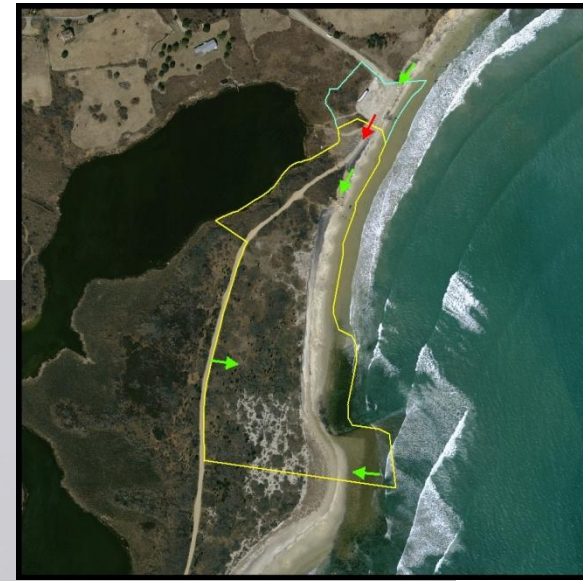
Photograph 2. The photograph below shows the narrow roadway from the parking lot to the south. The image to the right indicates the location and direction of the photograph below (red arrow) as well as the other photographs in the series (green arrows).

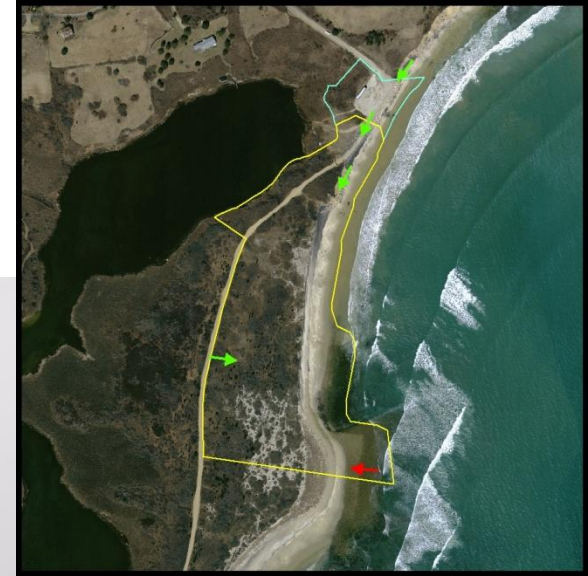
Photograph 4. The photograph below shows the “mussel bed” headland area looking towards the upland areas. The image to the right indicates the location and direction of the photograph below (red arrow) as well as the other photographs in the series (green arrows).

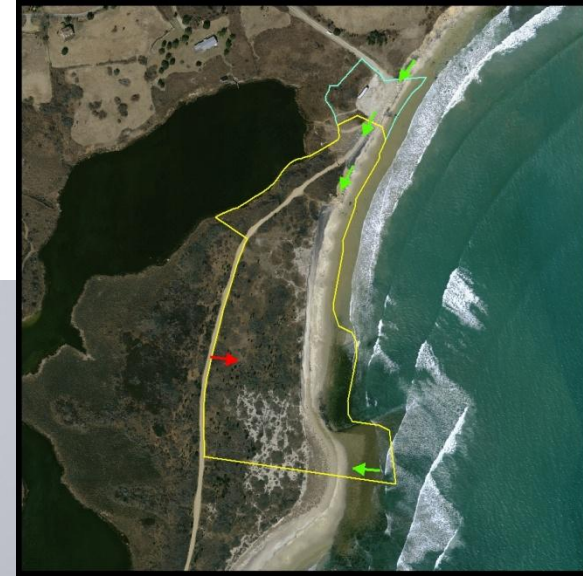
**A4:** The vegetation observed during the site visit appeared to be healthy and robust (Picture 5). This type of salt-tolerant vegetation with extensive root systems helps hold sediment in place, helping to stabilize the area. Also, reducing runoff erosion and trapping windblown sand, these plants are increasing the ability of the coastal resource area to buffer inland areas from storm waves, erosion, and flooding. The vegetation will likely remain healthy unless impacted by human activity or coastal erosion during a storm event. Erosion rates were presented in the previous section.

Photograph 5. The photograph below shows the approximate area of the proposed parking lot, looking towards the ocean from the road. The image to the right indicates the location and direction of the photograph below (red arrow) as well as the other photographs in the series (green arrows).
