Chilmark Panning; Menemsha Corridor Plan for Improvement [Analysis +Recommendations]

Martha's Vineyard Commission and the Town of Chilmark, MA

February 09, 2018

Presentation of Findings based on the Final Report, dated August 20, 2017 and Appendix B, dated December 11, 2017

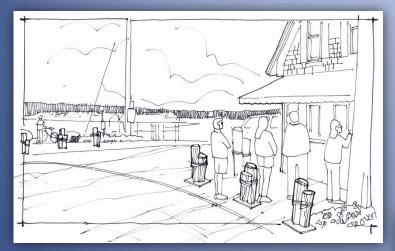
Pedestrian Paths

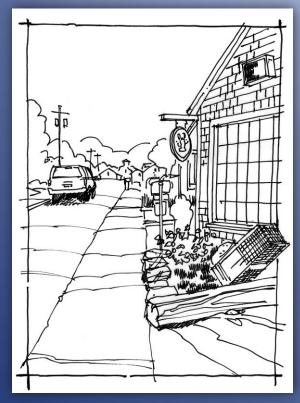
Looking toward North Road from the Beetlebung Cafe

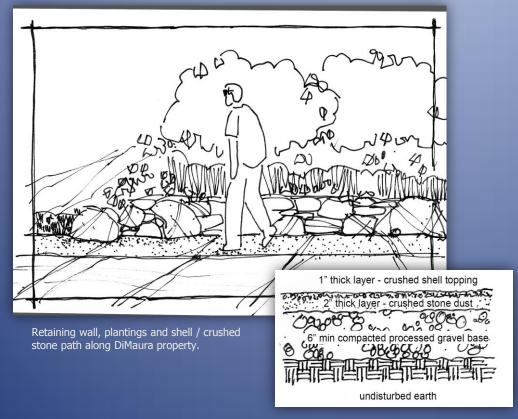
Cross-section through shell / crushed stone path

- Regrade the corner from Beetlebung Café (along the DiMaura property) with a crushed stone and shell walk to the edge of Crick Hill Road. Mediate the existing slope using fieldstone, boulders, etc.
- Cross Crick Hill Road and over the bridge with marked pavement. Prior to the markets, provide a cross-walk to the Comfort Station and proposed VTA bus stop.

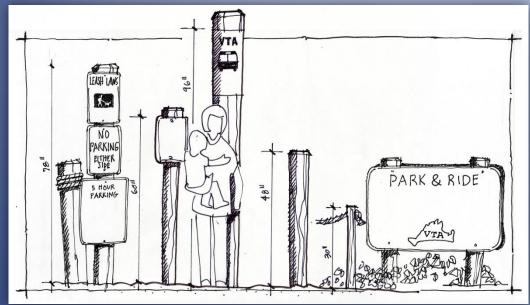
Signage and Way-finding

- Provide new signage consistent in size and style from the Galley to the beach. Make the new signage as inconspicuous as possible, using a common color scheme, graphics, etc.
- Repetition of pattern and placement is the key to the success of the signage package.
- Provide taller, larger diameter pier posts for hierarchically more significant items, such as the VTA pick-up points, emergency access, toilet facilities, etc.
- Suggest a painted graphic band at the top approx. 18 inches of these posts using a muted color scheme in keeping with the sun-bleached context of the existing area.
- The sun-bleached finish of any new wood surfaces can be accelerated using 'bleaching' stains, accomplished using 'Milk Paint.'
- Place informational signage in 2 locations.

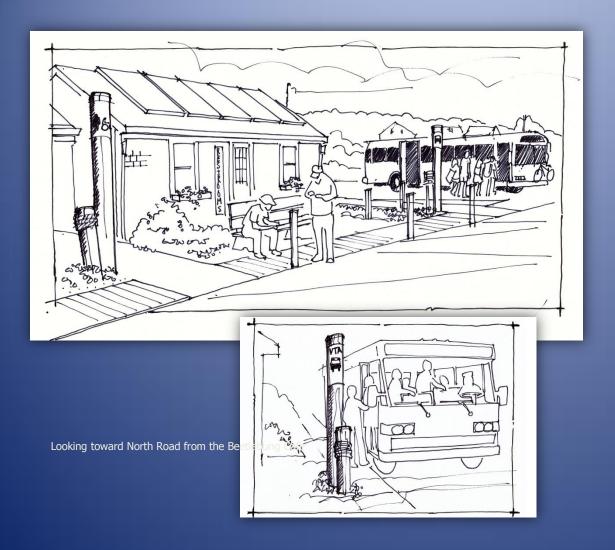
- Modify the existing gravel parking on the south side of the Comfort Station.
- Provide new gravel parking on the north side of the Comfort Station in reclaimed area.
- Provide a minimal width connector drive behind the Comfort Station terminating at a passenger loading area (bus stop) the street.
- Reorganize existing parking spaces in front of Comfort Station to make new curb-cuts and access for the employee parking/bus turn-around.

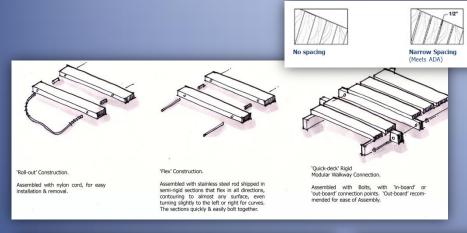
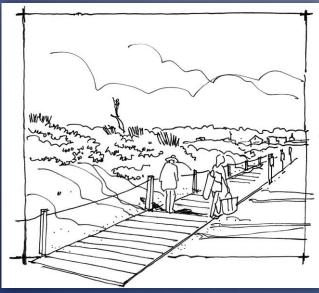
Seasonal Pedestrian Walkway (Comfort Station to Beach)

- Upgrade the seasonal walkway for access to the beach. Extend the walkway across the front of the Comfort Station to the bus stop.
- Provide new mat-type access from the beach entry to the high-tide water line for 'independent access.' Replace the existing seasonal walkway with another product with code-compliant spacing (1/2" max) or less at the required width of 36 inches which is stable and firm.

- Provide a system that can be bolted together, or is of the 'roll-out' type with longer lengths. Alternatively, there are modular panels comprised of boards fastened to 2x or 4x sleepers which with 'out-board' bolted connectors. The use of a woven polyester mat would be another suitable alternative, but slightly less firm.

- Surface preparation in the form of raking or leveling the sand base along the length so that any system placed on it is more consistently flat. Machine raking would require the least amount of time and produce a consistent grade over the length of the walkway.

- The path should be continuous from the public beach entry to the furthest toilet room entrance deck and should be minimum 36 inches or 48-60 inches as conditions allow. The wider width allows for passing in opposite directions, otherwise provide passing areas at intermediate points. Extending the boardwalk to the Harpooner Sculpture could provide one such passing area.

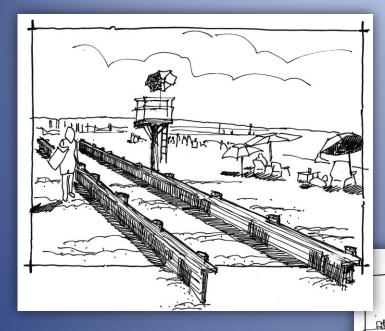
Blowing Sand Prevention

- Reconstruct the existing bulkhead windbreak at the same bench height in its mirror image, with the pocket facing the water.
- Replace damaged components, and provide a new opening for access for mobility impaired visitors to gain access without having to go around.
- Construct a secondary bulkhead, approx. 4
 feet toward the parking lot to disrupt the
 wind-borne sand a second time before the
 parking lot edge. Use the similar materials,
 such as treated pier pilings (dock posts), 2x
 and 3x material.
- Alternatively, a row of slatted 'sand-fence' can be an effective barrier to disrupt the wind energy. This is typically 48 inches high, comprised of wood slats, connector wires and wood posts.

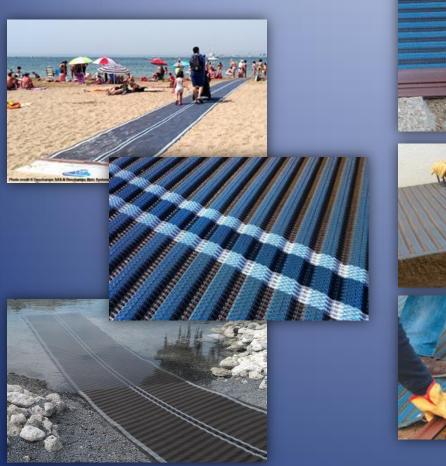
Beach Access to Water Line

- Provide a 60 inch wide temporary path to the high tide water level from the public beach entrance.
- Beach wheelchairs are not a substitute for providing beach access routes, as they do not provide independent access.
- This can be accomplished with a 'roll-up' type mat in lengths as required, similar to 'Mobi-mat' which is a non-slip woven polyester mat, in choice of blue or brown color, with or without striping for the Visually Impaired.
