Sediment Sampling and Testing In Support Of Dredged Material Suitability Determination

Menemsha Creek Federal Navigation Project Maintenance Dredging Martha's Vineyard, MA

US Army Corps of Engineers ® New England District

October 2013

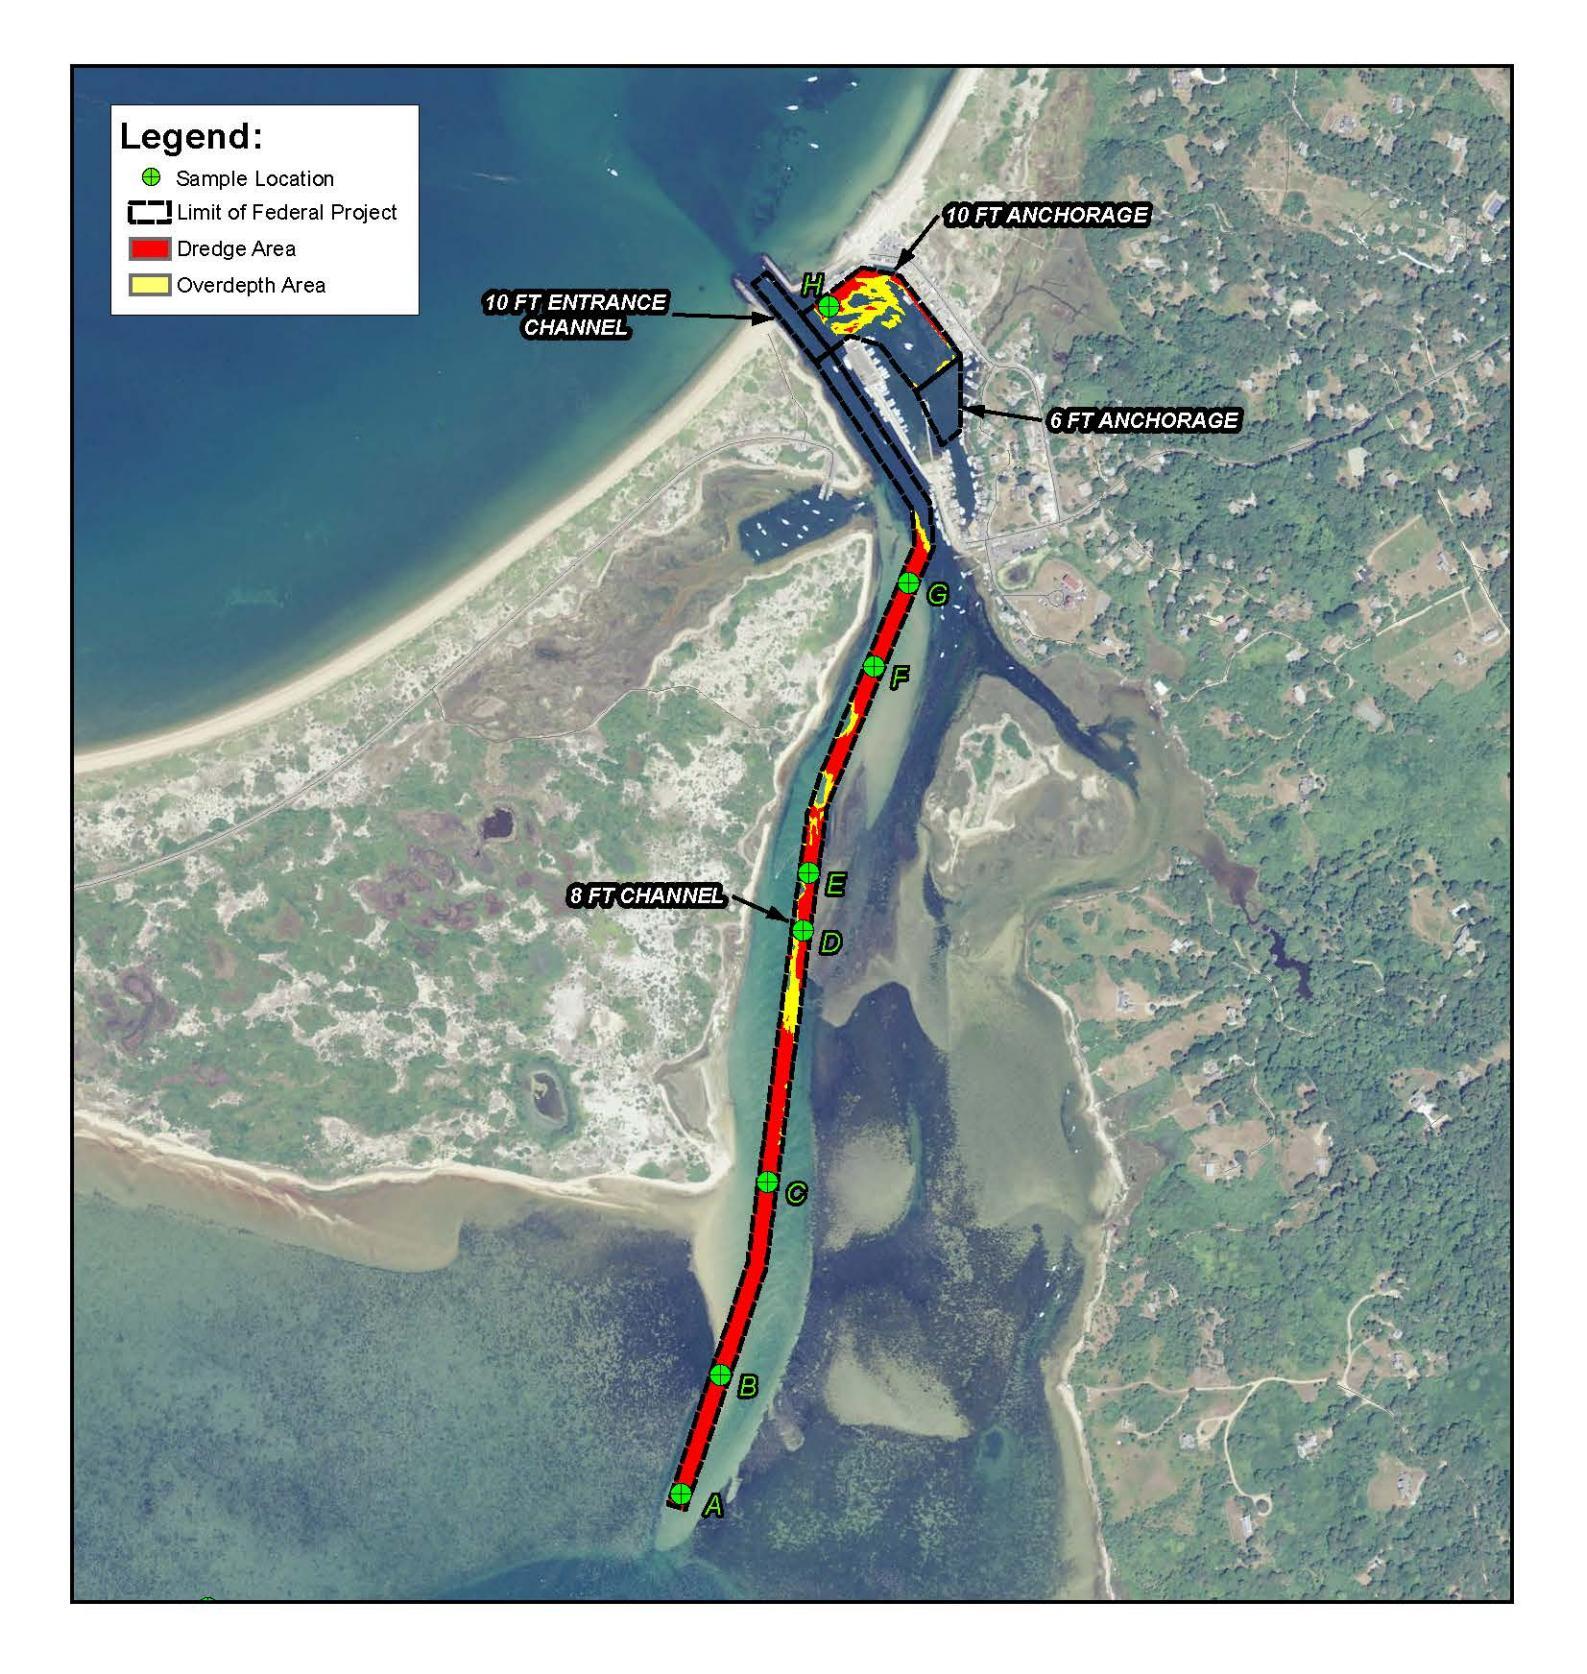
Sediment samples were collected to project depth (authorized depth plus one foot of overdepth) or refusal from 8 stations (Figure 1) using an SDI VibeCore-D electric vibracorer and 2.75" i.d. polycarbonate tubing. Upon collection the cores were secured in an upright position and allowed to settle before being processed on board the sampling vessel. Sampling equipment was cleaned with a brush and rinsed with site water prior to sampling and between each sample station. The core liners were assumed to be clean asreceived from the supplier but were rinsed in site water prior to use.

Sediment collection data is summarized in Table 1. Sampling logs are presented in Appendix B.

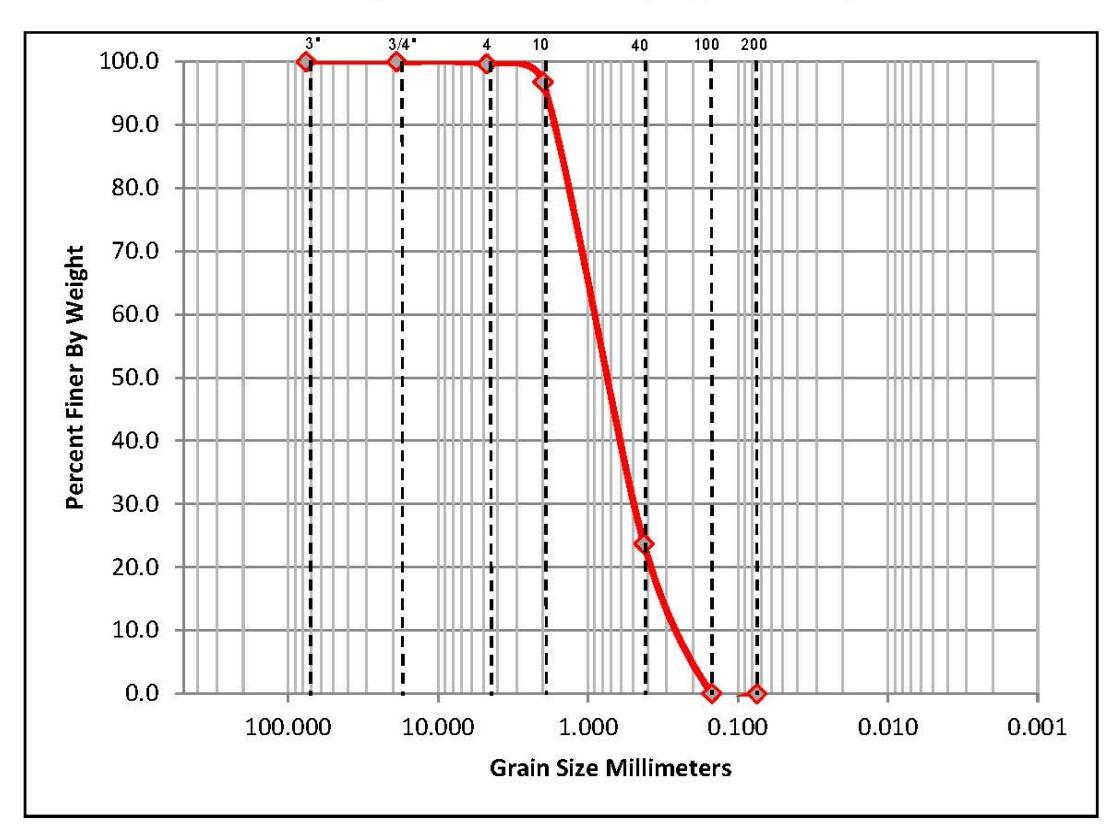
Project Name: Menemsha Creek Project Location: Marthas Vineyard, MA Sample ID: Menemsha-A

Particle Size Analysis - ASTM D 422-63 (reapproved 2002)

Sample Notes: SP - Grey, medium to fine sand with shell fragments.

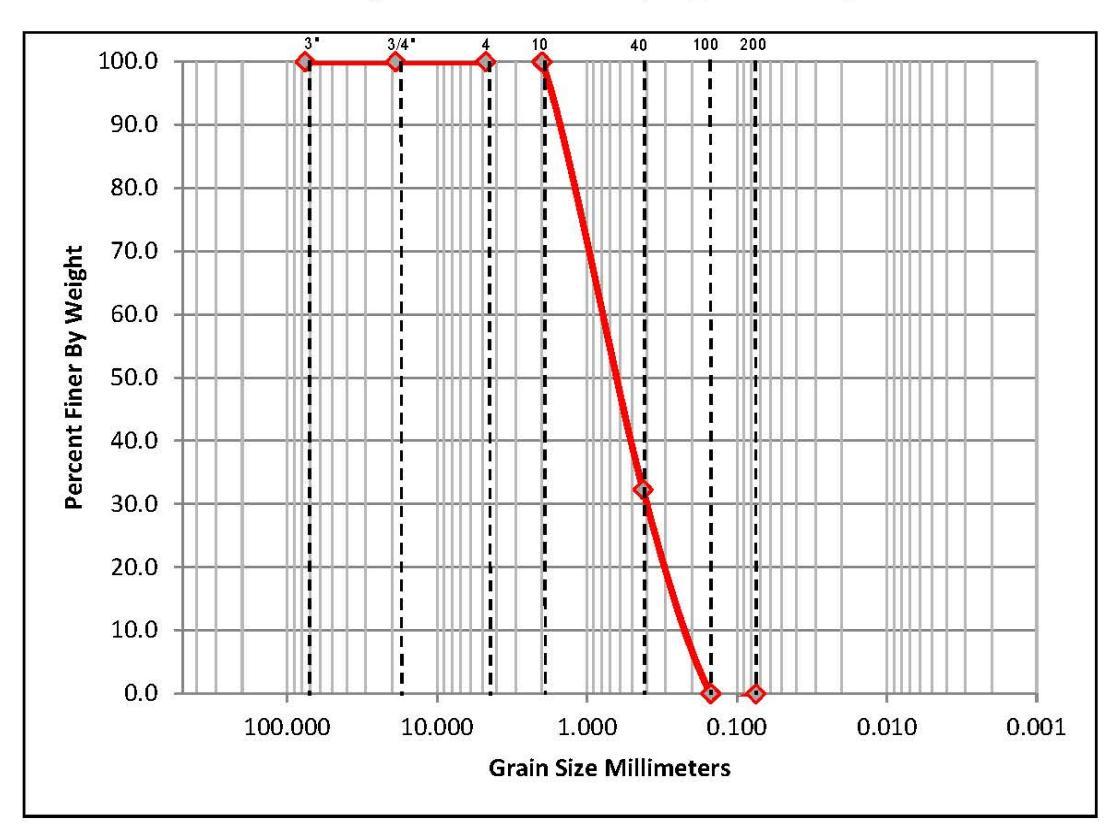
Project Name: Menemsha Creek Project Location: Marthas Vineyard, MA Sample ID: Menemsha-B

Particle Size Analysis - ASTM D 422-63 (reapproved 2002)

Sample Notes: SP - Tan, medium to fine sand.

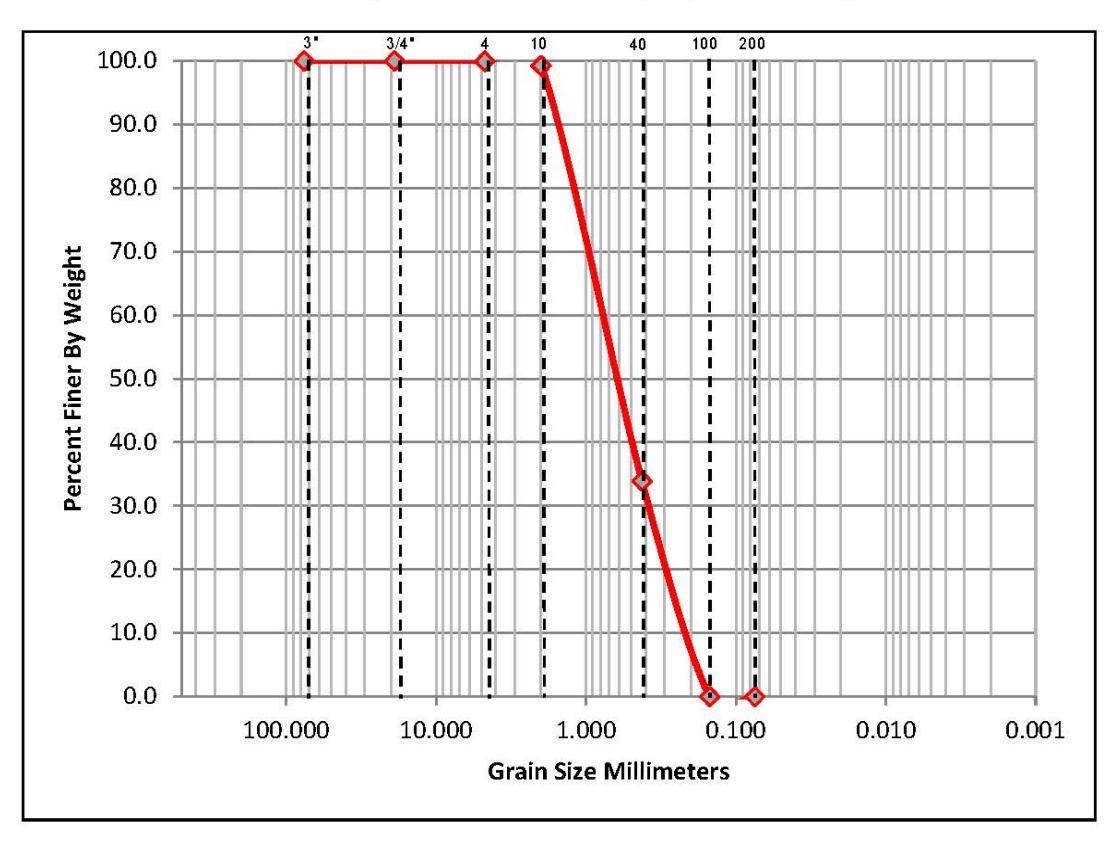
Project Name: Menemsha Creek Project Location: Marthas Vineyard, MA Sample ID: Menemsha-C

Sample Notes: SP - Tan/grey, medium to fine sand.

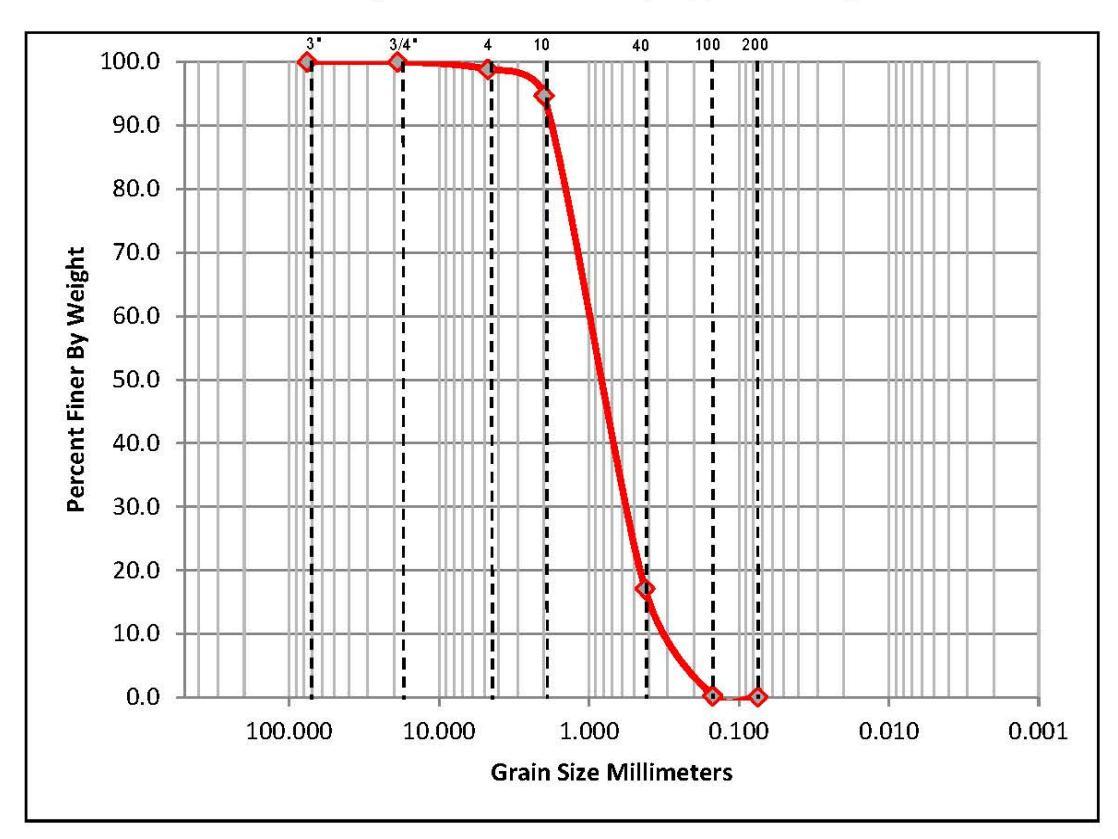
Project Name: Menemsha Creek Project Location: Marthas Vineyard, MA Sample ID: Menemsha-D

Particle Size Analysis - ASTM D 422-63 (reapproved 2002)

Sample Notes: SP - Tan/grey, medium to fine sand.

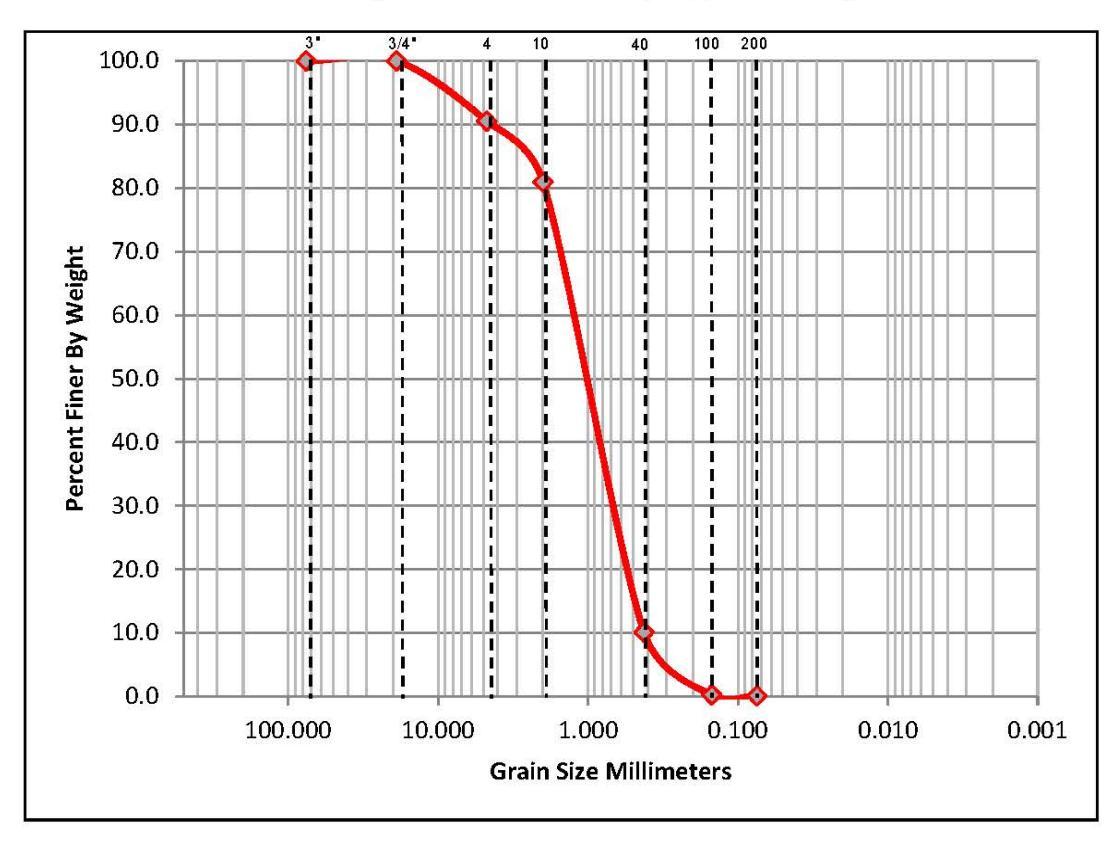
Project Name: Menemsha Creek Project Location: Marthas Vineyard, MA Sample ID: Menemsha-E

Sample Notes: SP - Grey, medium sand.

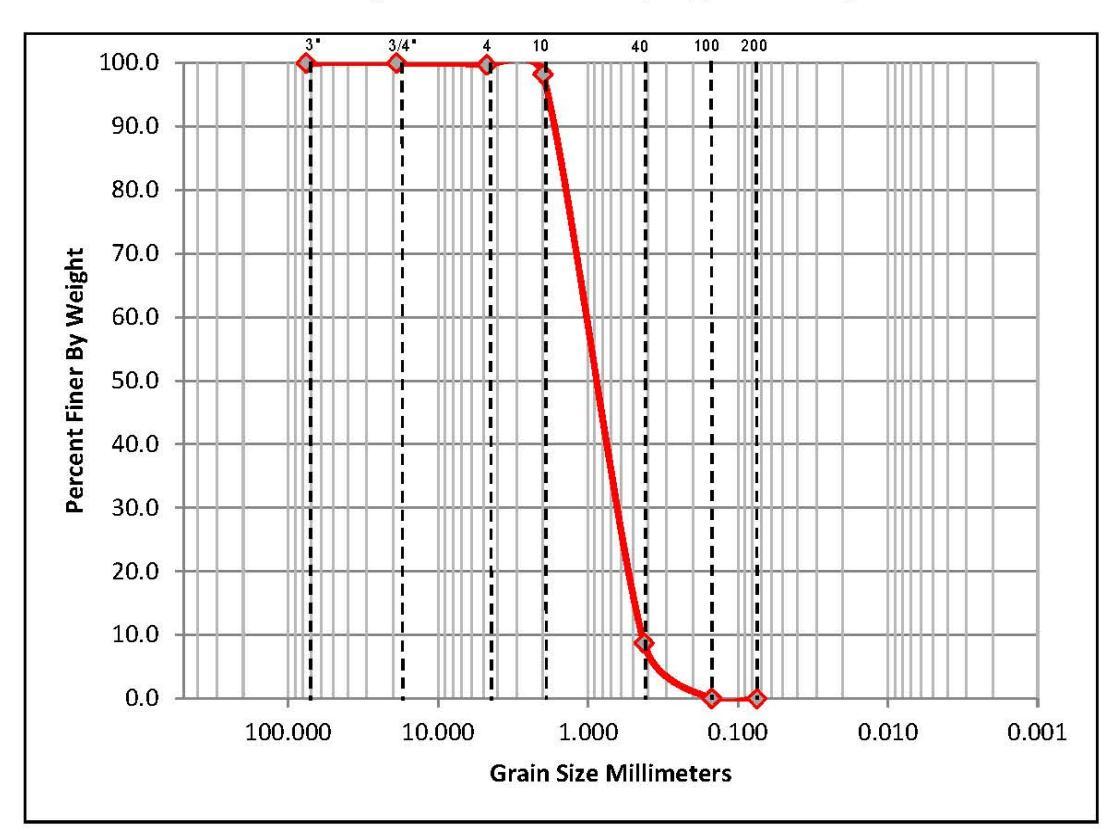
Particle Size Analysis - ASTM D 422-63 (reapproved 2002)

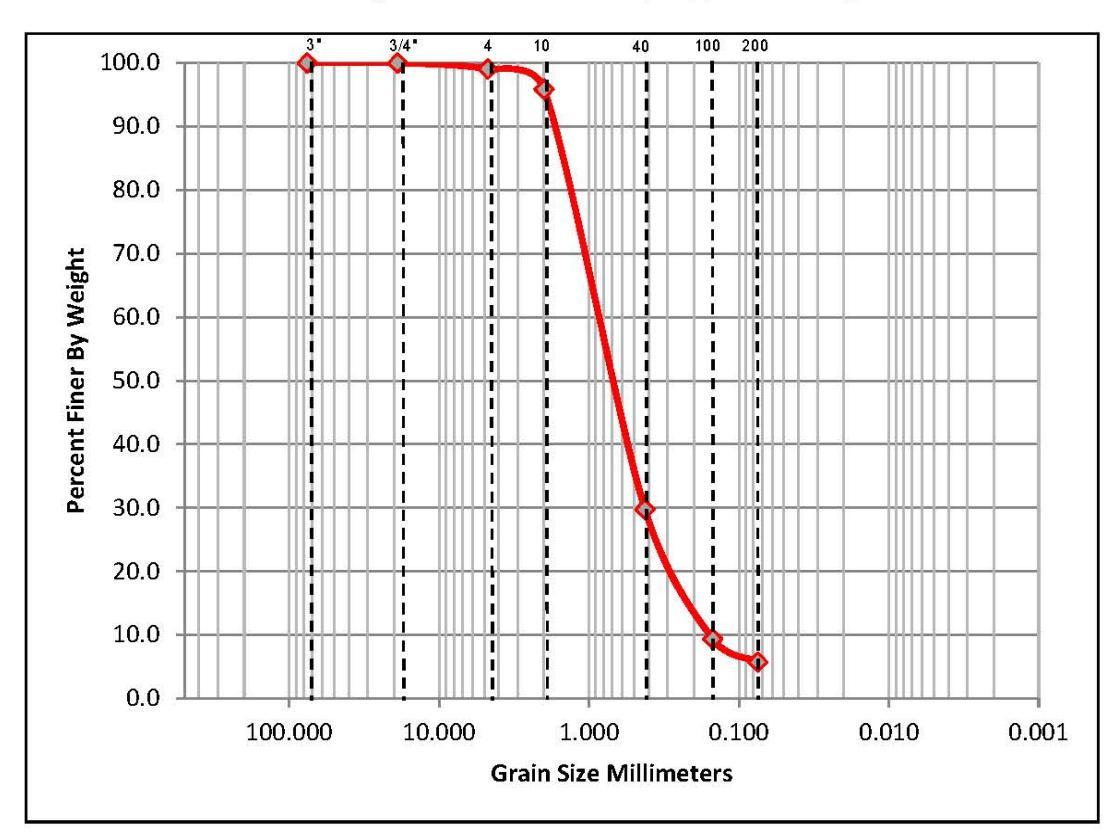
Particle Size Analysis - ASTM D 422-63 (reapproved 2002)
