**Site Plan**

**Chilmark, Mass.**

**Jerome Vascellaro**

Scale: 1" = 40' July 11, 2022

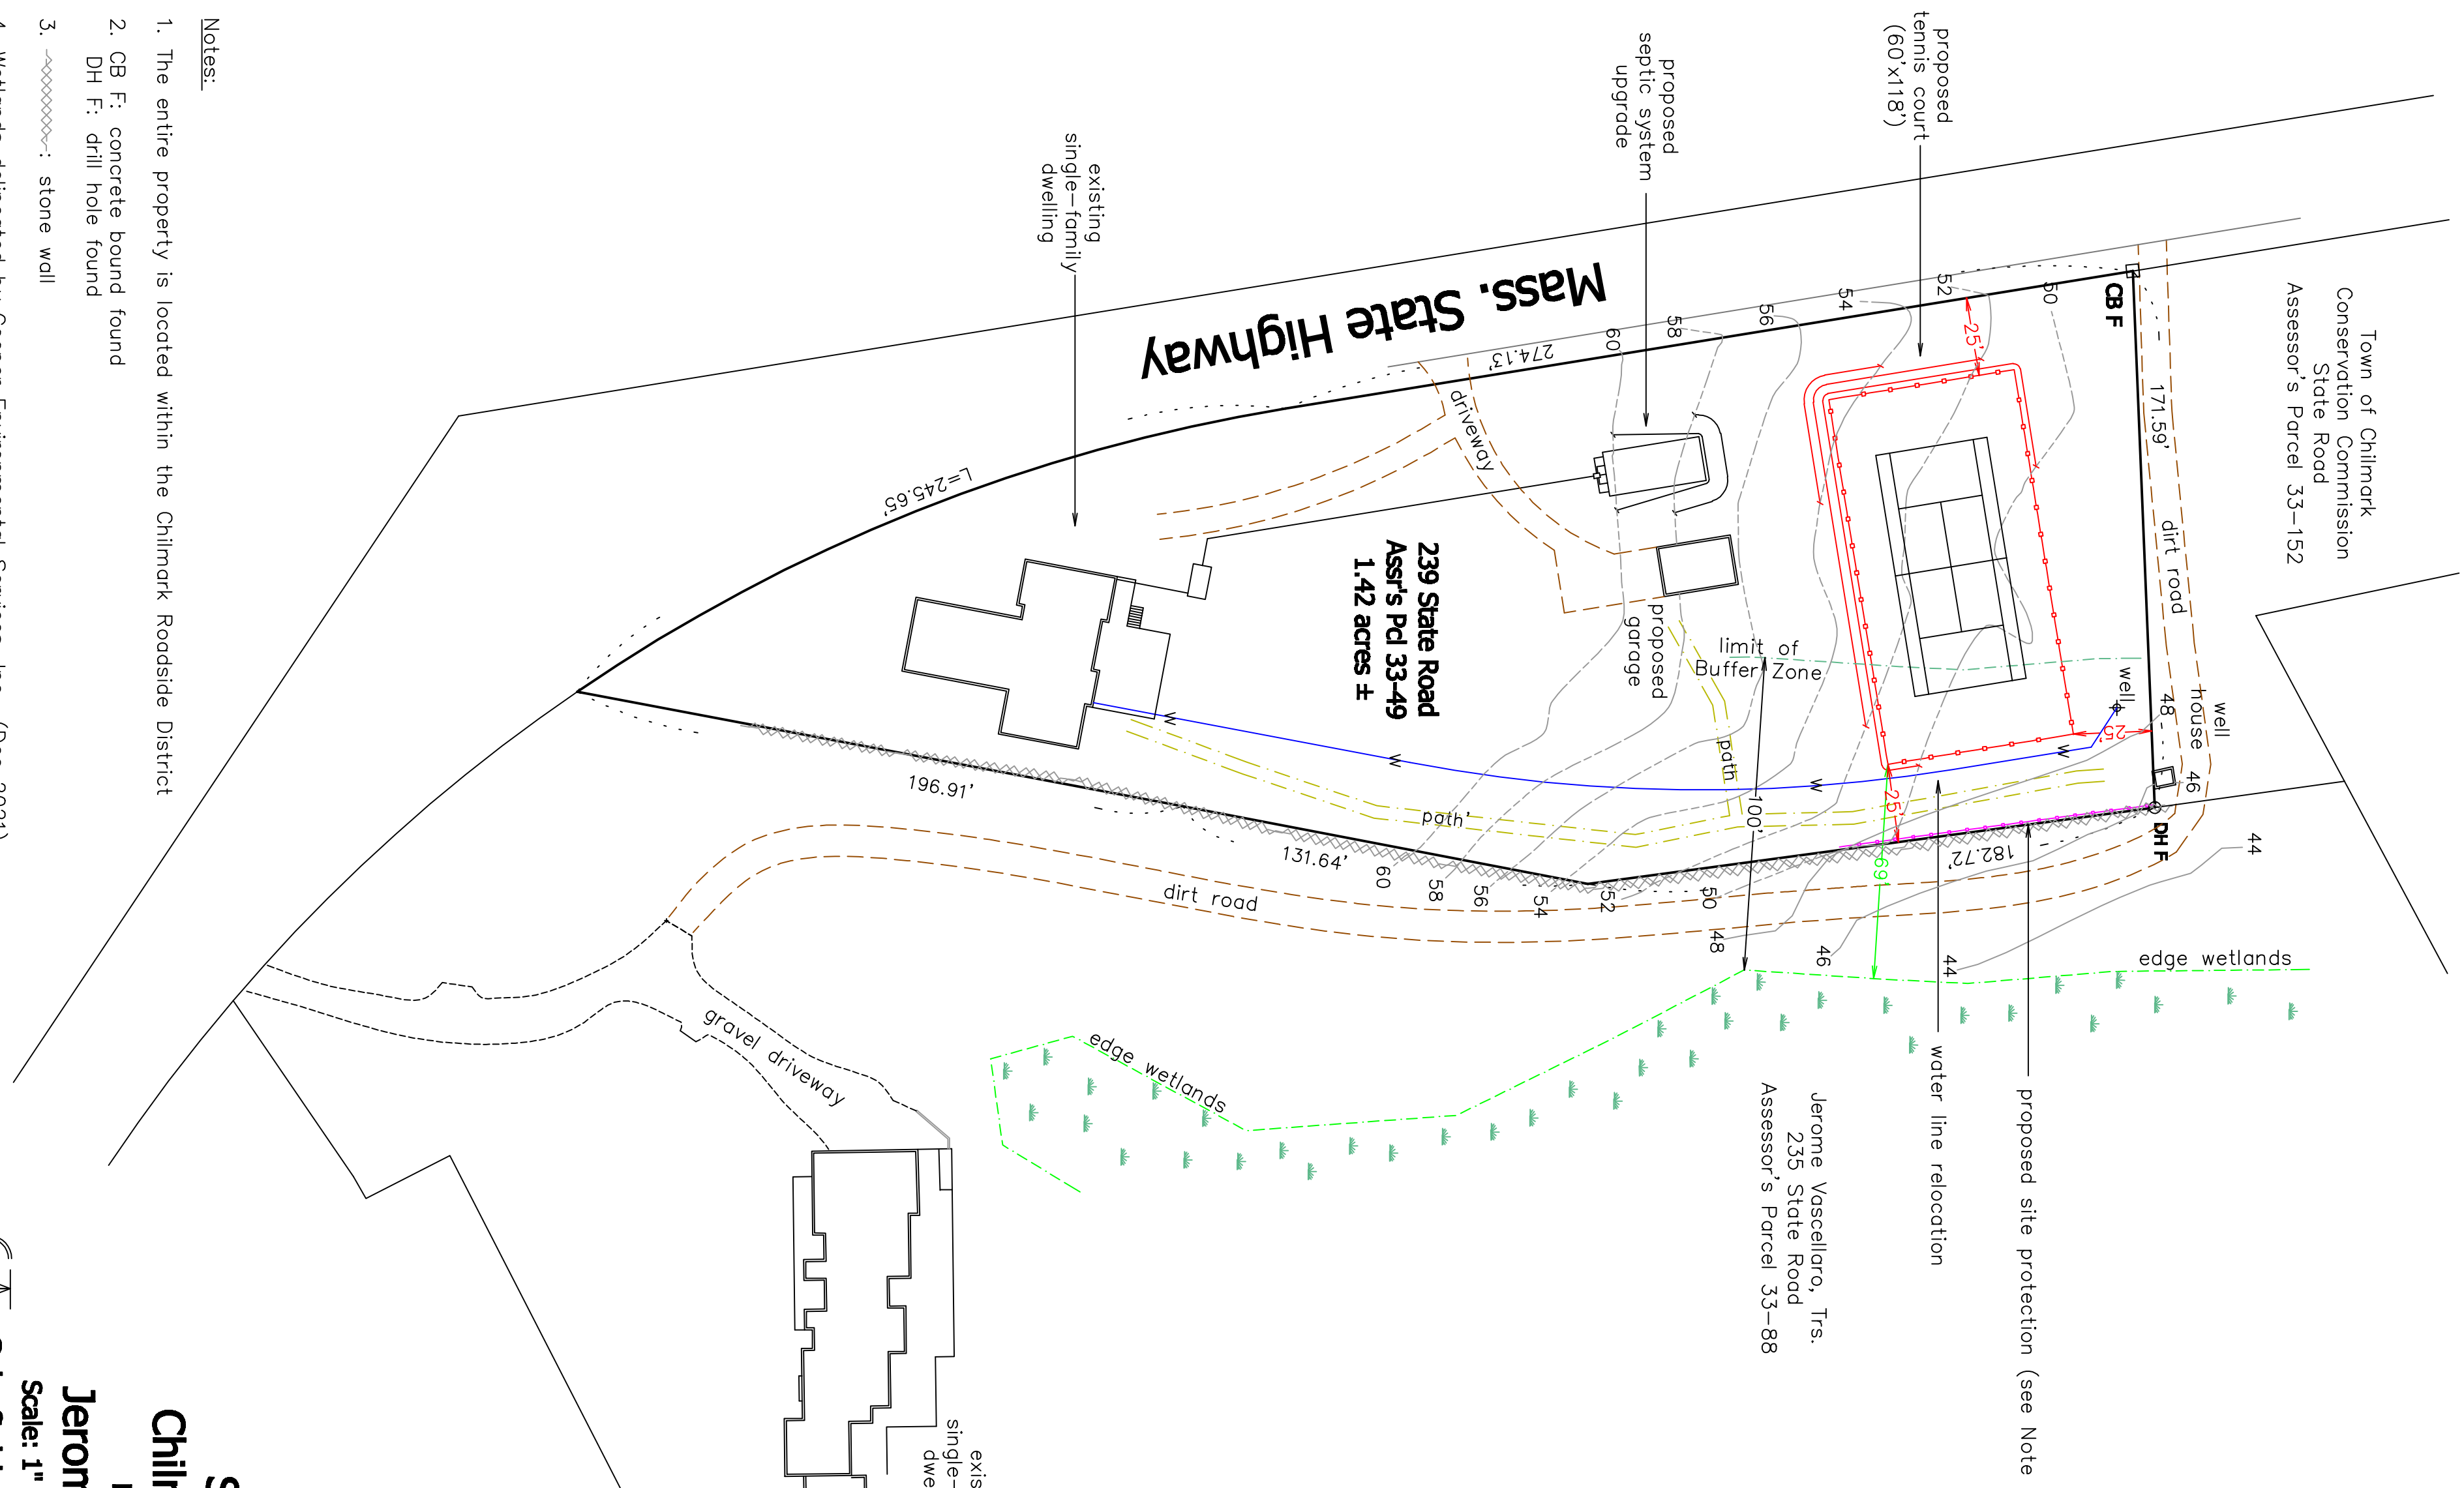
1. The entire property is located within the Chilmark Roadside District
2. CB F: concrete bound found  
DH F: drill hole found
3. : stone wall
4. Wetlands delineated by Cooper Environmental Services, Inc., (Dec 2021)
5. Silt fence to be installed along project side of stone wall and maintained throughout construction and stabilization of disturbed areas
